**Project:** Request for Expressions of Interest for 575 Balmoral Street,  
Winnipeg Manitoba

**REOI No:** MHHD2023-002

**Date:** 2023-05-02 **Addendum No:** 2 (Two)

<b>Technical Memorandum</b> 2019 Field Condition Assessment Findings Manitoba Housing and Renewal Corporation Center Village- 575 Balmoral (Winnipeg)	Page 1 of 12	
	Revision	
Reference: <b>663280-40ER-0001</b>	No.	Date
	00	2019-09-10

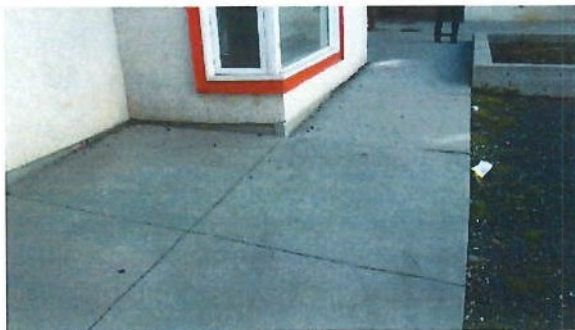
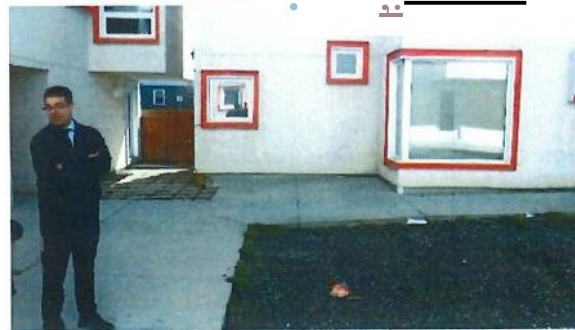
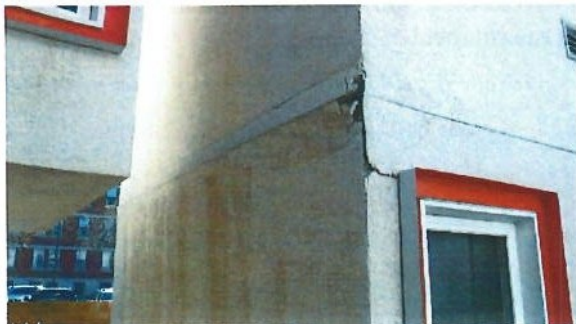
The most critical issue is the foundation uplift occurring at the north end of building A. The northwest corner of the east wing has experienced a significant uplift, causing failure of the exterior sheathing on the building, as well as associated failure of the stucco finish. Also being uplifted at this corner is the interior floor slab and exterior sidewalk. This uplift is jamming the window unit located at the corner,

causing inoperability and possible failure of the window frame. The cause of the uplift of the foundation cannot be attributed to one specific cause unless significant excavation work is completed, but is suspected to be caused either due to improper construction techniques, or water infiltration with frost heaving. It is possible that the pile is heaving, and lifting the grade beam & slab with it, or the grade beam has separated from the pile and is heaving along with the slab. The drawings indicate that crushable void forms were to be placed below the grade beams and slabs to avoid heaving due to expansion of the underlying soil. Either they were not installed, or the void form was not deep enough to compensate for the expansion under freeze/thaw conditions leading to the jacking. This jacking was not noticed to be occurring in other locations on the property in either this building or the other buildings. This leads to the conclusion of something being different at this particular location. A possible different soil strata, improper or not-installed void forms, incorrect void form product/substitution, or significant water accumulations compared to the rest of the site. Also of note at this corner, is a discrepancy between the drawings and the as-built condition. The architectural drawings show two separate window units butted up at the corner, which would allow for jack and king studs at the corner to properly support the floor and walls above. The actual window installed is a single-unit corner window, which leaves part of the floor and wall above unsupported unless framed differently than shown on the drawings.

Fig. 1.: Jacking corner of Bldg A (unit a8).

Fig. 2: Another view of jacking.

Fig. 3: Damaged wall and stucco due to jacking.

The repair of the Building A foundation will be the largest capital expenditure portion of repairs to the site. The slab outside the building and inside must be removed to inspect and repair the foundation. Excavation will be required to allow access, remove accumulations of soil which are preventing the concrete from returning back to original position. Possible replacement of the foundation may even be required but cannot be determined until the foundation issues are daylighted. The north wall of Building A should be repaired after the foundation issue has been corrected. Stucco finish and sheathing will have to be removed, and the stud framing inspected for any damage due to the uplift forces. Then the wall can be repaired, re-sheathed, and re-stuccoed. Windows will have to be replaced if the frames and operators are damaged, which is highly likely based on site observations. Windows which span around the corner as single-units should be replaced with two separate window units abutting the corner, with proper studs in the corner in order to support the upper levels.

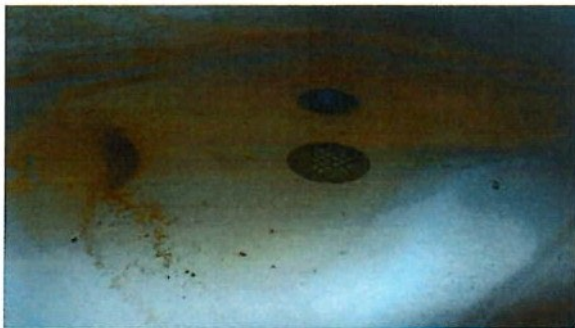
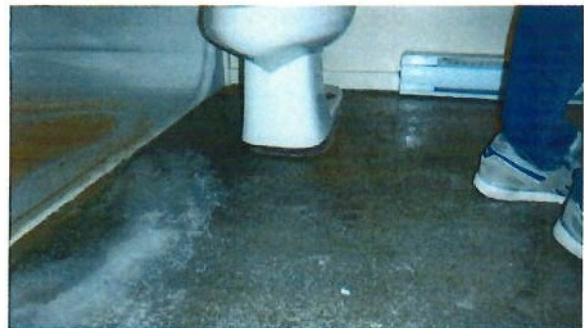
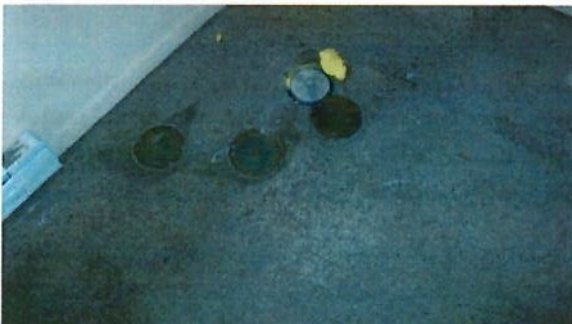
Also within the Unit a8 located at this spot in Building A are issues with the underslab plumbing. Heaving is causing the plumbing connection points to lift out of the slab. The result is the floor drain & cleanout, the shower drain, and the toilet flange to be raised approximately 1.5 inches above the slab. The toilet is still connected to the flange, and is precariously balanced on the top flange elevated above the slab.

Fig. 4: Shower drain lifted out of shower floor.

Fig. 5: Toilet raised off floor due to drain lifting.

Fig. 6: Floor drain raised out of floor.

The interior slab must be removed to retrench and replace all the underslab plumbing in the unit affected by the uplift. This should be completed simultaneously with the foundation repairs as noted above.

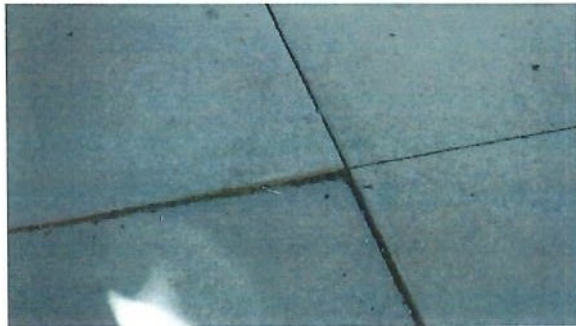
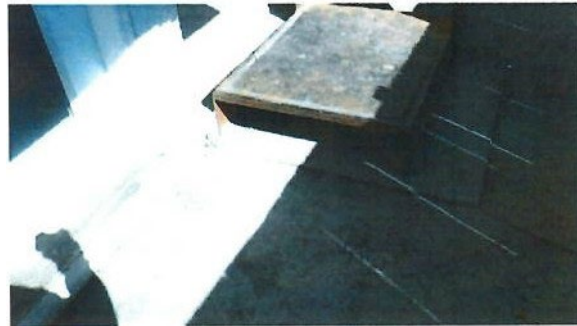
Throughout the site, sidewalks are uneven, sloped, and unaligned. Several step-ups and downs occur which do not meet code requirements for height. These are risks for trip and fall, as well as causing accessibility issues for those with mobility restrictions.

Poor drainage of the sidewalks is an interrelated concern. The sidewalks have shifted and become misaligned & sloped, with water collecting against foundation walls unable to drain away, and forms ice pads in the winter increasing the risk of slip and falls even more.

Fig. 7: Example of uneven sidewalk.

Fig. 8: Multiple elevations to walk through: concrete pad to left of metal platform, metal platform, lower concrete slab, uneven/unmatched sidewalk.

To ensure safe walkways (eliminate the unaligned sidewalks & trip hazards) and to ensure proper drainage, the courtyards will require replacement of the sidewalks and door landings. During this work, all of the site should be regraded to ensure all rainfall is directed towards and into the storm sewer grates,

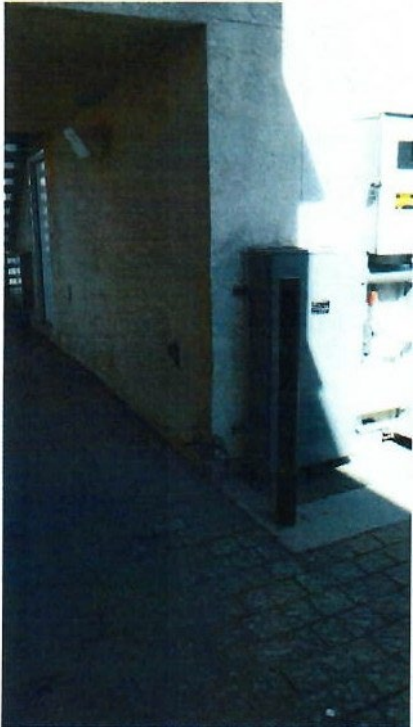
Several locations throughout the site on various buildings have cracked and failing stucco. The locations and heights of the damaged stucco lead to the conclusion that the failure has been caused by impact from objects, most likely vehicles driving through the north courtyard. There are also locations where stucco is missing from below windows and doors. As to why this stucco is missing, it is difficult to determine but a possible reason could be the stucco was damaged or removed during window frame or door frame replacement and was simply not replaced.

Fig. 10: Example of damaged stucco. Wall patch as well as corner bottom.

Patching of the damaged stucco is a simple repair to restore the exterior weather protection. Approximately a dozen spots up to approx. 1 square foot each are scattered throughout the site. This patching can be completed at the same time the north wall of Building A is re-stuccoed. A word of caution, patching stucco often ends up with the patch material being a slightly different colour than the original stucco. This may not be of concern to MHRC, but if so, they have the option to paint the exterior walls after completion of the repairs. This painting will then become an ongoing maintenance item every few years.

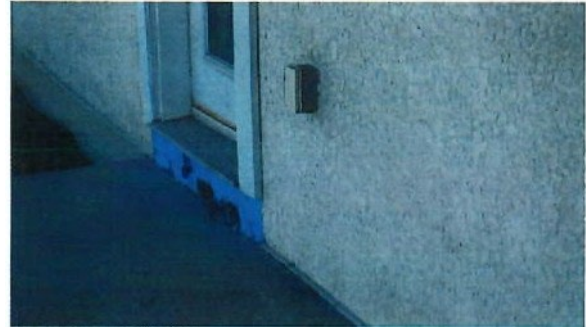
Fig. 9: Example of missing stucco below door.

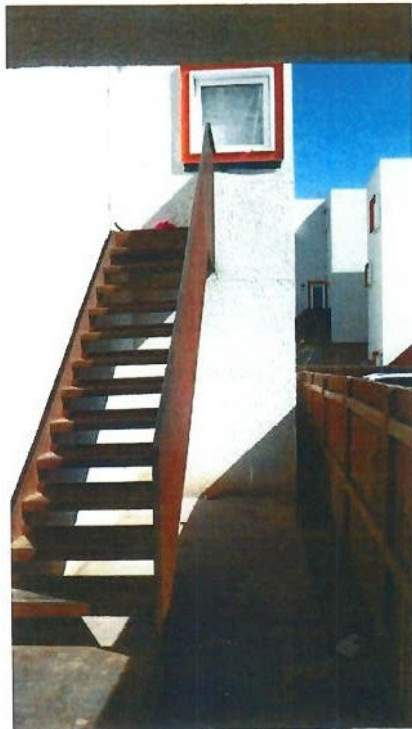
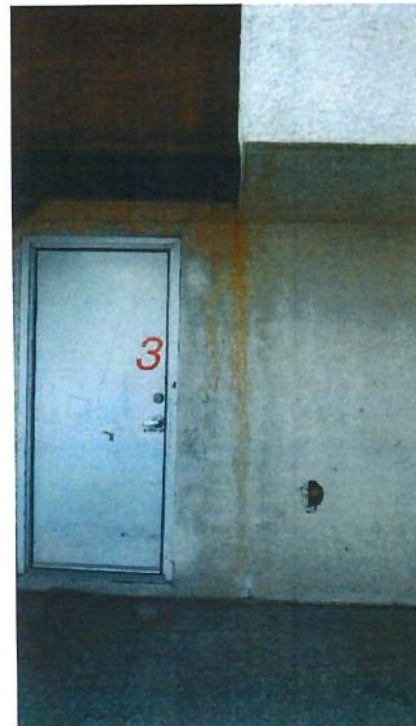
All of the exterior steel access stairs, platforms, guards, and handrails are covered in surface corrosion. At this point, the amount of corrosion has not affected the structural integrity of them, but this is a cosmetic and serviceability issue. There exists a steel which is specifically intended to be left to develop a rusted patina, known as weathering steel, but this would be inappropriate to use in a contact/touch situation. With corroded handrails, people are less likely to grip them not wanting to dirty or contaminate their hands, and therefore increase their risk of fall and related injury. If the corrosion is left to continue, there is a chance that corroded metal particles and flakes will begin to come loose, and if hands are placed on, then embedment into the skin and injury could result.

Fig. 11: Example of corroding stairs.

Fig. 12: Example of staining occurring on stucco due to stair corrosion.

All of the exterior access stairs, platforms, guards, and handrails should be properly cleaned and coated with a rust inhibiting paint system to prolong life and reduce the risk of resident injuries.

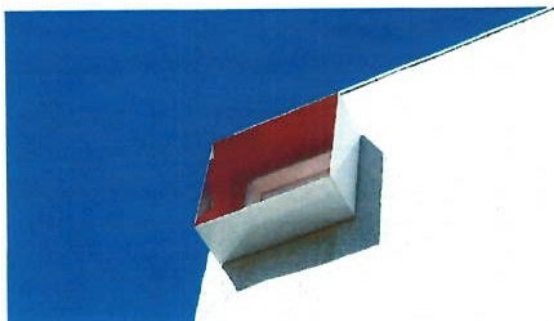
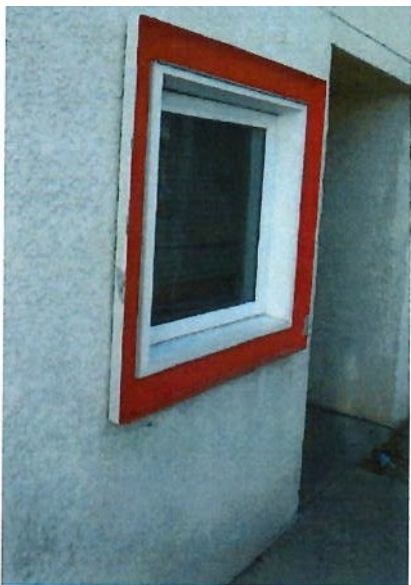
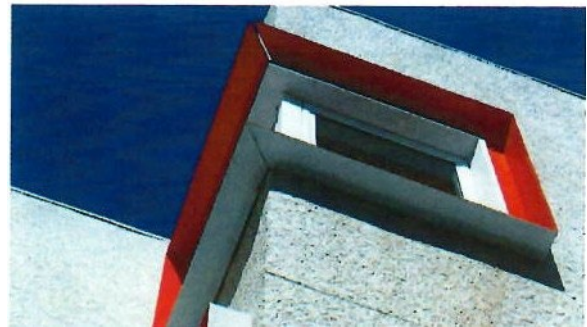
Numerous locations have window accent trims where the paint is peeling, and joints have separated/opened up leading to a deteriorated appearance. The peeling paint is most likely caused simply by the exposed cut edge of the metal trims allowing the paint to lift over time. The joint gaps are being caused either from improper installation (gaps at time of install) or shifting/loosening of the fasteners.

Fig. 13: Peeling window trims.

Fig. 14: Another example of peeling trim.

Fig. 15: Split corner in window trim.

All of the window accent metal trims should be properly cleaned and coated with new paint to keep as an accent feature. Adjustment can be attempted to bring the gapped corners into contact by bending the pieces slightly or by loosening, adjusting alignment, and retightening the fasteners. An alternative would be to simply remove the metal trims, but the remaining fastener holes would require filling and patching. Alternatively, MHRC could remove all the paint and leave the galvanized/galvalume substrate exposed. This would result in the trims having a bright metal finish but overtime they will discolour and lose their brightness.

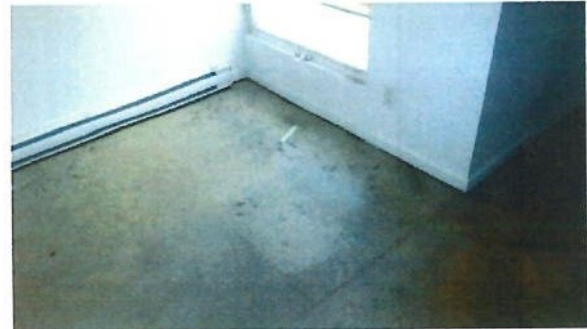
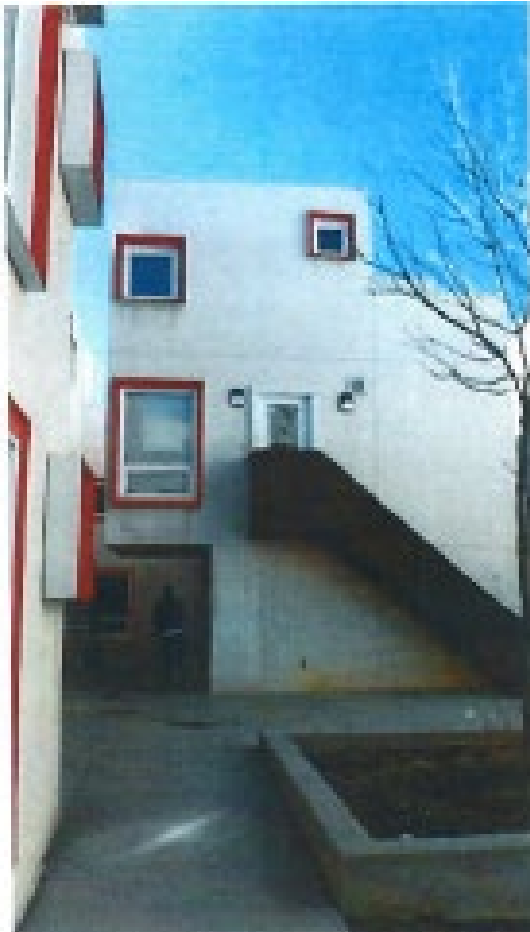
A concern exists over the method of framing the cantilever floors. Every building onsite has a second floor and sometimes a third floor yet on top, where a large cantilever exists. Both the second and third floors cantilever out approximately 6 feet with an approximately same distance backspan. This is very undesirable in wood framed structures, where the usual standard of practice is the cantilever distance is limited to no more than 1/4 to 1/3 of the backspan in order to limit deflection and vibrations and ensure structural stability. It appears as though all outer edges of the cantilevers are sagging approximately an inch, and in units without furniture or people in the room. Interior floor concrete topping is cracking in most cases. Wood structures have a greater propensity to suffer from creep, which is a permanently induced and often continuously-increasing deflection from dead loads.

Fig. 16: Interior view of cantilever.

Fig. 17: Exterior example of cantilever dropping at outer edge.

The second largest capital expenditure work recommended is for the cantilever portions of the buildings. To properly support the upper floors and roof, additional structure is required. The first option may be to install braces from the underside of the outer edge back diagonally to the foundation wall at the floor slab. This will help support the outer edge, reducing deflections, and direct forces into the building foundations. Unfortunately, this may restrict pathways of travel around the site. The second option would be to install support columns on new foundations along the outer edge of the cantilevers. This would be less restrictive to paths of travel however it would be a more expensive option as new foundation work would be required.

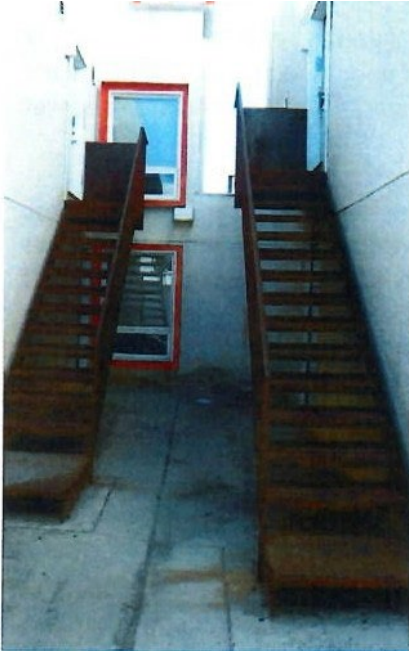
A last and important item of note is the perceived compromised safety and security on site due to the layout and shape of the buildings. There are numerous hidden spots, blind spots, and areas beyond clear line of sight from the roadways and unit entrance doors. Also of concern is the ability of first responders to have clear and easy access to units. With very tall and very narrow spaces, there is limited firefighting access. limited mobility and clear "spray lines" exist throughout.

Fig. 18: A typical secluded entrance way where a security assessment may prove beneficial.

MHRC has indicated concerns about site security. Concerns regarding site security need to be further studied and developed by a qualified Professional Security Consultant, but could potentially include: additional lighting, visibility mirrors at blind corners, and security cameras. All items installed be tamper/vandal-proof.
