May 1, 2017

RE: Your File: 3960.00, Fairway Colony Wastewater Treatment Lagoon, Secondary Cell Liner

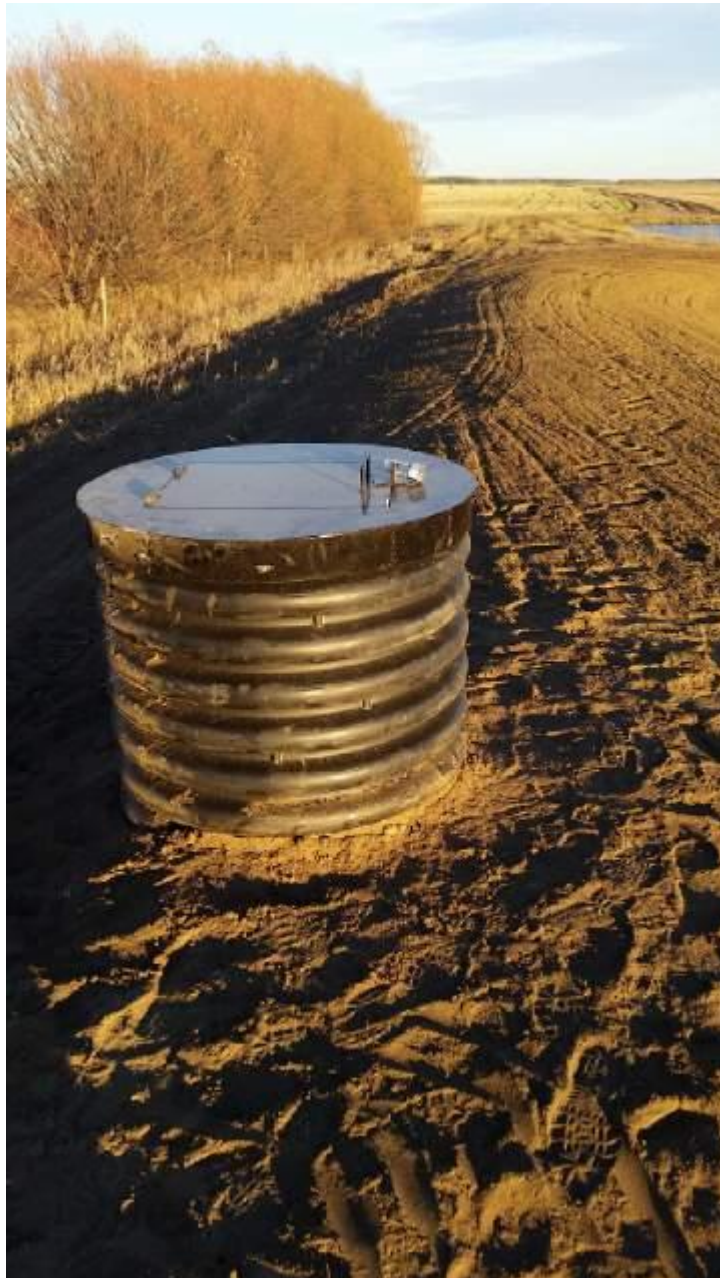
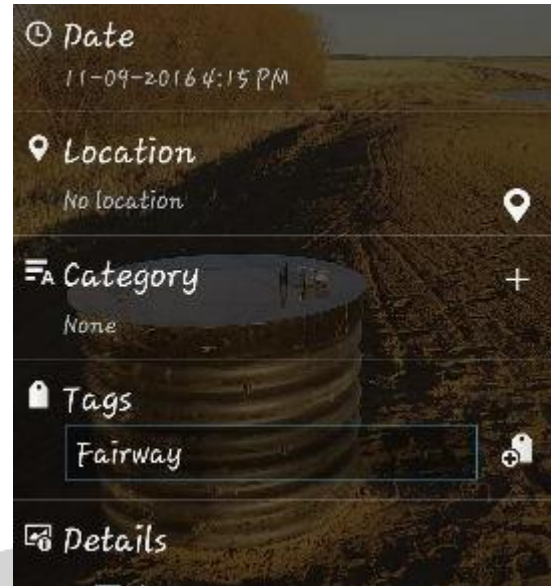
Photo #1

Taken November 9, 2016 at 4:15pm and originally submitted in our November 2016 report.

Ambient daytime temperature 20C, dry and sunny.

Photo taken on north berm looking east. Sump is trimmed to 1.0m above top of berm.

The cover is bolted in place, and was padlocked when EFM left site.

The Owner Fairway Colony is responsible for installation of the dewatering pump.

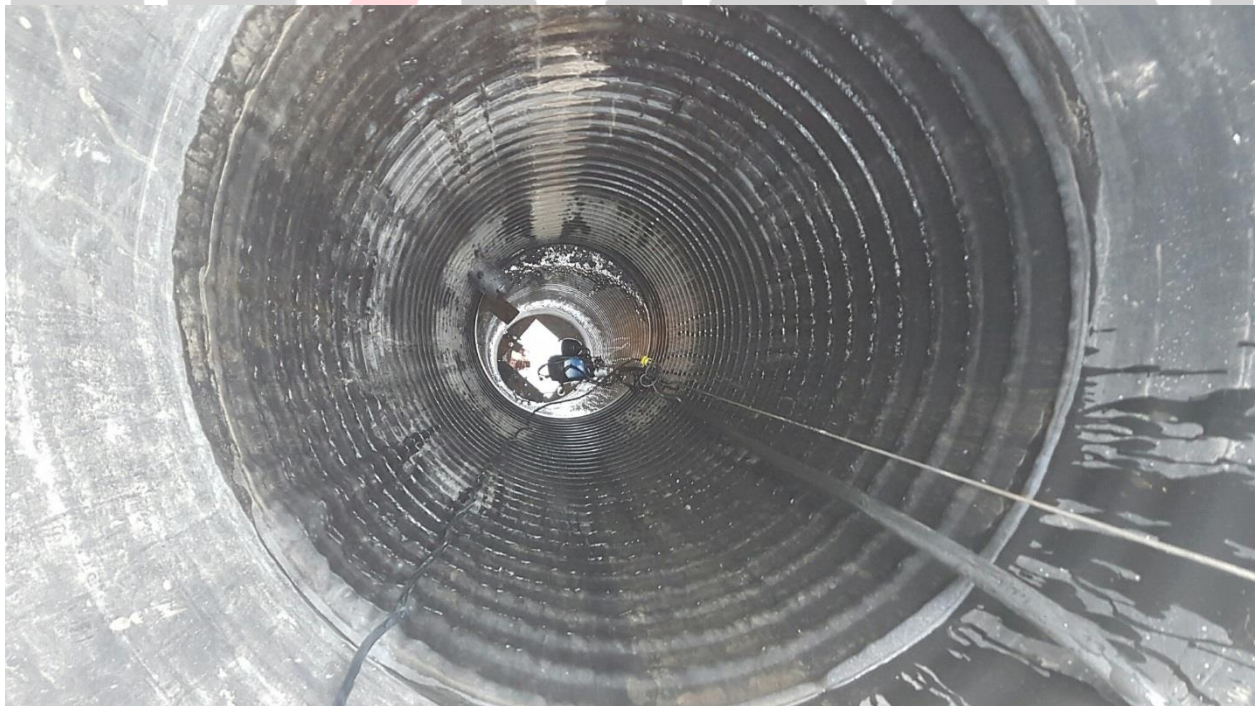
Photo #2 – looking down into the sump (January 31, 2017).

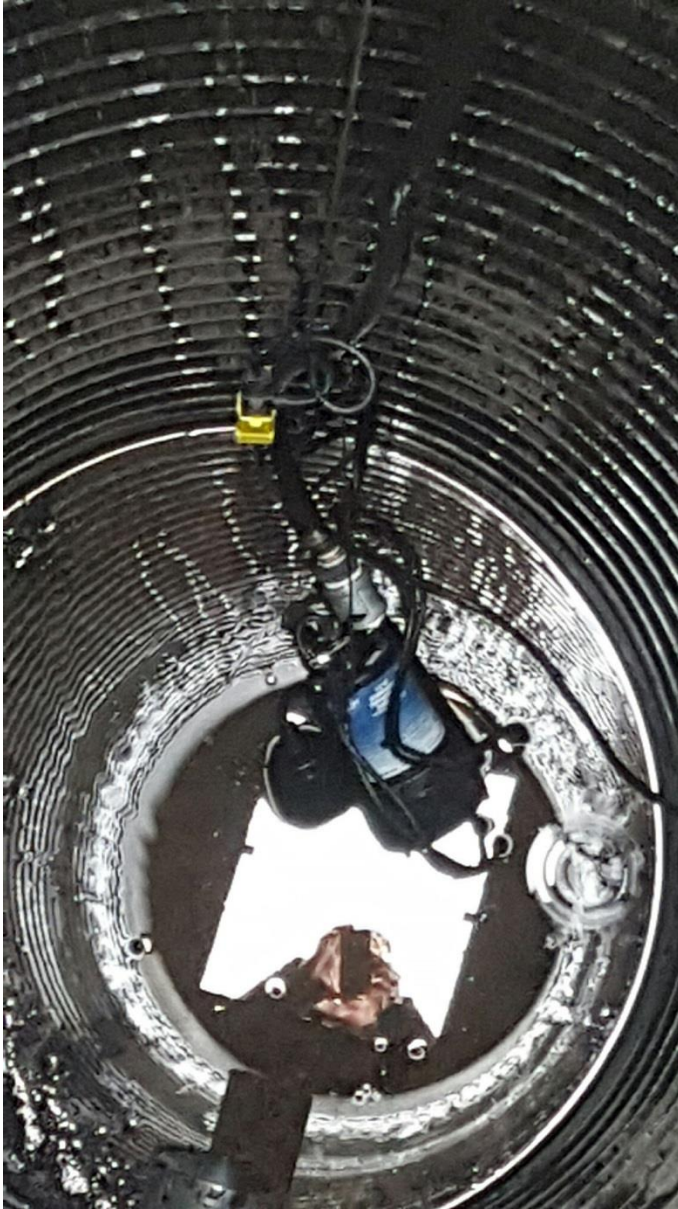
Photo #3  
Looking down into the sump (January 31, 2017).

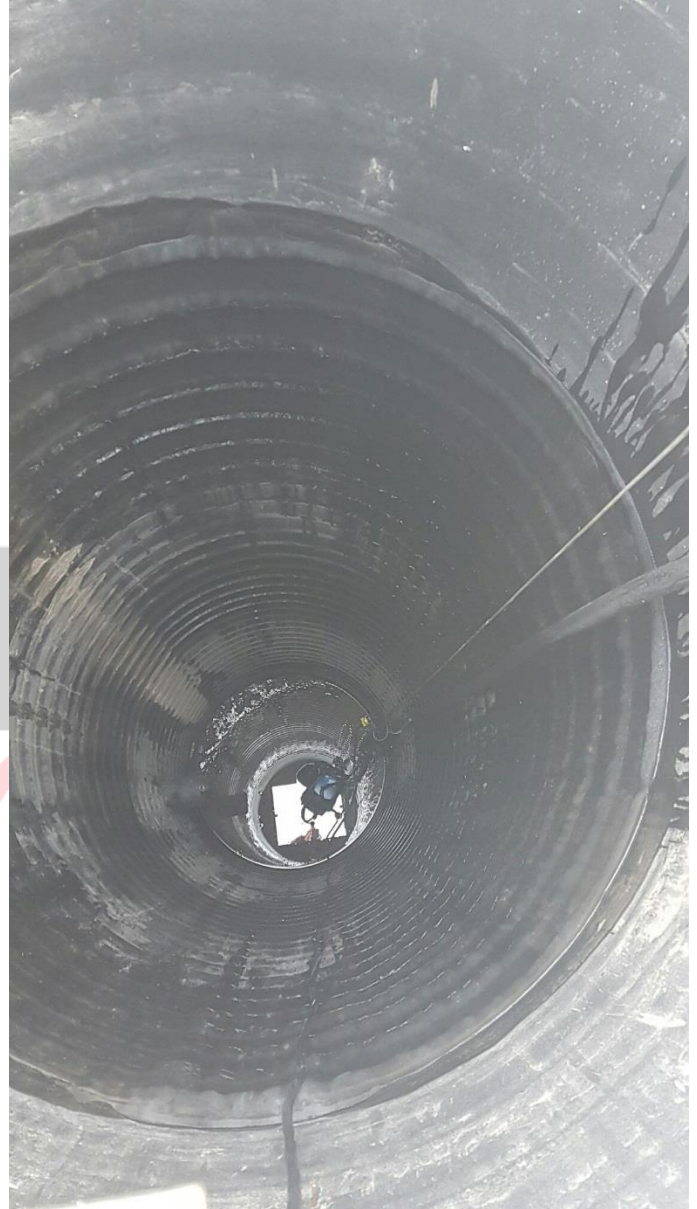
Photo #4  
Looking down into the sump (January 31, 2017).

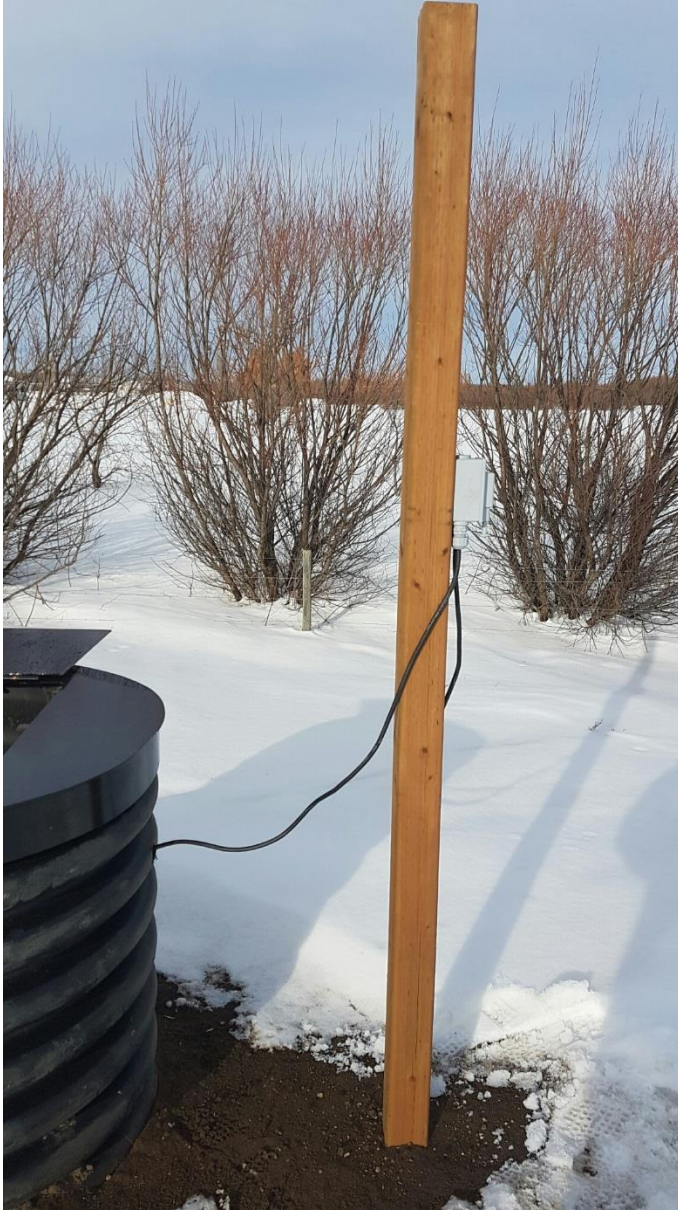
Photo #5  
Sump electrical hookup (January 31, 2017).

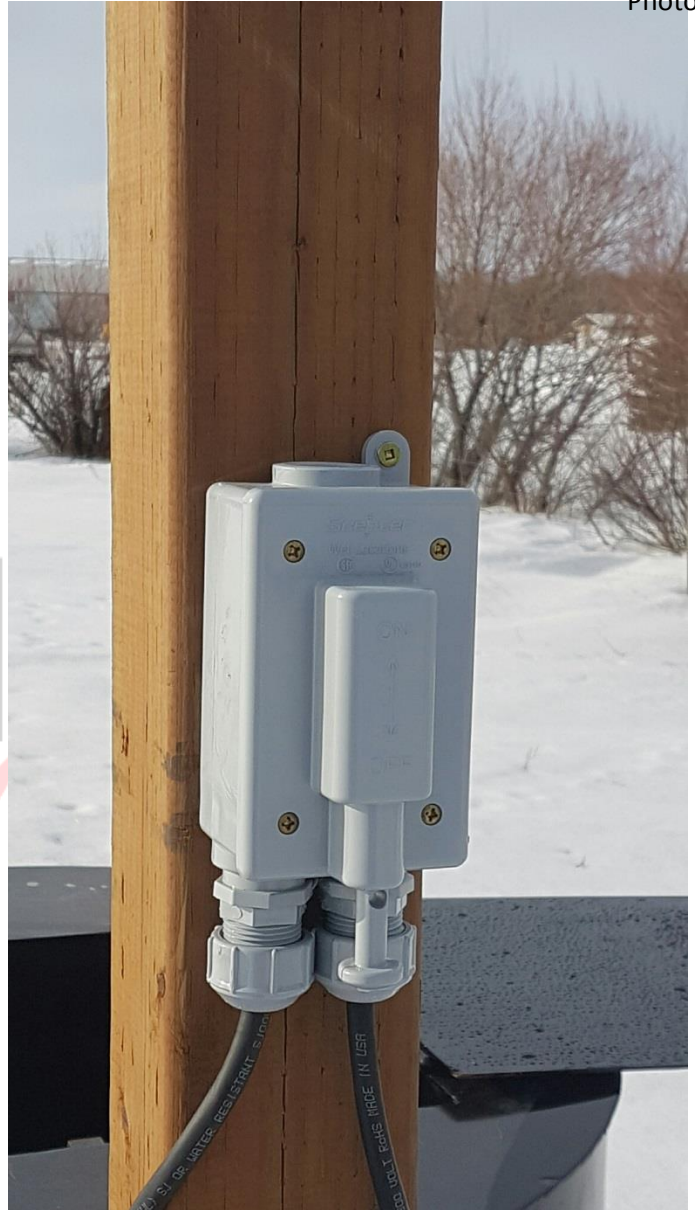
Photo #6  
Sump electrical hookup (January 31, 2017).

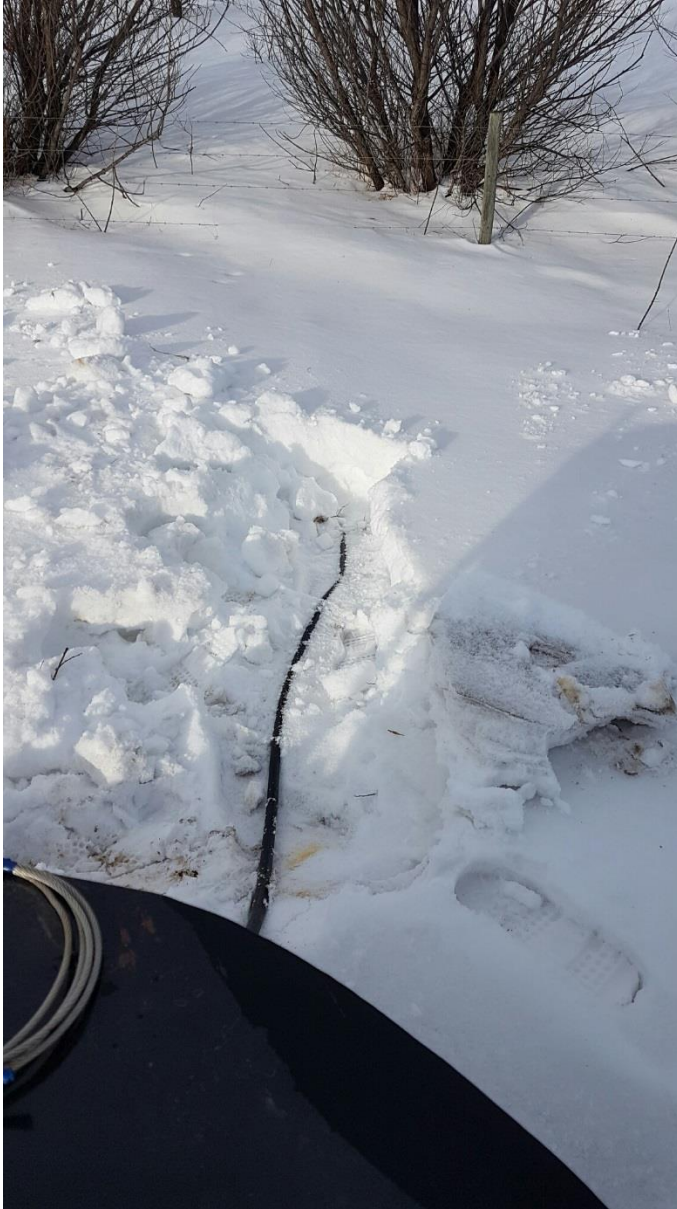
Photo #7  
Sump discharge pipe (January 31, 2017).

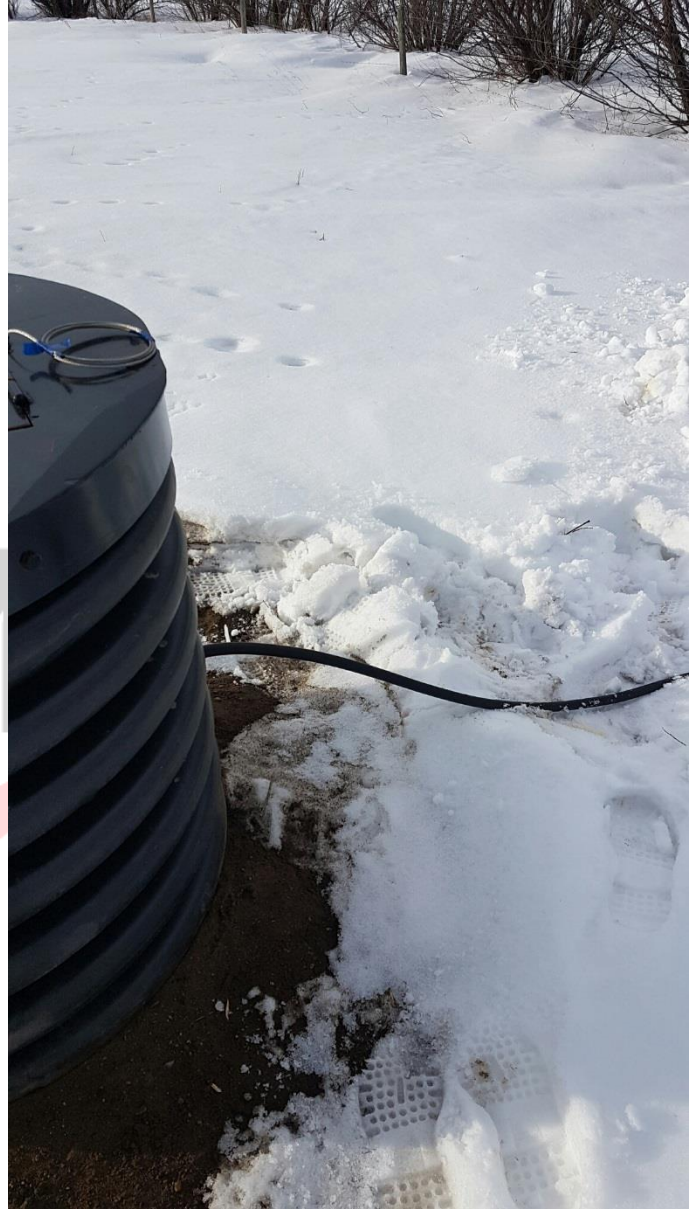
Photo #8  
Sump discharge pipe (January 31, 2017).
