# LAKE MANITOBA LAKE ST. MARTIN

## OUTLET CHANNELS PROJECT

MANITOBA TRANSPORTATION AND  
INFRASTRUCTURE

### Red-headed Woodpecker Habitat Management Plan

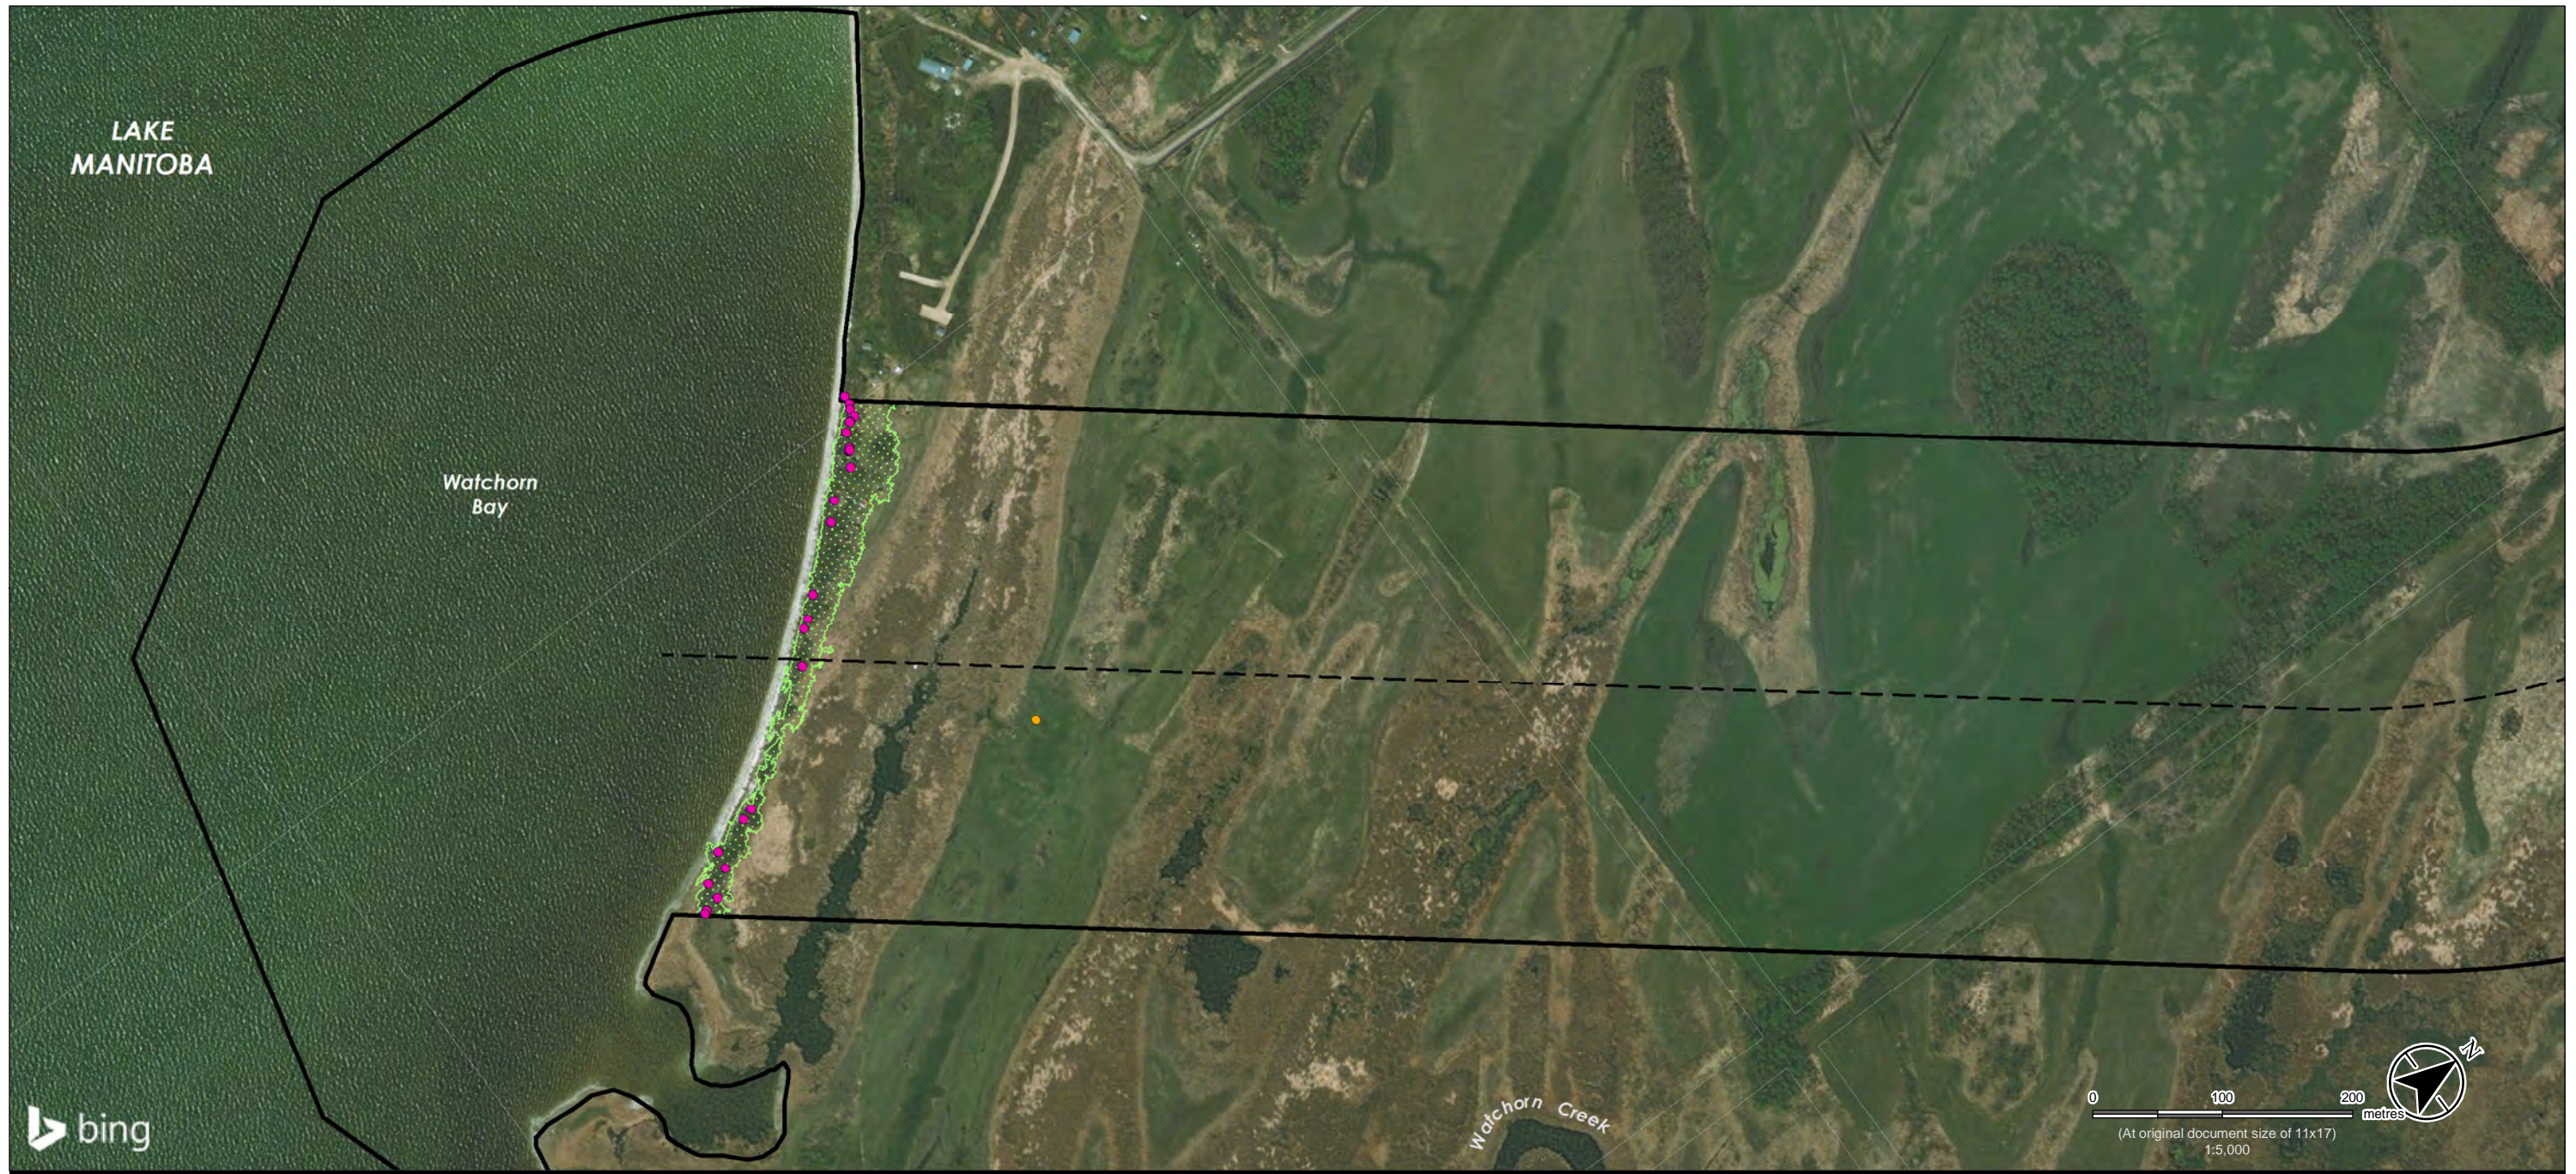
**Figure No.**  
**2-2**

**Title**  
**Decadent Tree Survey Results 2021**

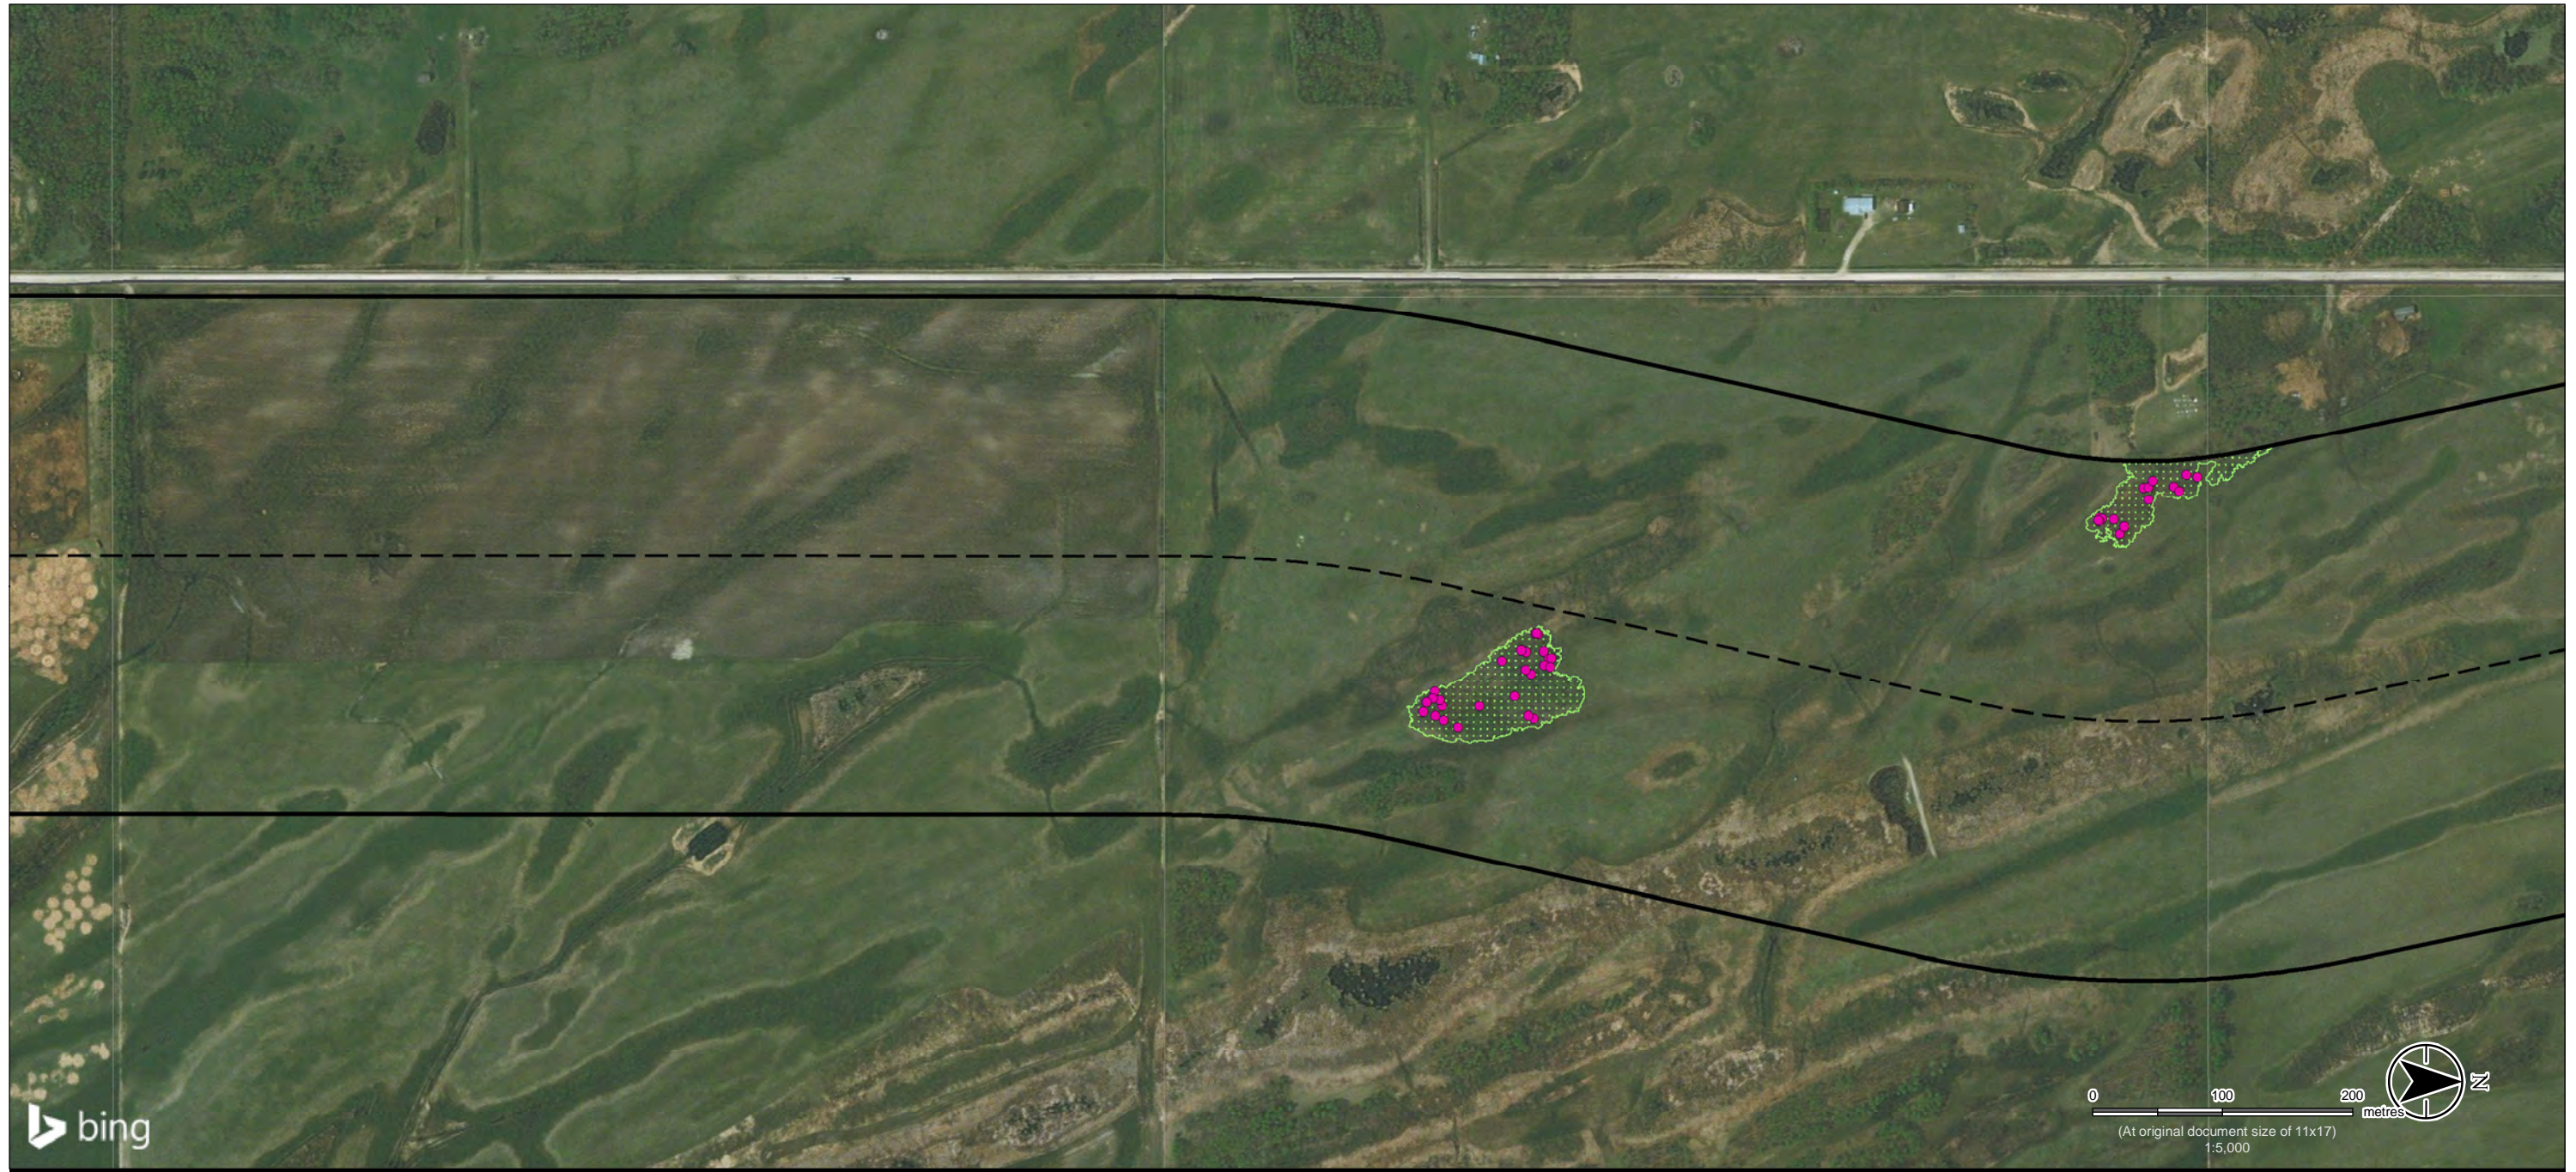
**Figure No.**  
 2-4

**Title**  
 Decadent Tree Survey Results 2021

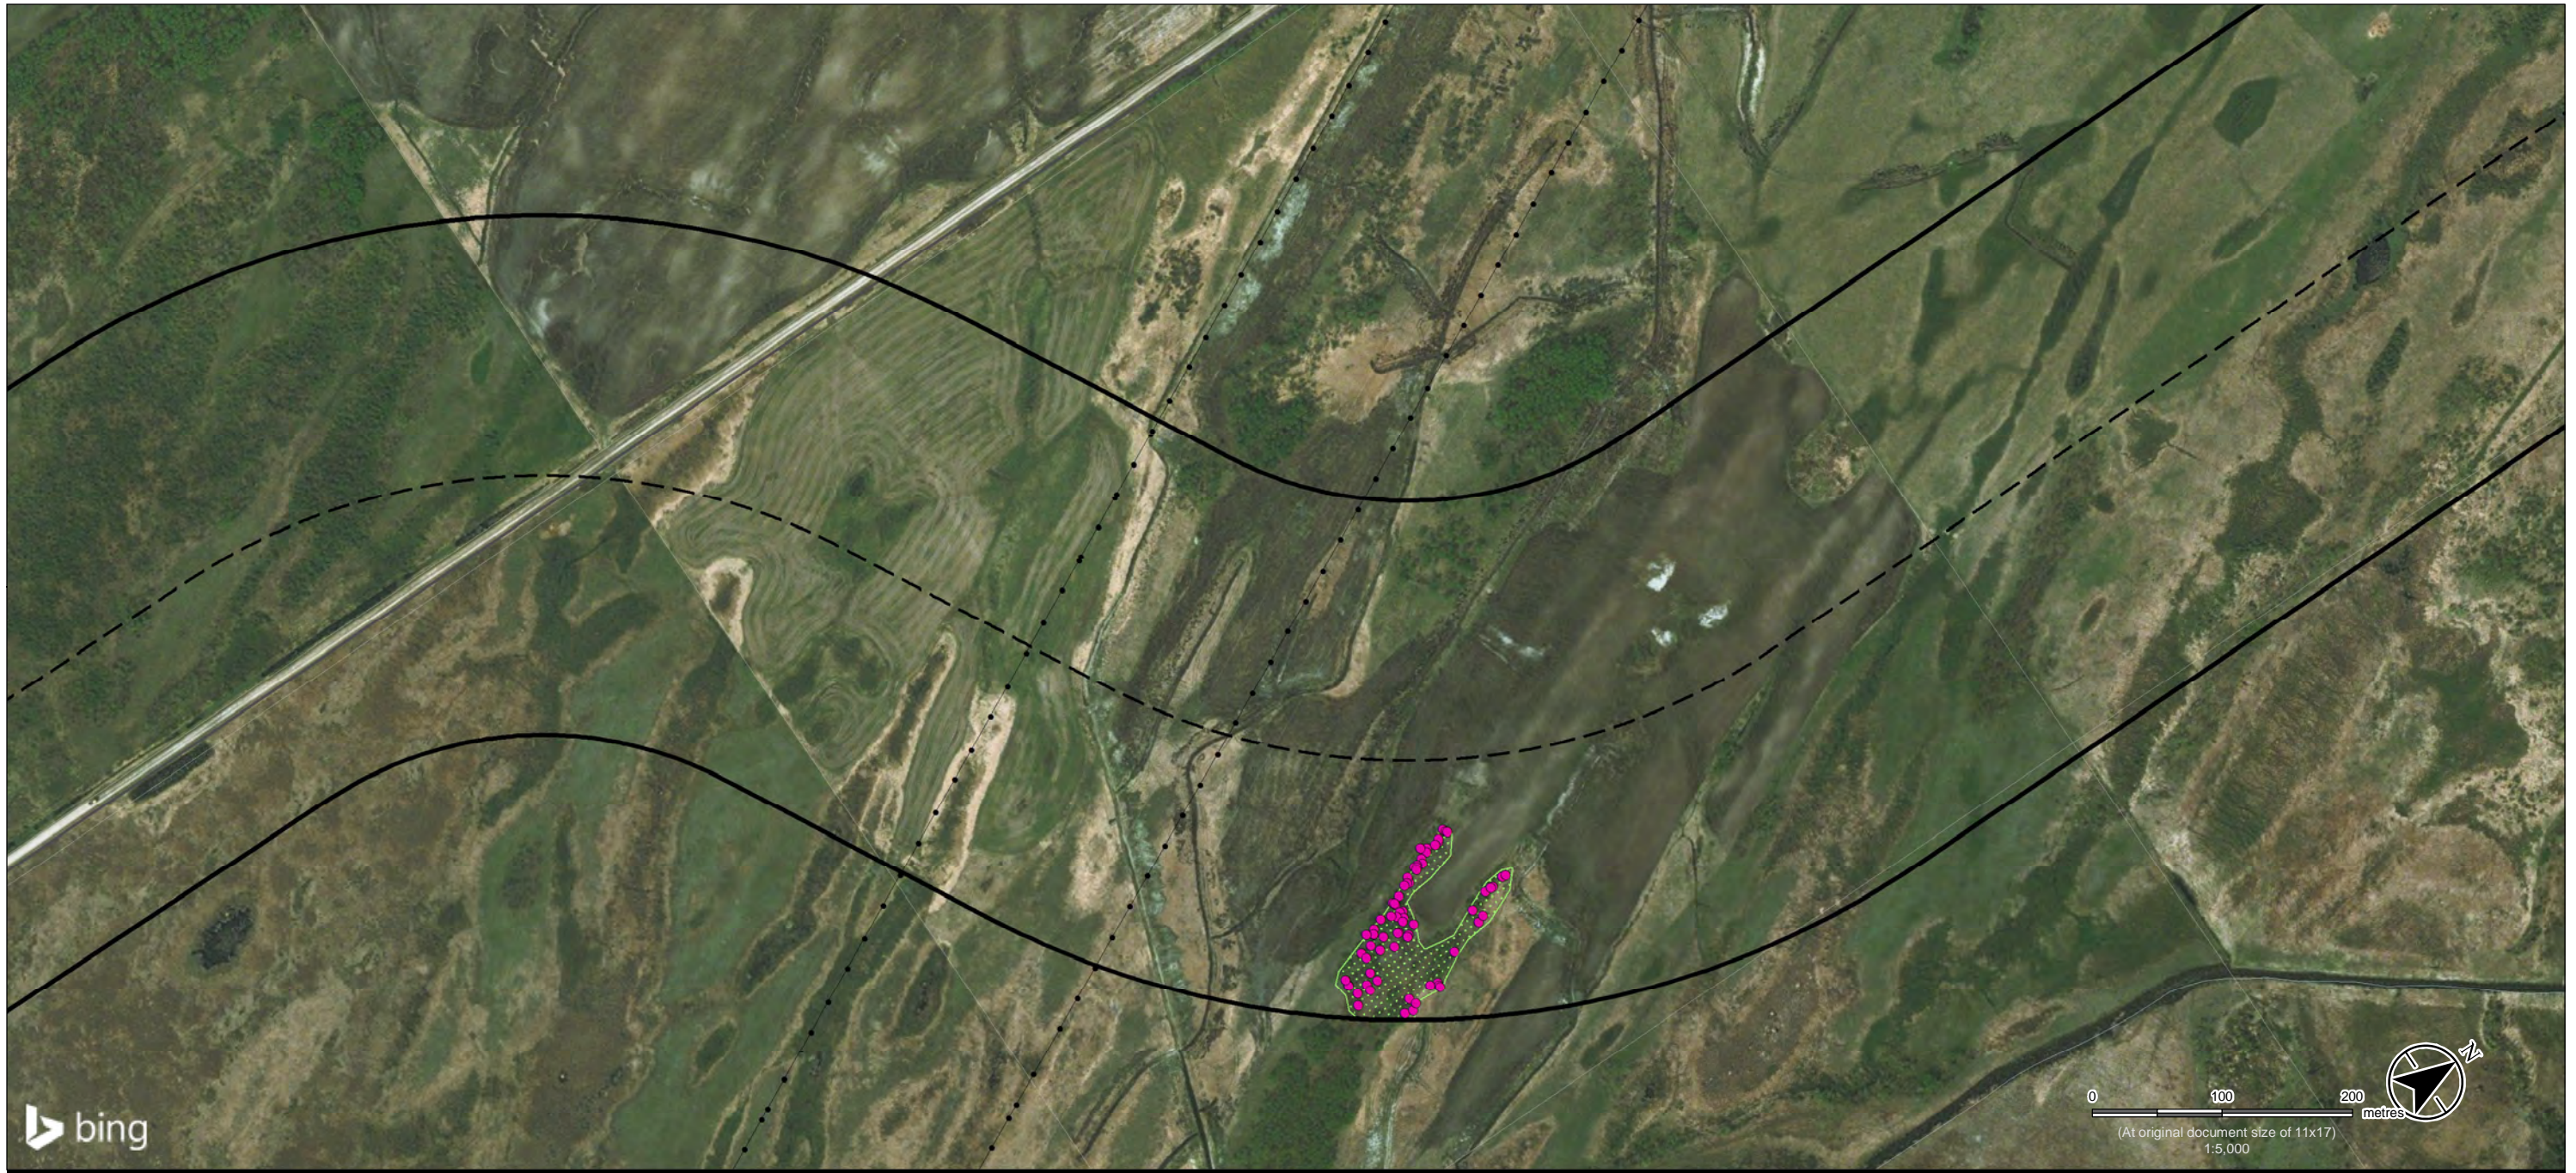
**Figure No.**  
 2-9

**Title**  
 Decedent Tree Survey Results 2021

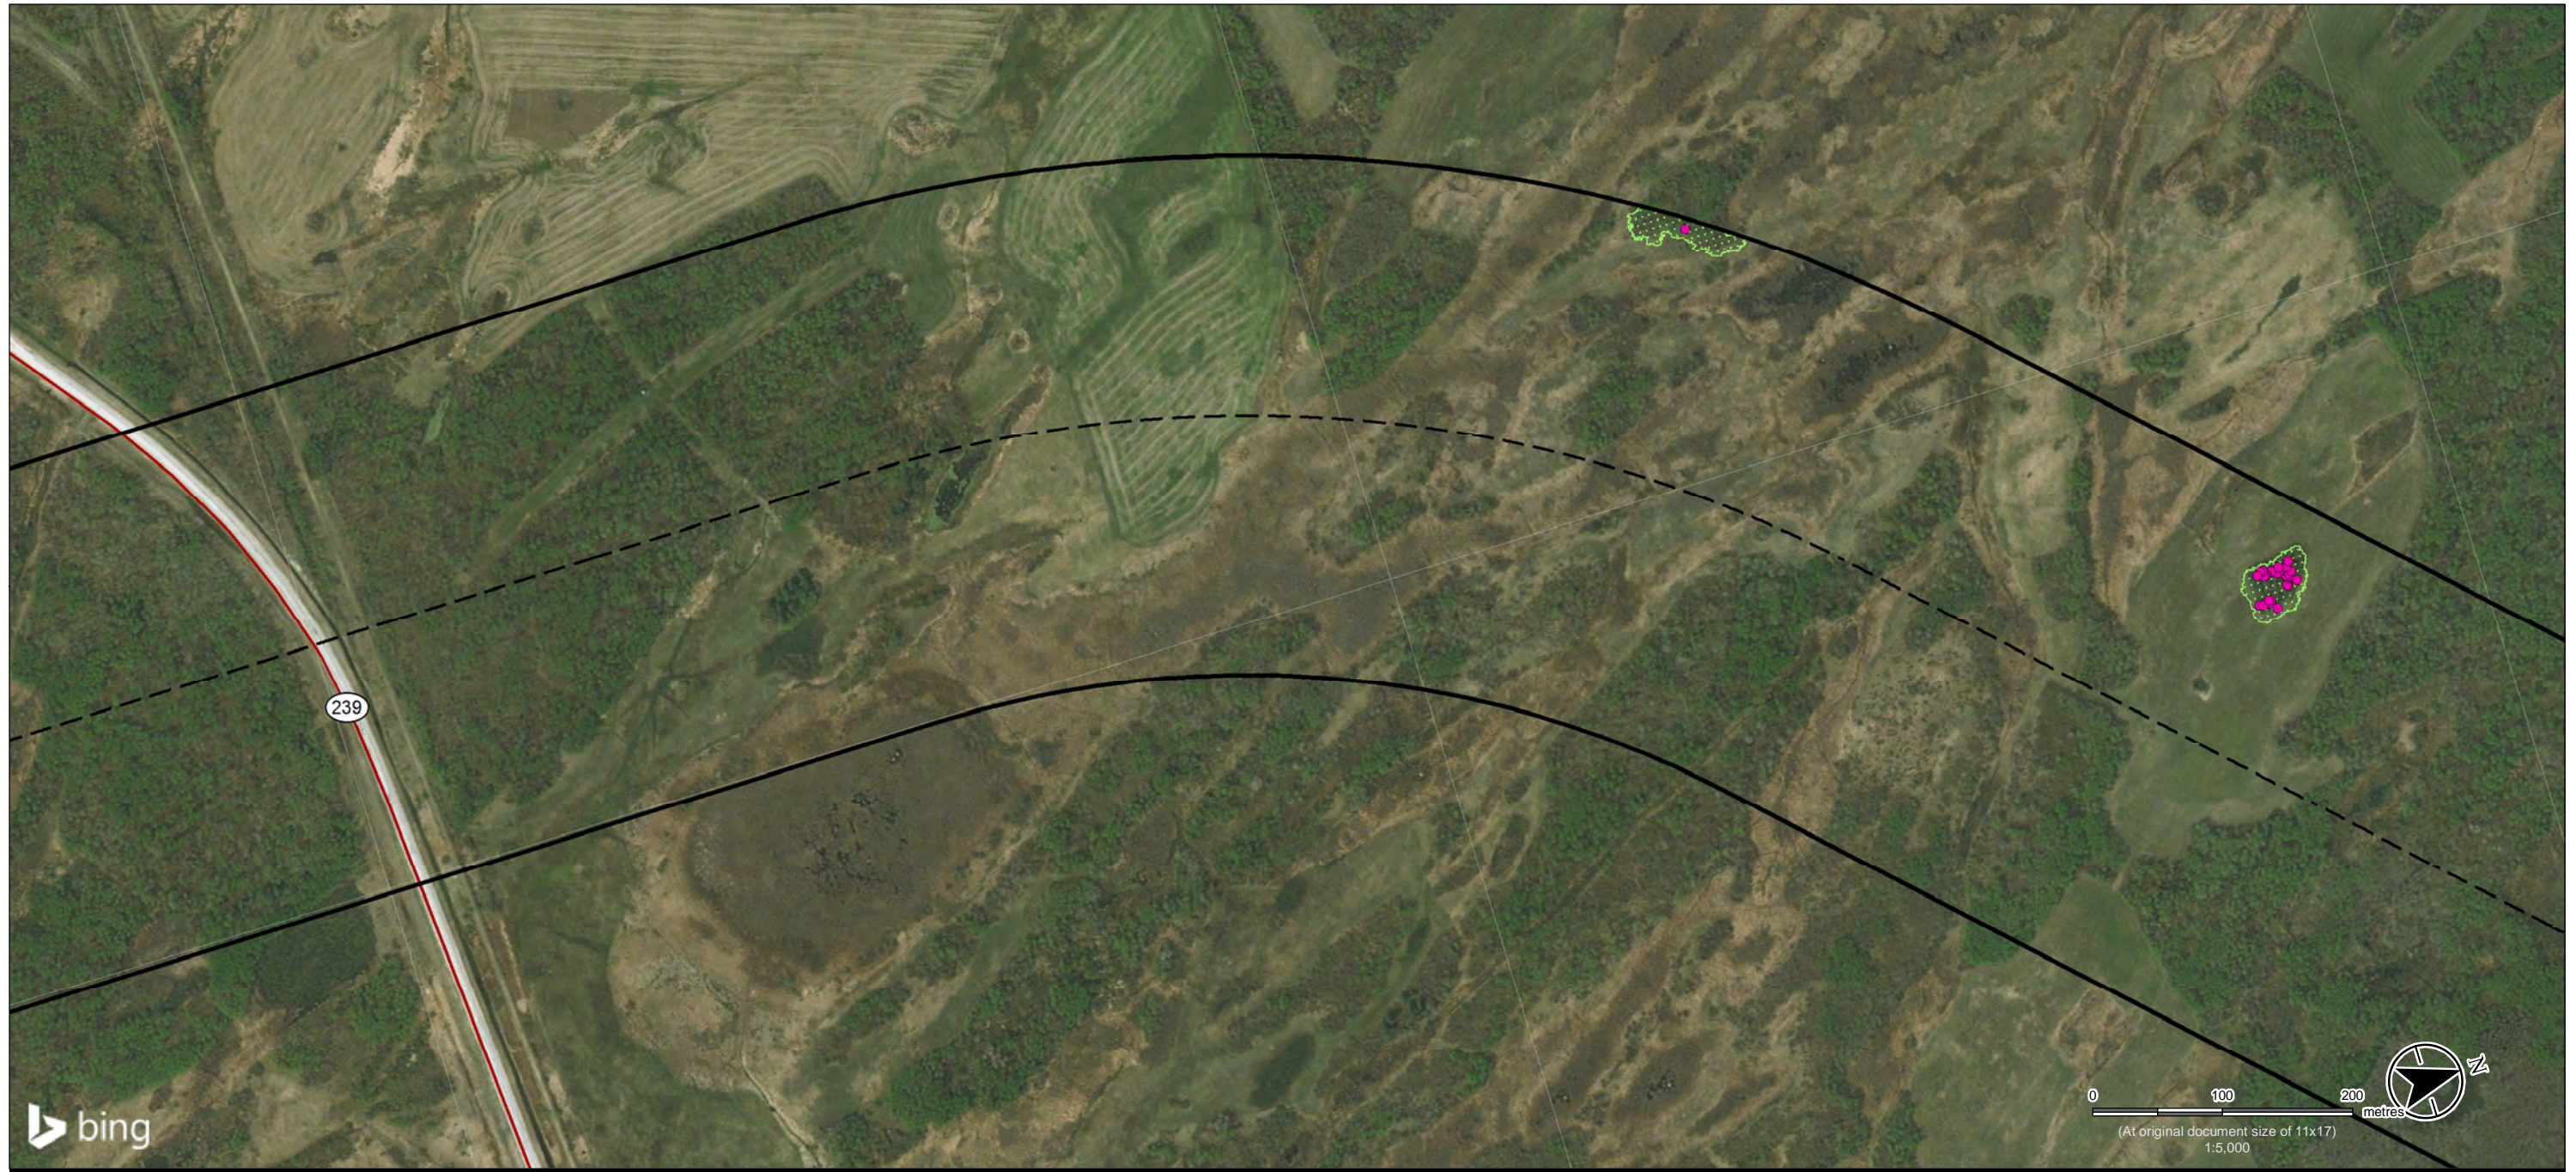
**Figure No.**  
**2-11**

**Title**  
**Decadent Tree Survey Results 2021**

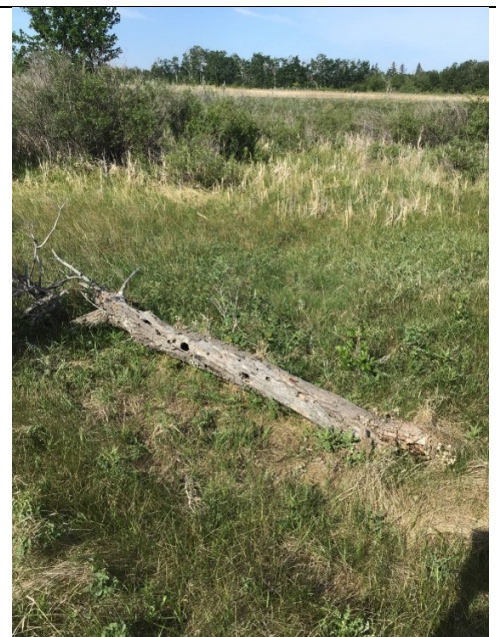
**Photograph 4**

*View of historical red-headed woodpecker nesting tree (EEI 2017; 14N 530725E 5689963N).*

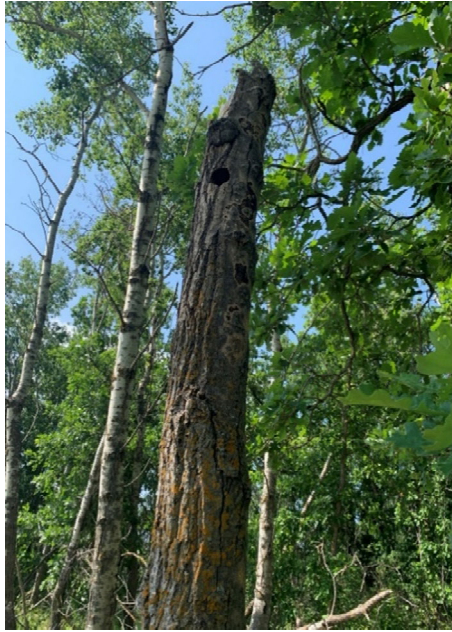
**Photograph 5**

*View of confirmed red-headed woodpecker nesting tree (14N 530674E 5682826N).*

Nesting Evidence	Tree Characteristics				Stand Characteristics		Photo No.
	Species	Health	Height (m)	dbh (cm)	Stand Area (ha)	No. Decadent Trees	
<b>Confirmed</b>	Trembling Aspen	Dead	3	18.5	0.4	8	5
<b>Possible</b>	Trembling Aspen	Fair	20	30	0.7	26	6
<b>Possible</b>	N/A (advanced decay)	Dead	9	29	0.7	26	7
<b>Possible</b>	Trembling Aspen	Poor	11	27	1.1	89	8

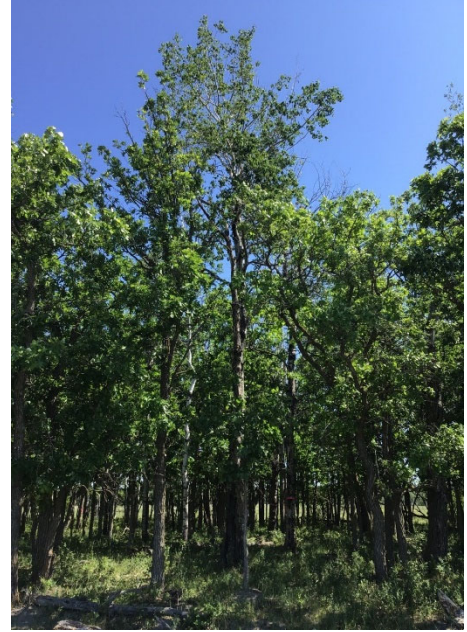
**Photograph 6**

*View of potential red-headed woodpecker nesting tree (14N 530866E 5685510N).*

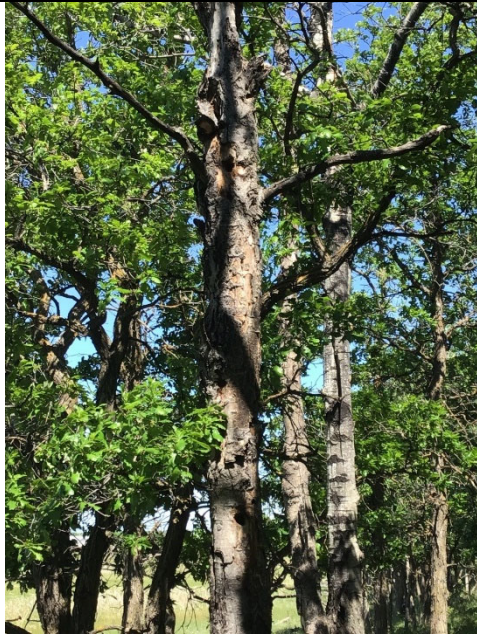
**Photograph 7**

*View of potential red-headed woodpecker nesting tree (14N 530871E 5685508N).*

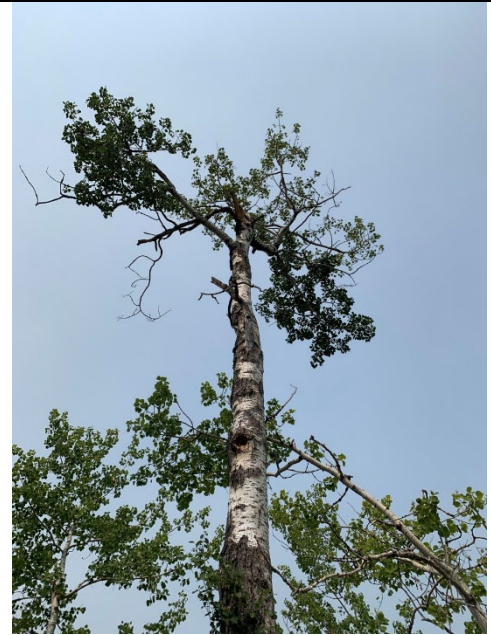
**Photograph 8**

*View of potential red-headed woodpecker nesting tree (14N 532370E 5701612N).*
