**Application for an  
Environmental Act Licence for  
an Additional Secondary Cell  
to the Existing Adam Lake  
Campground Wastewater  
Treatment Lagoon in Turtle  
Mountain Provincial Park**

Project No. 111217030

**Adam Lake Campground in  
Turtle Mountain Provincial Park  
Wastewater Lagoon  
Upgrading Study**

Final Report

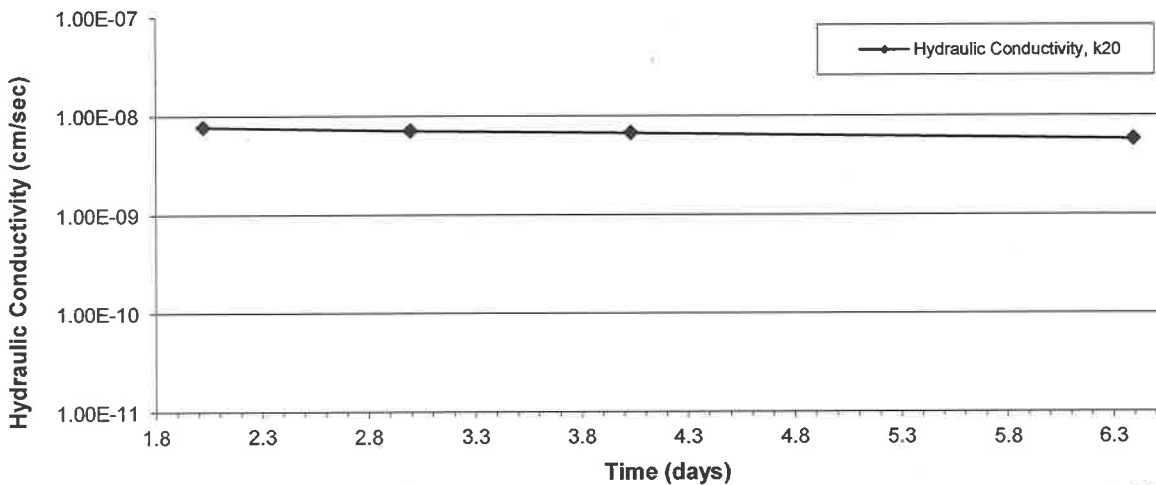
**SAMPLE FIELD I.D.:** TH4 @ 5' - 7.5'  
**SOIL DESCRIPTION:** Clay, brown, stiff, moist, high plasticity, trace silt

**DATE TESTED:** November 2 to November 13, 2015  
**CONFINING PRESSURE (kPa):** 102.0  
**EFFECTIVE SATURATION STRESS (kPa):** 34.5  
**ASSUMED SPECIFIC GRAVITY:** 2.71  
**HYDRAULIC GRADIENT:** 19.0  
**TYPE OF PERMEANT LIQUID:** De-aired Water  
**HYDRAULIC CONDUCTIVITY, "k" (cm/s):** 7.0E-09  
**HYDRAULIC CONDUCTIVITY, "k<sub>20</sub>" (cm/s):** 6.8E-09

Height (mm)	Diameter (mm)	Wet Mass (g)	Dry Density (g/cm <sup>3</sup> )	Water Content (%)	Saturation (%)
<b>Initial Reading</b>	77.2	72.7	590.1	1.327	38.5	100.3
<b>Final Reading</b>	78.0	73.2	597.2	1.309	39.1	99.0

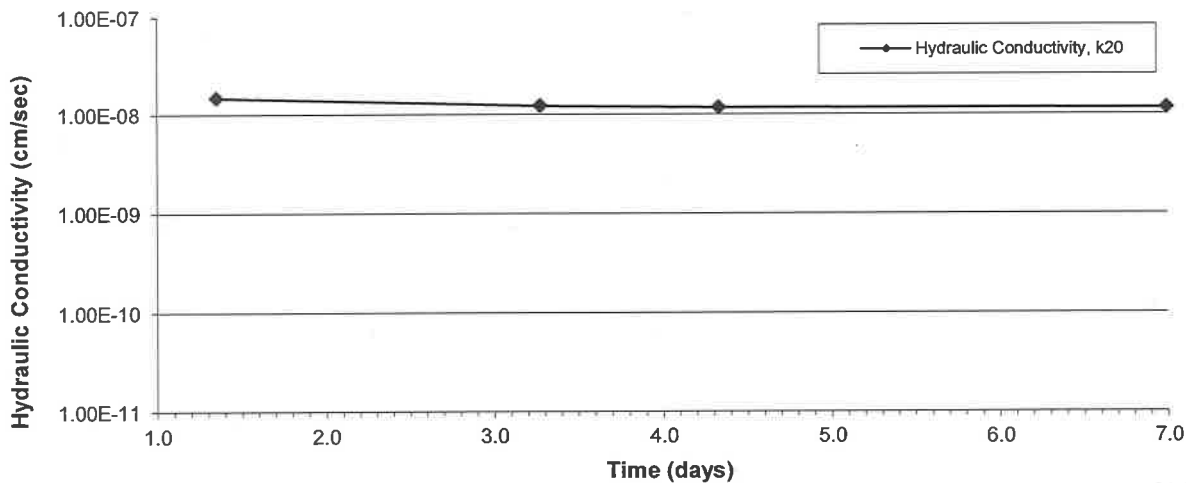
**SAMPLE FIELD I.D.:** TH12 @ 5' - 7.5'  
**SOIL DESCRIPTION:** Clay, brown, stiff, moist, high plasticity, trace silt inclusions

**DATE TESTED:** November 2 to November 13, 2015  
**CONFINING PRESSURE (kPa):** 102.0  
**EFFECTIVE SATURATION STRESS (kPa):** 34.5  
**ASSUMED SPECIFIC GRAVITY:** 2.71  
**HYDRAULIC GRADIENT:** 18.9  
**TYPE OF PERMEANT LIQUID:** De-aired Water  
**HYDRAULIC CONDUCTIVITY, "k" (cm/s):** 1.3E-08  
**HYDRAULIC CONDUCTIVITY, "k<sub>20</sub>" (cm/s):** 1.3E-08

Height (mm)	Diameter (mm)	Wet Mass (g)	Dry Density (g/cm <sup>3</sup> )	Water Content (%)	Saturation (%)
<b>Initial Reading</b>	77.7	72.8	618.2	1.460	30.9	97.7
<b>Final Reading</b>	78.7	73.2	630.9	1.436	32.6	99.5

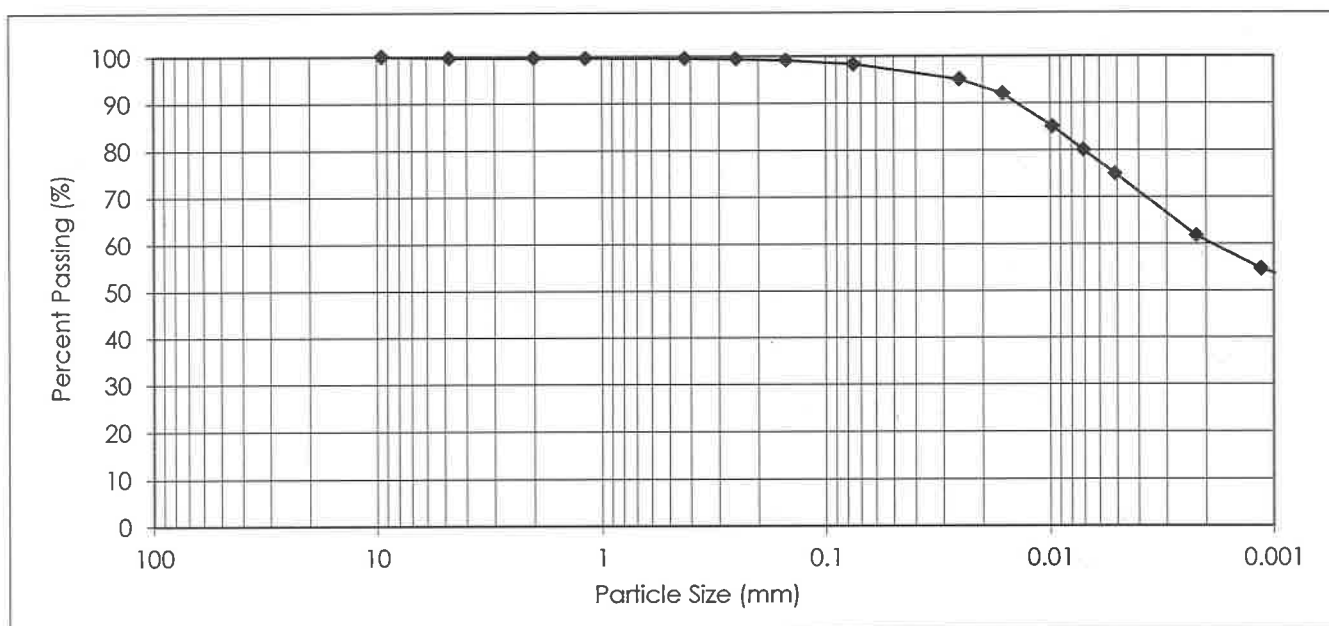
SAMPLED BY: Larry Presado, C.Tech.  
 SAMPLE ID: TH2 @ 2.5'

PARTICLE SIZE	PERCENT PASSING
37.50 mm	100.0
25.00 mm	100.0
19.00 mm	100.0
16.00 mm	100.0
12.50 mm	100.0
9.50 mm	100.0
4.75 mm	99.7
2.00 mm	99.7

PARTICLE SIZE	PERCENT PASSING
1.18 mm	99.6
0.425 mm	99.6
0.250 mm	99.4
0.150 mm	99.1
0.075 mm	98.3
0.005 mm	74.4
0.002 mm	60.4
0.001 mm	53.7

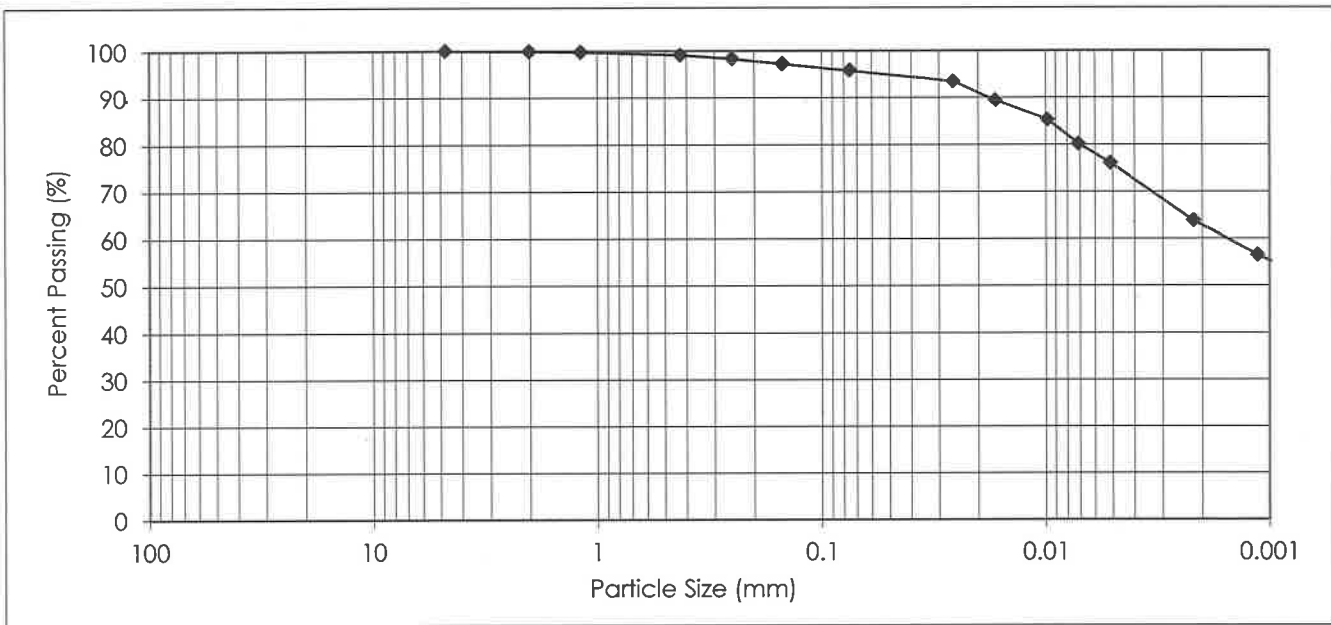
SAMPLED BY: Larry Presado, C.Tech.  
 SAMPLE ID: TH5 @ 5'

PARTICLE SIZE	PERCENT PASSING
37.50 mm	100.0
25.00 mm	100.0
19.00 mm	100.0
16.00 mm	100.0
12.50 mm	100.0
9.50 mm	100.0
4.75 mm	100.0
2.00 mm	99.9

PARTICLE SIZE	PERCENT PASSING
1.18 mm	99.8
0.425 mm	99.1
0.250 mm	98.3
0.150 mm	97.2
0.075 mm	95.8
0.005 mm	75.6
0.002 mm	62.6
0.001 mm	55.3

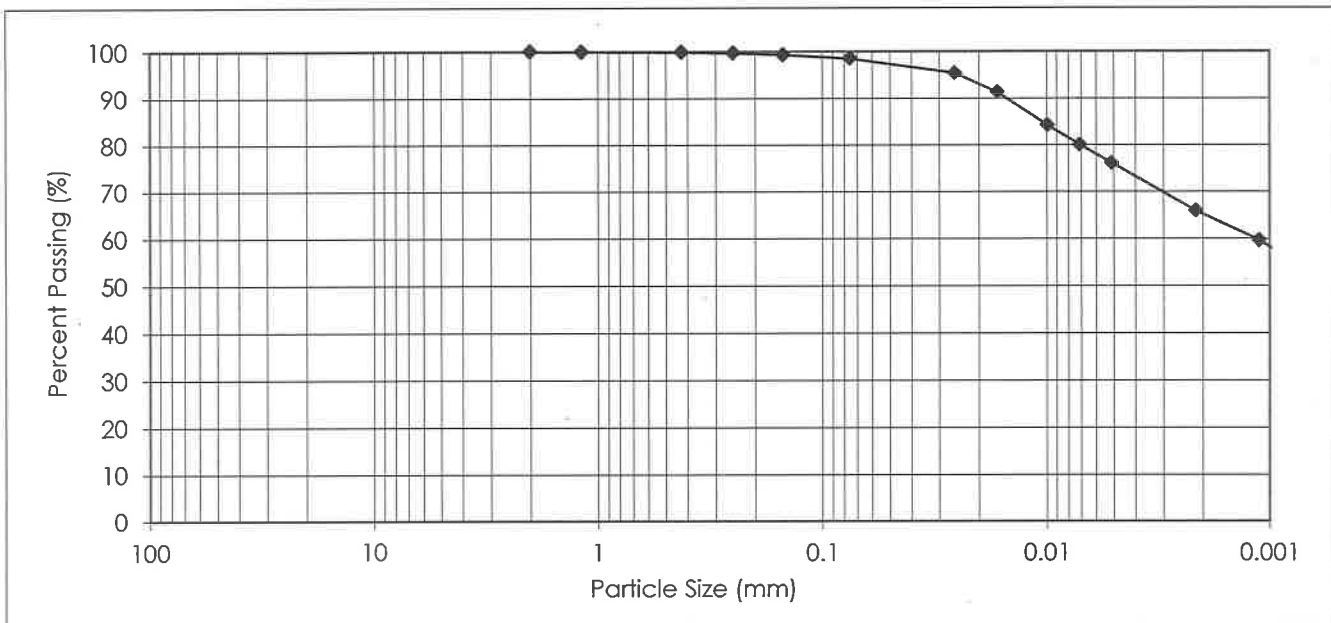
SAMPLED BY: Larry Presado, C.Tech.  
 SAMPLE ID: TH7 @ 2.5'

PARTICLE SIZE	PERCENT PASSING
37.50 mm	100.0
25.00 mm	100.0
19.00 mm	100.0
16.00 mm	100.0
12.50 mm	100.0
9.50 mm	100.0
4.75 mm	100.0
2.00 mm	100.0

PARTICLE SIZE	PERCENT PASSING
1.18 mm	100.0
0.425 mm	99.9
0.250 mm	99.7
0.150 mm	99.3
0.075 mm	98.6
0.005 mm	75.7
0.002 mm	65.0
0.001 mm	58.1

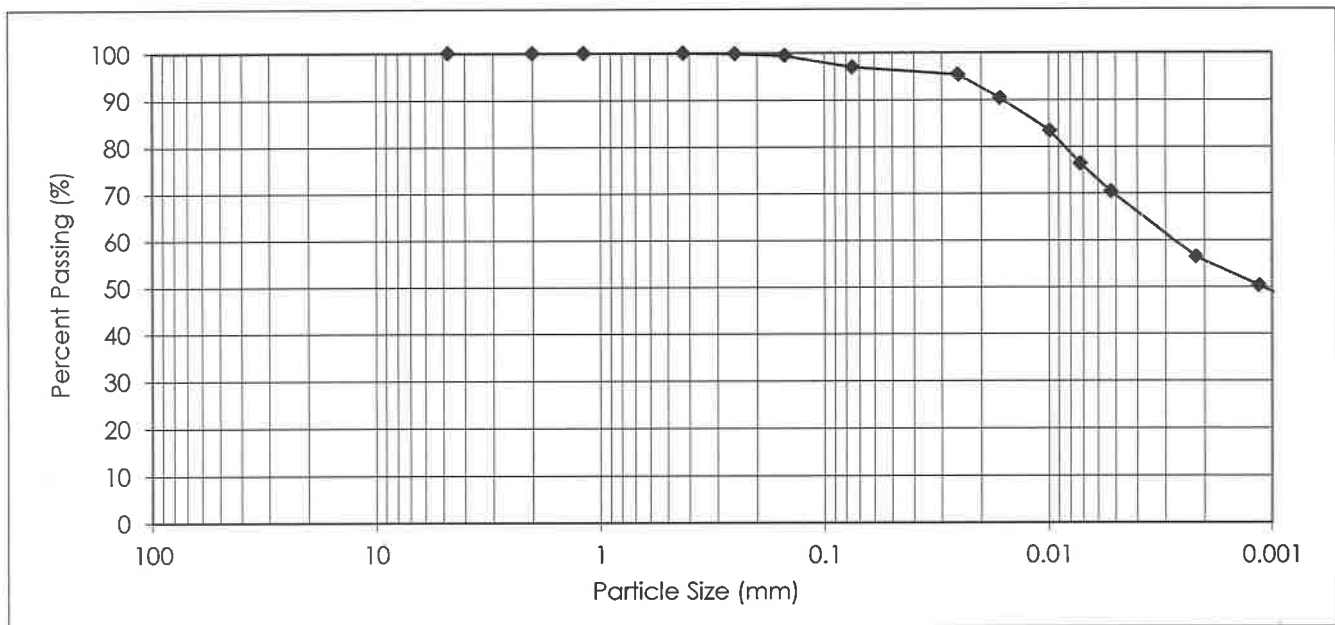
SAMPLED BY: Larry Presado, C.Tech.  
 SAMPLE ID: TH12@2.5'

PARTICLE SIZE	PERCENT PASSING
37.50 mm	100.0
25.00 mm	100.0
19.00 mm	100.0
16.00 mm	100.0
12.50 mm	100.0
9.50 mm	100.0
4.75 mm	100.0
2.00 mm	100.0

PARTICLE SIZE	PERCENT PASSING
1.18 mm	100.0
0.425 mm	99.9
0.250 mm	99.8
0.150 mm	99.4
0.075 mm	97.0
0.005 mm	69.3
0.002 mm	55.3
0.001 mm	48.9

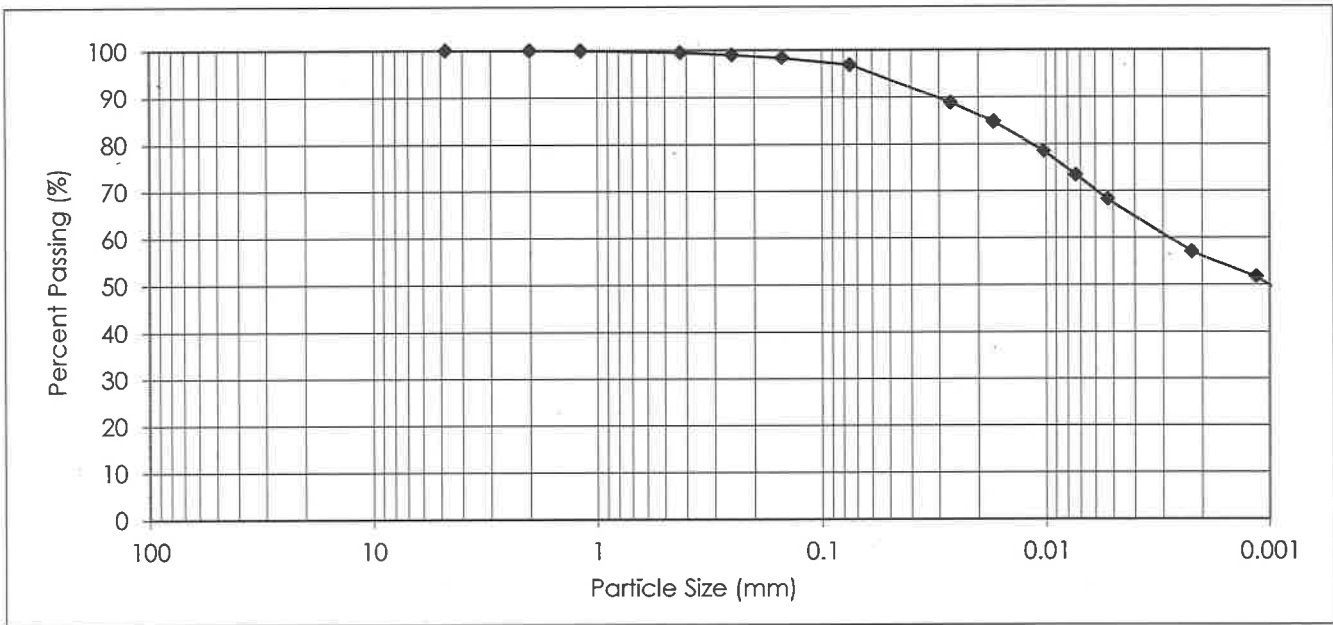
SAMPLED BY: Larry Presado, C.Tech.  
 SAMPLE ID: TH13 @ 5'

PARTICLE SIZE		PERCENT PASSING		PARTICLE SIZE		PERCENT PASSING	
37.50 mm		100.0		1.18 mm		99.9	
25.00 mm		100.0		0.425 mm		99.5	
19.00 mm		100.0		0.250 mm		99.0	
16.00 mm		100.0		0.150 mm		98.3	
12.50 mm		100.0		0.075 mm		96.8	
9.50 mm		100.0		0.005 mm		67.1	
4.75 mm		100.0		0.002 mm		55.8	
2.00 mm		100.0		0.001 mm		49.7	
Gravel, % 75 to 4.75 mm	Sand, %			Silt, % <0.075 to 0.002 mm	Clay, % <0.002 mm	Colloids, % <0.001 mm	
	Coarse <4.75 to 2.0 mm	Medium <2.0 to 0.425 mm	Fine <0.425 to 0.075 mm				
0.0	0.0	0.5	2.7	41.0	55.8	49.7

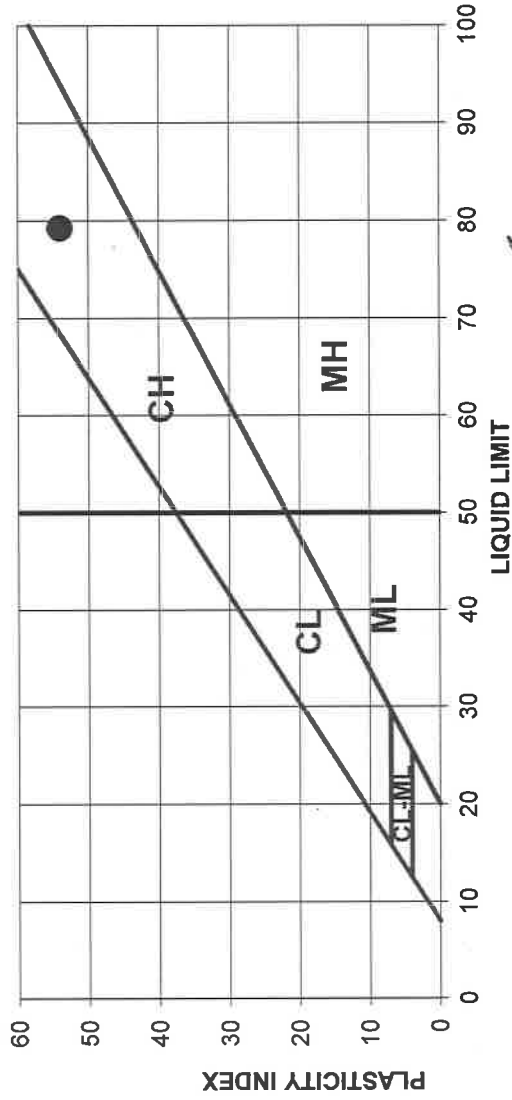
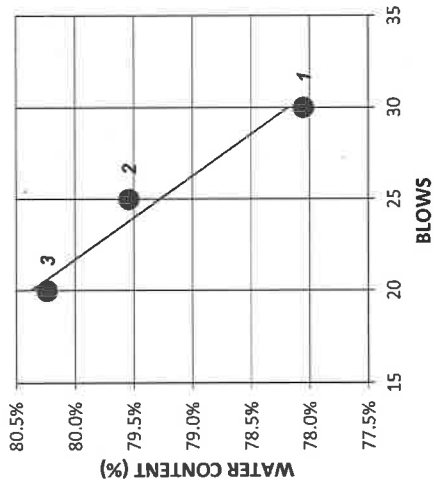
Trial	LIQUID LIMIT			PLASTIC LIMIT		
	1	2	3	1	2	3
No. of Blows	30	25	20	297	318	318
Tare No.	249	277	287	34.16	33.11	33.11
Wt. Sa. (wet+tare) (g)	39	38	39	31.47	30.6	30.6
Wt. Sa. (dry+tare) (g)	31	31	31	20.91	20.64	20.64
Wt. Tare (g)	20	21	21	10.6	10.0	10.0
Wt. Dry Soil (g)	10.6	9.6	10.1	2.7	2.5	2.5
Wt. Water (g)	8.3	7.6	8.1	25.5%	25.2%	25.2%
Water Content (%)	78.1%	79.5%	80.2%

RESULTS	
LL	79
PL	25
PI	54

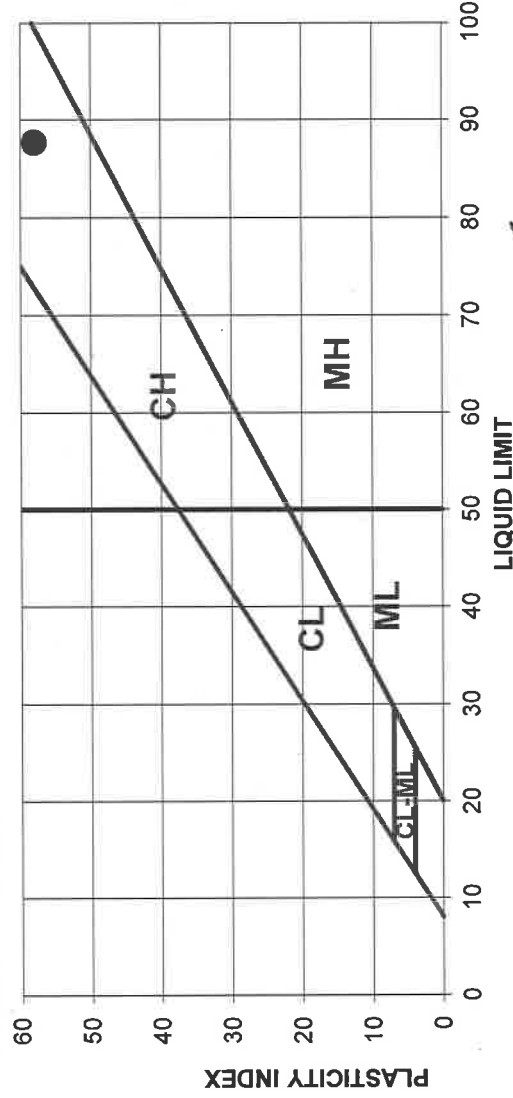
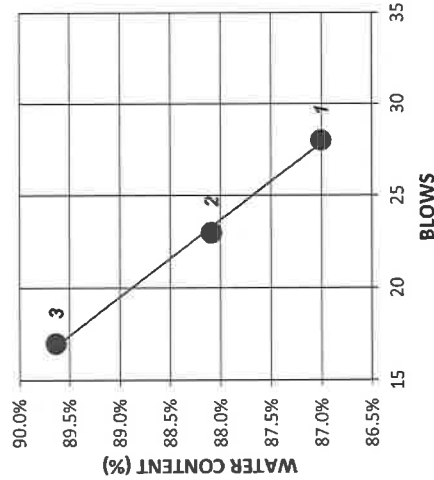
Trial	LIQUID LIMIT			PLASTIC LIMIT		
	1	2	3	1	2	3
No. of Blows	28	23	17			
Tare No.	283	314	308	268	267	267
Wt. Sa. (wet+tare)(g)	39	38	37	32.86	29.23	29.23
Wt. Sa. (dry+tare)(g)	30	30	29	30.08	27.25	27.25
Wt. Tare (g)	21	21	21	20.97	20.74	20.74
Wt. Dry Soil (g)	9.6	9.3	8.5	9.1	6.5	6.5
Wt. Water (g)	8.4	8.2	7.6	2.8	2.0	2.0
Water Content (%)	87.0%	88.1%	89.6%	30.5%	30.4%	30.4%

RESULTS	
LL	88
PL	30
PI	58
