BIPOLE III TRANSMISSION PROJECT

2014 Biophysical Monitoring and Mitigation Report

Report to Manitoba Conservation and Water Stewardship
In Accordance with Manitoba *Environment Act* Licence No. 3055

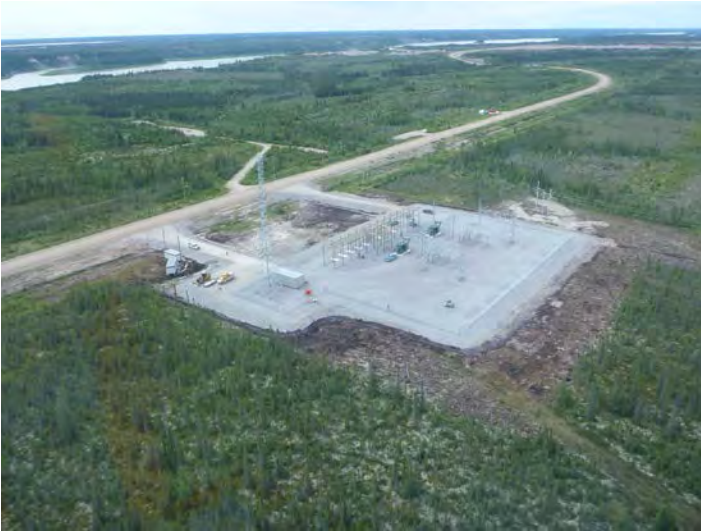
Photo 2: Keewatinohk Construction Power Station

Transmission line construction activities began in mid-December at the Keewatinohk Construction Power Station with the associated construction power line (KN36) (Photo 2). Clearing was completed for the entire 310 metre (m) wide right-of-way (ROW) that will contain the 5 AC collector lines connecting Keewatinohk Converter Station to Henday Converter Station at Limestone (Map 2).

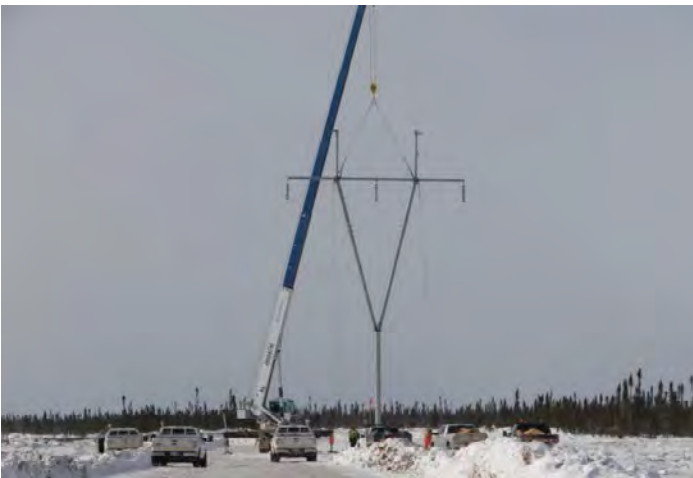
Photo 3: Installation of a Transmission Structure for the Construction Powerline

The construction power line (KN36) is also on this ROW. All 30 km of line KN36 were cleared, towers installed and stringing completed in order to provide construction power to the area (Photo 3). These construction activities were carried out through a joint venture between Fox Lake Cree Nation and Valard Construction.

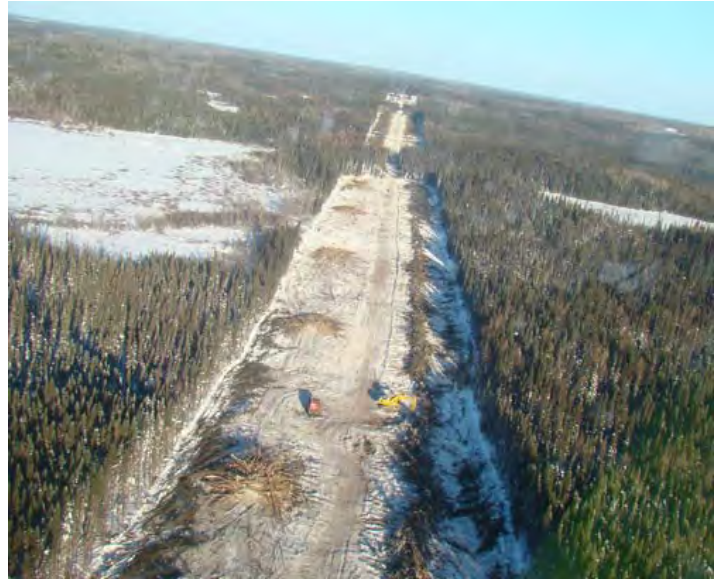
Photo 4: Aerial Shot of Clearing of Bipole III Transmission Line

Transmission line construction activities also began with ROW clearing in sections N2B and N3 in early 2014 through a joint venture between Swampy Cree Tribal Council and Sigfusson Northern (Photo 4).

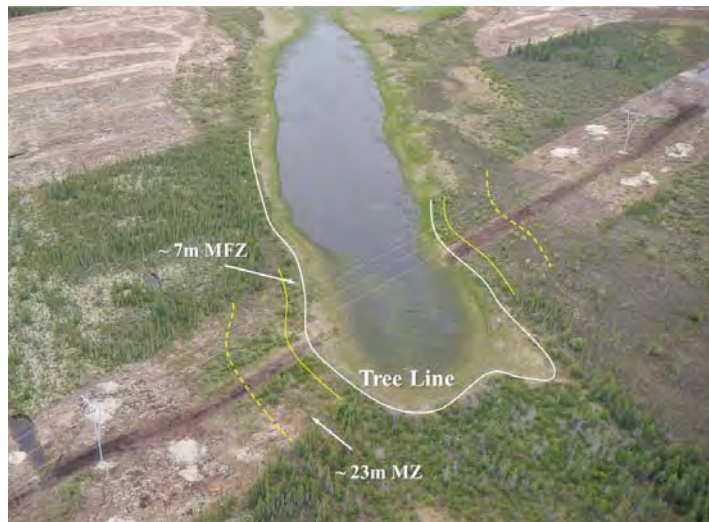
Photo 5: Riparian Zone Measurements

against the list of prescribed mitigation to determine level of compliance as well as recording observations of the conditions of sites. Riparian buffers, vehicle crossings, tower and anchor locations, and rutting and erosion were some of the parameters evaluated.

Of the 29 stream crossings surveyed, all sites were in compliance with 13 of the 21 mitigation measures. Of the 8 mitigation measures in non-compliance, the most common deviations from the prescribed mitigation were slash present below the tree line and minor rutting and stream bank damage. As well permanent structures (tower and/or anchors) for the Construction Power line were situated within the floodplain at five sites, including Goose Creek. During tower spotting it became apparent that previous design decisions and feedback from public engagement regarding minimizing right of way width to 310 metres for the AC Collector and Construction Power lines resulted in towers placed within the floodplain making it impossible to maintain the full riparian buffer of 30 metres at four sites. Manitoba Hydro took special measures during the installation of the towers/anchors under frozen ground conditions to minimize effects to the floodplain. Care was also taken during tower spotting when within the floodplain as to not affect the active channel, so as to not directly impact fish.

Manitoba Hydro went to great efforts in the field to identify and flag appropriate boundaries for riparian zones and buffers under difficult winter conditions in a complex riparian environment. Decisions were made in the field and in conjunction with MCWS to mark buffer zones under deep snow conditions and where there was difficulty in identifying the location of some stream channels. The riparian zones adjacent to most streams were adequately protected based on inspection and MCWS review. All inspection reports indicated that there were no major issues and that the work was in compliance with the applicable approvals and permits.

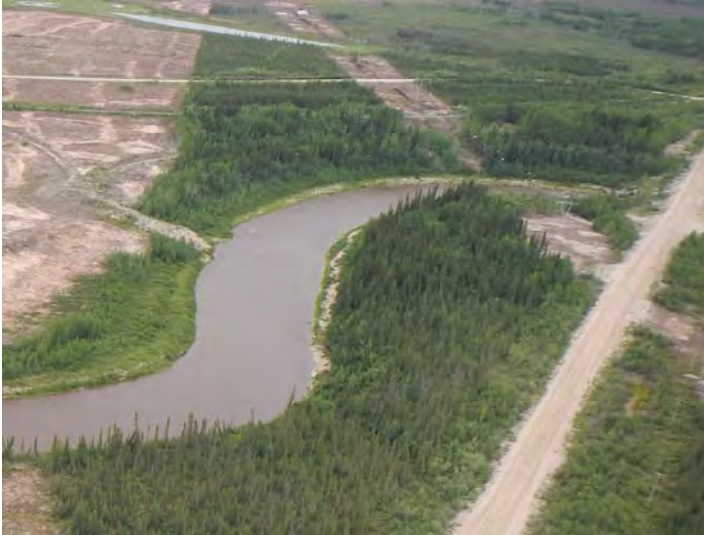
Photo 6: Limestone River crossing

Generally, monitoring activities determined the portion of the buffer closest to stream channels was hand-cleared and machinery was used for selective clearing further from the bank within the riparian buffer zone. At some sites the majority of trees as required for vegetation clearance requirements and shrubs were removed within the buffer, but ground cover remained intact.

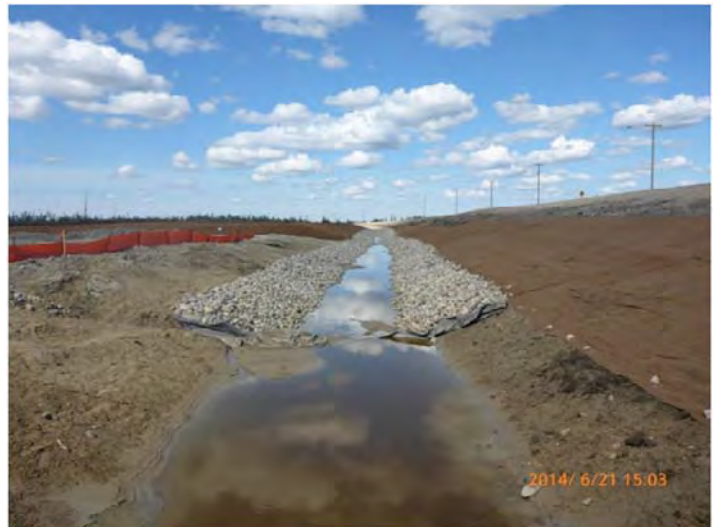
Photo 7: Erosion Control Measures on a Drain Leading to Goose Creek

Rock lining of collector drains, use of rock berms, and natural contouring of landscape were all measures used to keep soil and sediment in place at the Keewatinohk Converter Station site (Photo 7). Silt fencing, coconut fibre mats and permanent geo-textiles were installed in exposed areas to prevent sediment entering channels and streams where it could harm fish habitat in Goose Creek. During construction activities, daily monitoring of water quality was undertaken to ensure measures were effective and that any remedial action could be taken immediately. The suspended load of sediment appeared to be relatively low and sediment control measures effective.

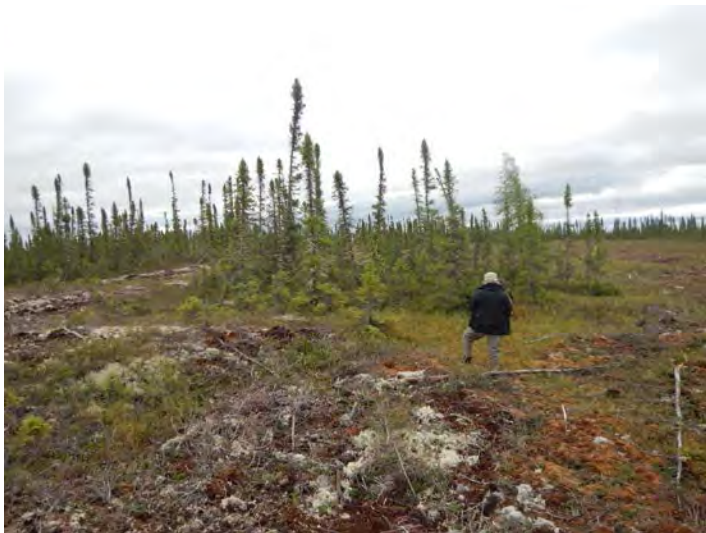
Photo 10: Uncleared Buffer Around Vegetation Species of Conservation Concern

Through fieldwork, it was determined that recommended mitigation was implemented during clearing activities for most sites and effective where implemented (Photo 10). From surveys a further mitigation measure is recommended around the Assiniboine River crossing. Eliminating tree removal by spanning the steep slope or, where possible, reducing clearing at this location is desired to protect populations of several species of conservation concern observed.

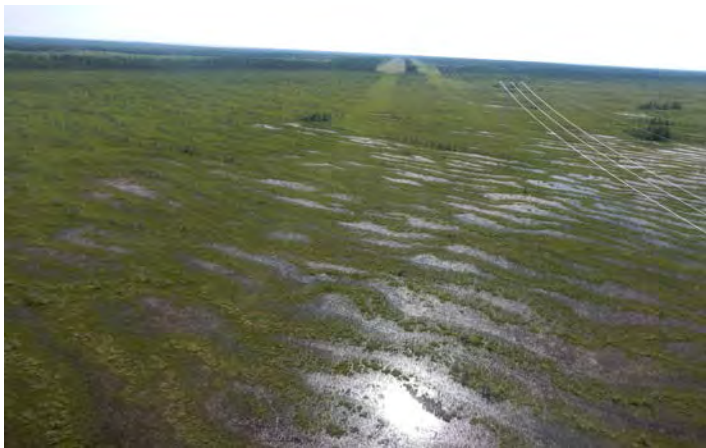
Photo 12: Patterned Fen Wetland Along Bipole III Right-of-Way

Wetlands are valued for their biological diversity and ecological function. The monitoring program for wetlands was aimed at assessing the effect of ROW development on vegetation community health in environmentally sensitive sites (ESS). In the sections cleared in 2014, four patterned fen wetlands sites previously identified in the Project assessment in 2010 were selected for vegetation assessment (Photo 12). Two sites were analyzed for wetland vegetation in paired on ROW and off ROW comparisons. Diversity index, species evenness and species richness had similar ranges in value to the paired survey sites, suggesting that vegetation clearing in these wet sites may not be affecting these vegetation parameters. The only difference was for total percent species cover which was slightly lower on the ROW compared to adjacent to the ROW which was expected immediately following clearing activity and will recover in subsequent growing seasons. For the Project areas cleared during 2013/14, the effect predictions for environmentally sensitive wetland vegetation were accurate with the exception of diversity measures in year one.

Through field work, map review and discussion, it was determined that while some recommended mitigation measures were implemented during clearing activities, others were implemented partially or not at all. Where implemented, mitigation was determined to be effective. In the absence of mitigation, some site disturbance were apparent. All sites appeared to utilize existing access roads and trails, had vehicle traffic confined to established trails, and construction activities were carried out on frozen ground to minimize surface damage. Approximately 42 hectares were disturbed by clearing activities in the environmentally sensitive wetlands and all sites did not retain a 30 m vegetated buffer surrounding the ends of the wetlands. However, no rehabilitation was prescribed as natural revegetation is expected to repair the disturbance caused by construction.

As a result of this information, protection of wetland zones are being reviewed with the Environmental Inspectors for potential improvements in ESS flagging and communication with clearing contractors. Riparian zones were previously noted in the aquatic section and remedial actions described.

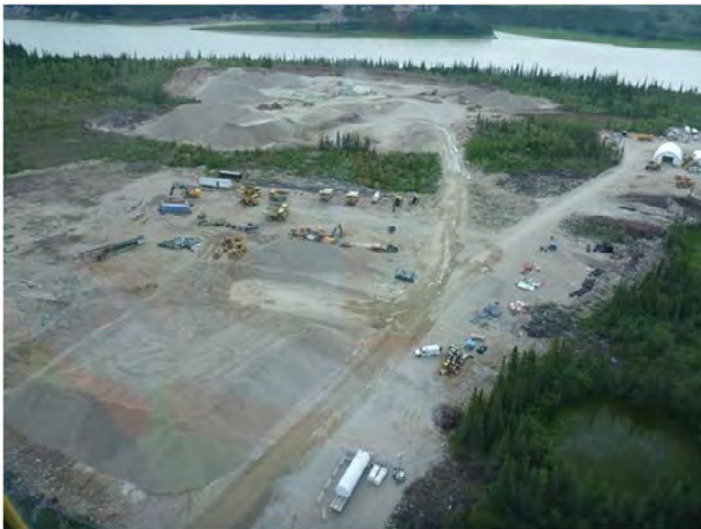
Photo 13: Borrow Pit Requiring Rehabilitation Post Construction

The degree of disturbance was assessed at all sites visited to determine whether natural re-vegetation was feasible (Photo 13). It is recommended the Keewatinohk Construction Camp lagoon, Conawapa Road ditch immediately adjacent to the lagoon and the ditches surrounding the Keewatinohk Converter Station be re-vegetated using native seed.

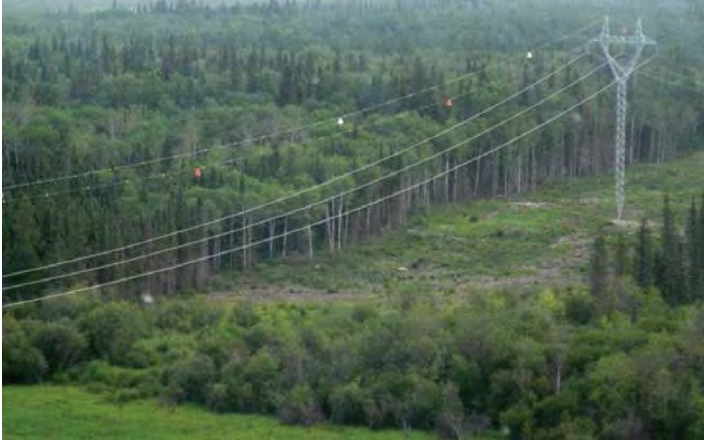
Photo 15: Bird Diverters on a Transmission Line

The 2014 surveys consisted of verification surveys to determine the relative significance of each ESS identified in the EIS based on the density and richness of bird species that have a greater potential for bird-wire collision (e.g., waterfowl, waterbirds, colonial nesting birds). The relative significance of ESS's will allow for a priority assessment for the placement of bird diverters and for bird diverter effectiveness monitoring (Photo 15).

As a result of additional aerial surveys carried out in 2014, a number of the original 144 sites and some new sites have been deemed to be candidate high risk ESS that are recommended for installation of bird diverters when the Bipole III conductors are installed. These sites will be monitored after construction for occurrences of bird-wire collisions in accordance with the BMP. Comparison will be made between high risk sites with bird diverters versus lower risk sites with no diverters.

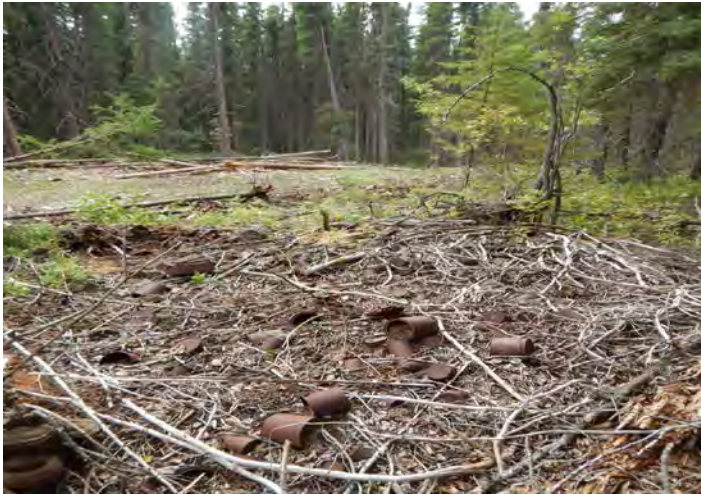
Photo 18: Tin Cans and Refuse Pile Related to Hudson Bay Railway Construction

Three out of four water crossings identified as ESS for heritage were surveyed. At the Saskatchewan River crossing, a historic steam boiler was discovered along the edge of the ROW but was not considered a heritage concern. Two crossings of the Mitishto River were investigated. At one site, tin cans, animal bones and glass bottles were discovered along an access trail (Photo 18).

The material was likely from construction of the Hudson's Bay Railroad in the 1930's and was not of heritage value to warrant designation as an archeological site. In the future, it is recommended Environmental Monitors be on-site to observe all tower footing excavations within 100 metres of heritage environmentally sensitive site locations in case unknown heritage resources are revealed.

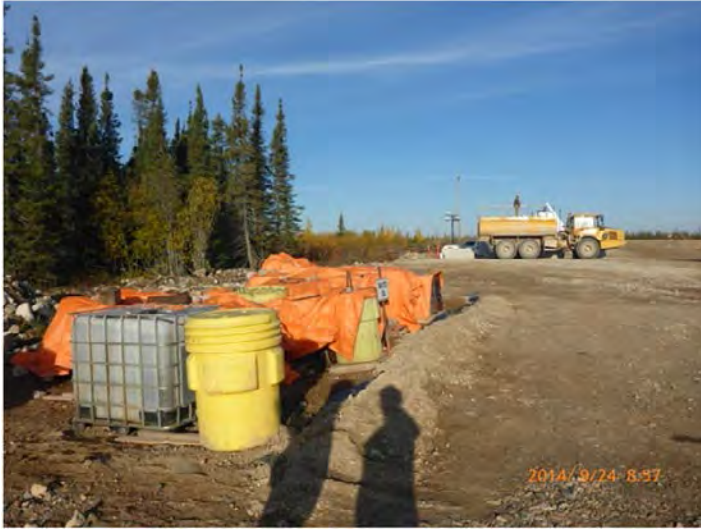
Photo 19: Temporary Hazardous Materials Storage Area at Keewatinohk Converter Station Work Area

Manitoba Hydro requires all contractors to have a spill response plan. All contractor spills, regardless of quantity are reported to Manitoba Hydro. All hazardous materials on Keewatinohk Converter Station site are segregated and stored in lined temporary storage cells (Photo 19).
