# Lake Winnipeg East System Improvement Transmission Project

## 2016 Vegetation Biophysical Monitoring Report

Prepared for:  
Manitoba Hydro  
360 Portage Avenue  
Winnipeg, MB

Project No. 1595 | February 2018

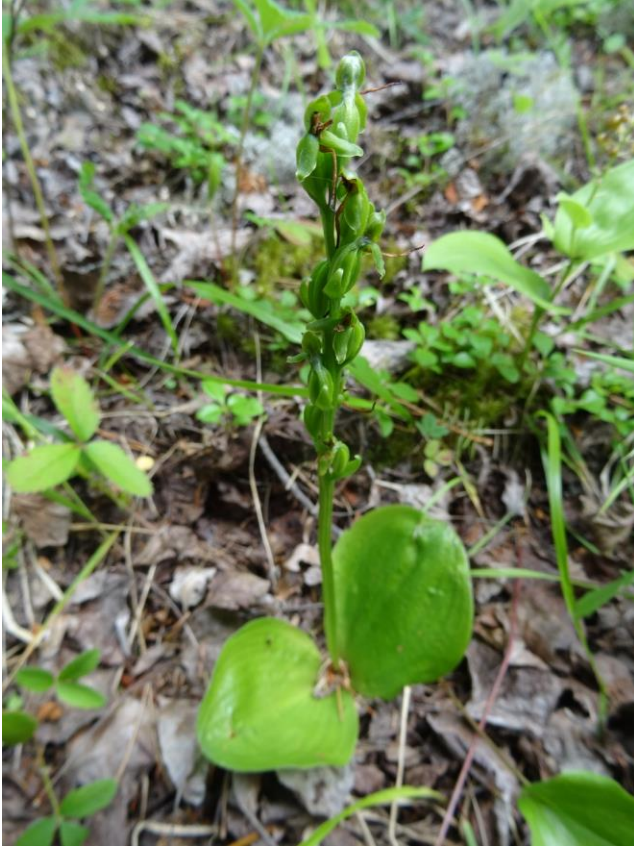
The 2016 survey of the known Hooker's Orchid population (LWE-Eco-302) documented a total of 11 plants (3 flowering, 8 basal leaves only). These plants were noted to be in healthy condition with flowering stems up to 15cm in height and no signs of sun scald or other indications of plant stress.

DSC04731 – Hooker's Orchid (*Platanthera hookeri*) at LWE-Eco-302 on July 8, 2016.

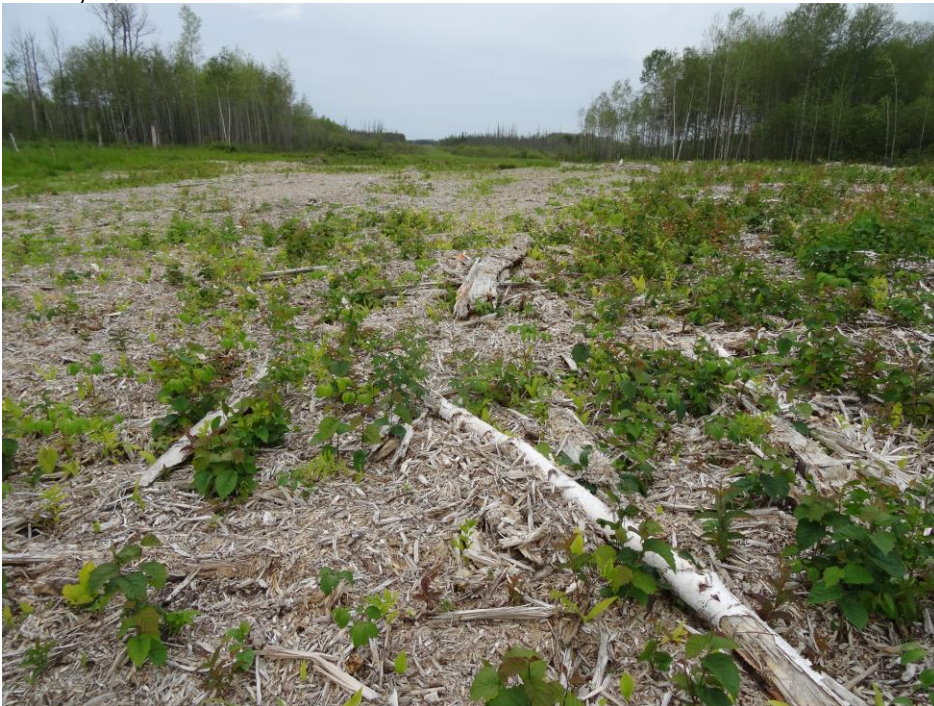
With the exception of LWE-Eco-301, all identified population of SCC vegetation appeared to be in good condition. It is noted that one of the identified mitigations “provide a 5m vegetated (shrub and herbaceous) buffer around the site” had not been implemented for LWE-Eco-304 - Swollen Sedge or LWE-Eco-301 – Dwarf Bilberry. Swollen Sedge has responded positively to the clearing, is widespread at that location and other areas within the RoW and is not likely to be affected. Dwarf Bilberry was not relocated and additional mitigation is discussed further in the following section.

The inability to relocate Dwarf Bilberry within LWE-Eco-301 was likely a result of the thick covering of wood mulch acting to smother the plants. It is unclear at this time if the plants are live and remain present beneath the mulch. Additional mitigation for this ESS is recommended in Section 5.0.

DSC04758 – Location of Dwarf Bilberry (*Vaccinium caespitosum*) population LWE-Eco-301 on July 9, 2016

It may be advisable to lightly scarify or remove mulch from a 10x10m area at this location using hand tools to remove the mulch and encourage growth. Removal of mulch using a heavy equipment blade or bucket may damage or kill any persistent Bilberry plants and is not recommended. Left untouched it is possible that plants could grow through the mulch; however the preferred rocky outcrop habitat of this species would not be maintained thus limiting potential for regeneration and long-term survival of this population.

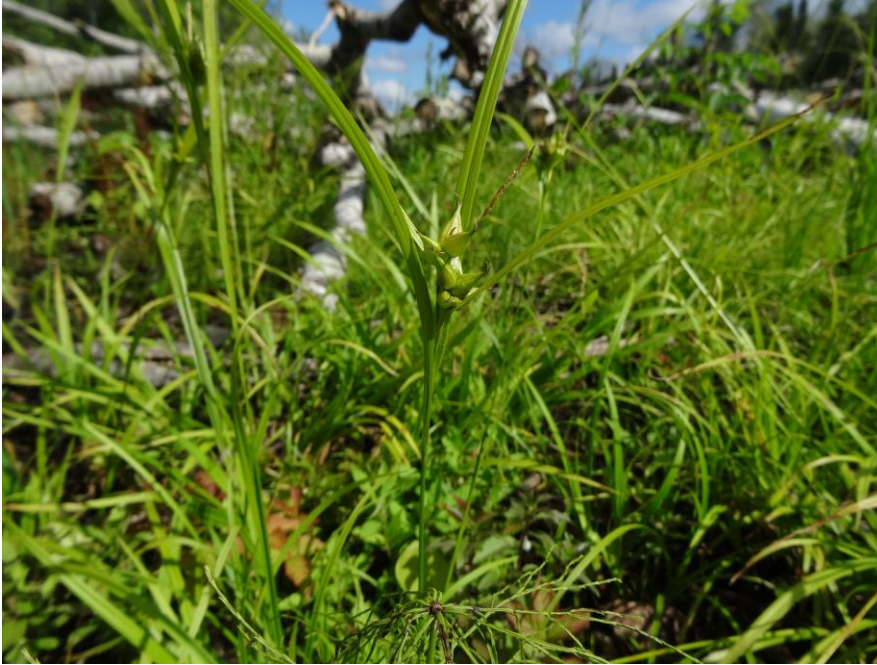
The disappearance of an SCC or its significant decline within an ESS is identified as a decision trigger and threshold for action. Given that the Swollen Sedge located at LWE-Eco-304 has responded positively to the clearing, and is somewhat widespread and common within the RoW (as numerous other stands were located), no additional mitigation is recommended for this ESS.

DSC04707 – Swollen Sedge (*Carex intumescens*) LWE-Eco-304 on July 8, 2016.

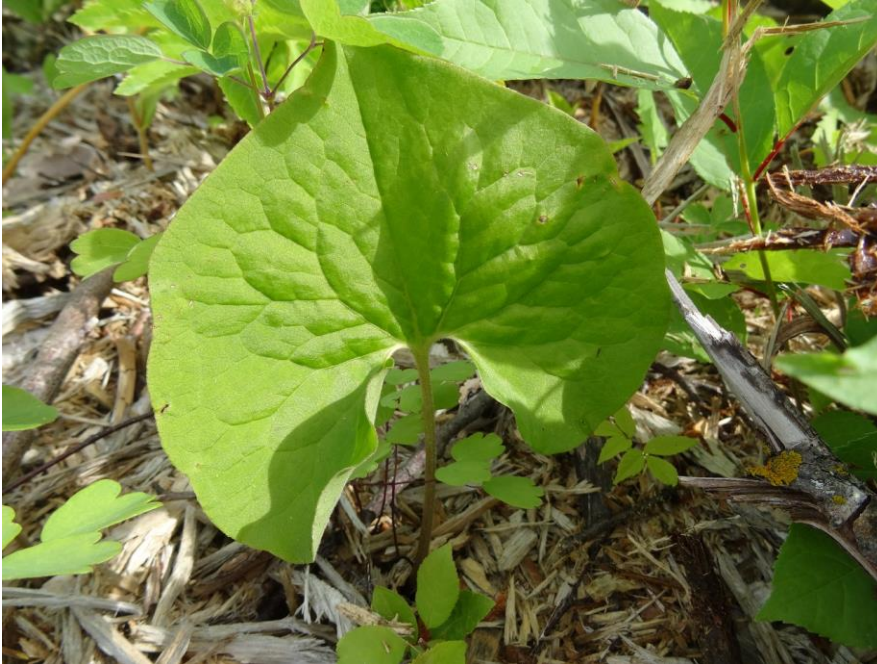
DSC04740 – Wild Ginger (*Asarum canadense*) within LWE-Ruse-208 on July 9, 2016.

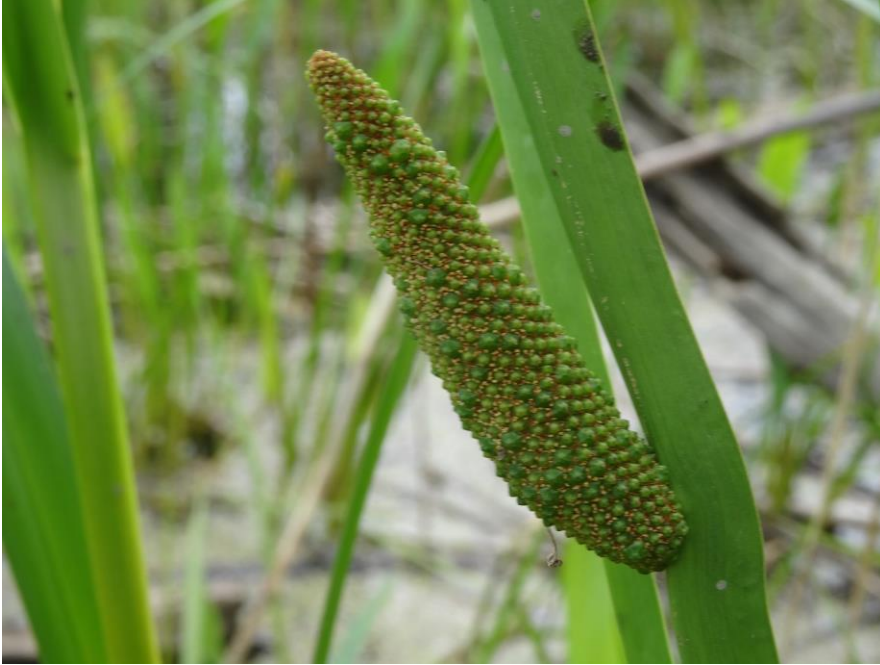
DSC04800 – Sweetflag (*Acorus americanus*) at LWE-Ruse-201 on July 10, 2016.
