*ENVIRONMENT ACT LICENCE
PROPOSAL FORM*

Name of the development: Remediation of Omand's Creek between Dublin and Saskatchewan Avenues	
Type of development per Classes of Development Regulation (Manitoba Regulation 164/88): Class 2 - 8. Water Development and Control	
Legal name of the proponent of the development: City of Winnipeg	
Location (street address, city, town, municipality, legal description) of the development: 1460 Dublin Avenue	
Name of proponent contact person for purposes of the environmental assessment: Tracy Stople	
Phone: 204.986.2221 Fax: 204.986.7311	Mailing address: 4th Floor, 185 King St, Winnipeg, MB R3B 1J1
Email address: TStople@winnipeg.ca	
Webpage address: www.winnipeg.ca	
Date: Nov 29/2013	Signature of proponent, or corporate principal of corporate proponent: Printed name: ROB LOUDFOOT

RE: Former Dominion Bridge Site - Geotechnical Input For Omand's Creek Remediation

**Subject Remedial Action Plan, City of Winnipeg
Former Dominion Bridge Operations Yard,
1460 Dublin Avenue, Winnipeg, Manitoba**

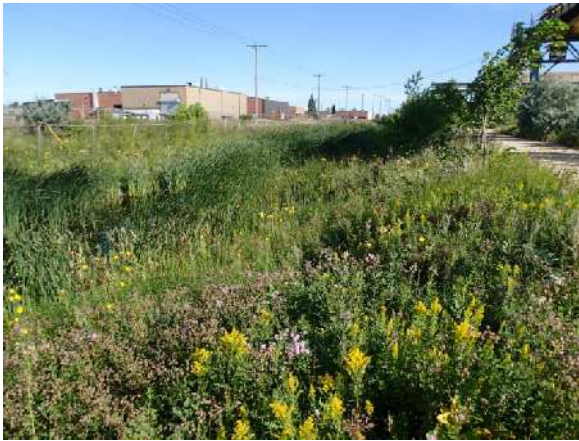
Figure 01 – Facing north along the east bank

The east bank is well vegetated with tall grasses and shrubs with the overbank area used as a gravel road along the east edge of the creek ROW as shown on Figure 01. A retaining wall constructed along a significant length of the east bank is in very poor structural condition. The wall was constructed using vertical structural steel members (angles and rails), steel walers and steel plate or timber railway ties as wall facing (Figure 02). It appears that some sections of the wall may be tied back with steel rods and anchors. The wall is up to about 1.5 m high in some areas and gravel backfill is visible in gaps in the wall. There is also fill material and debris visible immediately upslope of the wall. In front (creek side) of the wall, the channel bank slopes at approximately 3.5 horizontal to 1 vertical (3.5H:1V) towards the edge of the water. There were no visible signs of active slope instabilities along the east channel but that wall has a considerable lean towards the creek suggesting insufficient lateral resistance to earth (fill) pressures.

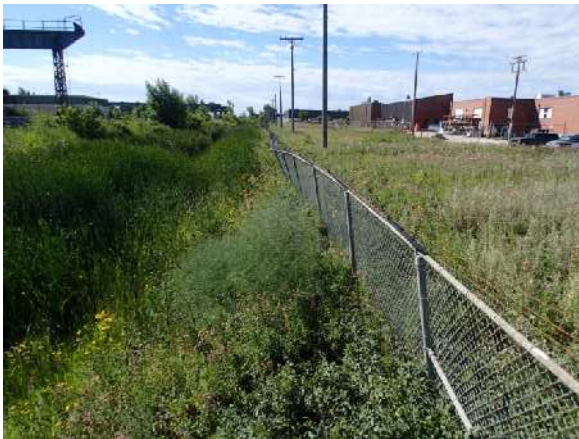
Figure 03 – Facing south from west bank

The west bank is heavily vegetated with grasses, shrubs and small trees. A chain link fence runs along the property line between the creek and McCrossen St. right-of-ways and a line of hydro poles and overhead wires extend the entire length of the east bank, approximately 3.0 m onto the McCrossen St. right-of-way. The west bank slopes range from about 1H:1V to as flat as 5H:1V. Four sections of the west bank along the McCrossen St. right-of-way show signs of instabilities in the form of a head scarp, slumping and tension cracking near the top of bank that extend by about 1 m onto the McCrossen St. right-of-way. These sections are from approximately Stations 1+00 to 1+30, 1+95 to 2+40, 2+50 to 2+60, and 2+70 to 3+10 (total of about 125 m) as shown on Drawing 01. These instabilities are evident by the chain link fence within these stretches which has deflected towards the creek and is leaning towards the creek as shown on Figures 03 & 04.

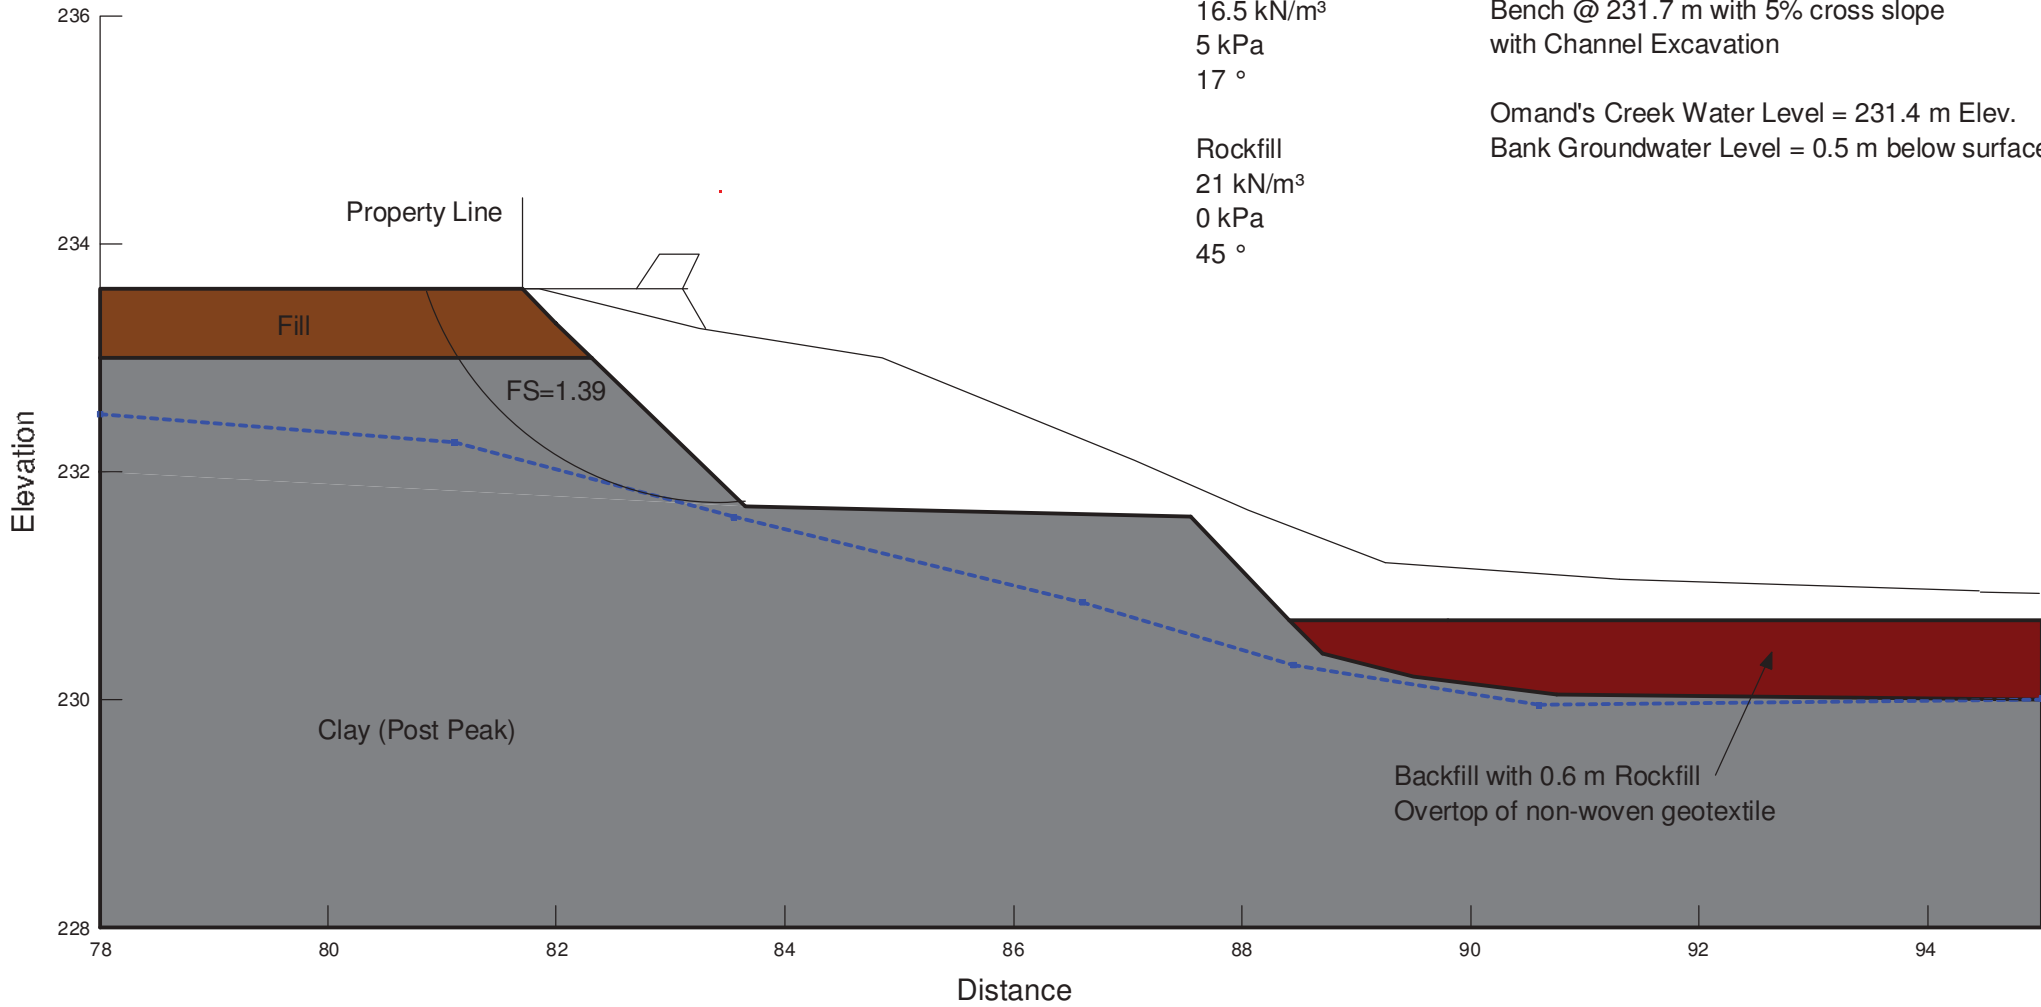
**East Bank
Stage 3 Backfill**

Cross Section D
Bench @ 231.7 m with 5% cross slope
with Channel Excavation

Omand's Creek Water Level = 231.4 m Elev.
Bank Groundwater Level = 0.5 m below surface

Stage 2 - Excavation	1.31	Excavate 1.0 m thick contaminated materials in channel
Stage 3 – Backfill	1.39	Backfill channel bottom excavation with 0.6 m rockfill
Stage 4 - Backfill	2.10	Backfill remainder of channel bottom excavation with 0.4 m clay. Regrade channel side slopes to 4H:1V

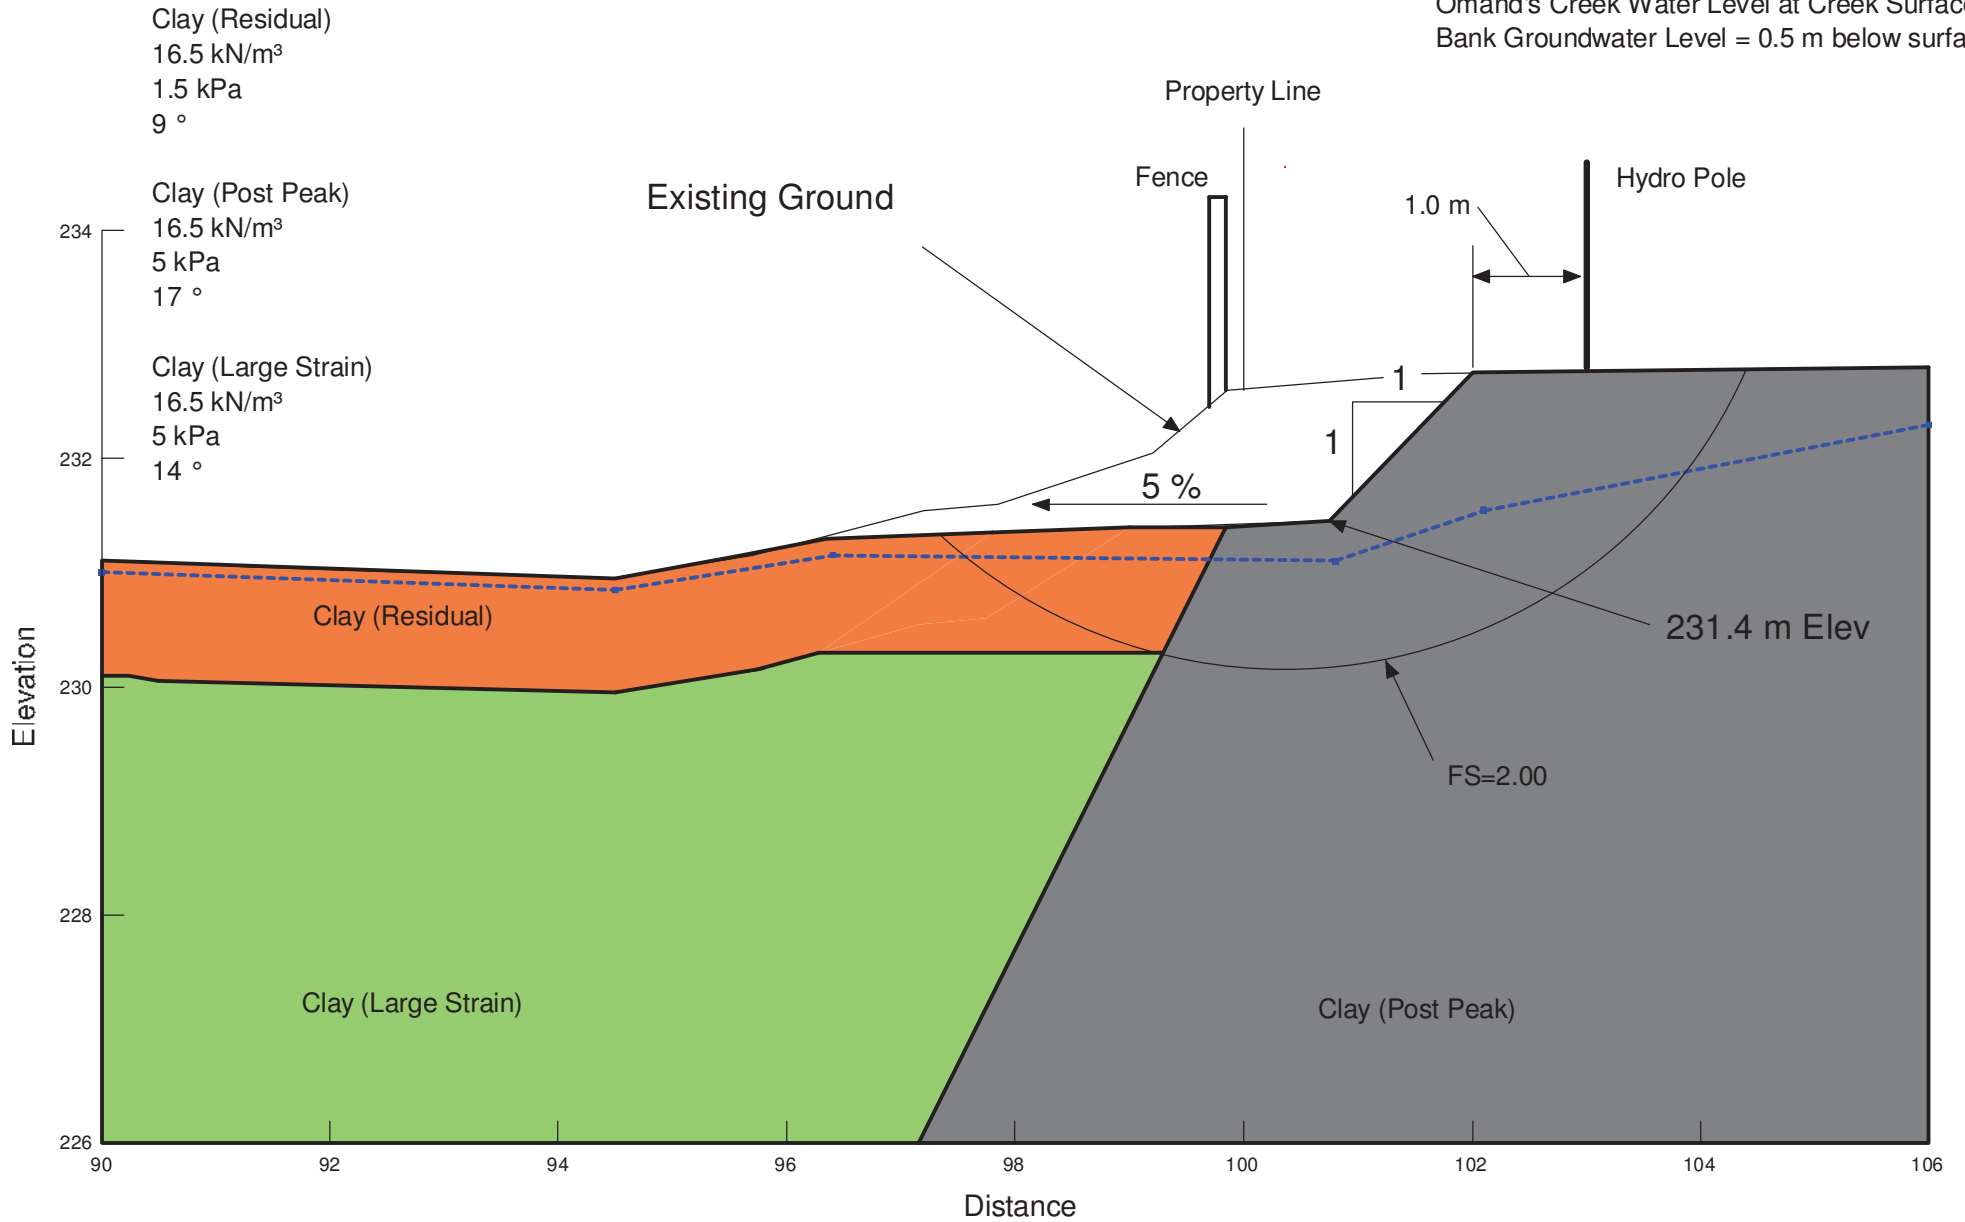
**West Bank
Stage 1 - Excavation**

Cross Section D
Bench @ 231.4 with 5% Cross Slope

Omand's Creek Water Level at Creek Surface
Bank Groundwater Level = 0.5 m below surface

Stage	Factor of Safety	Description
Existing	1.00	Back analysis of existing geometry
Stage 1 - Excavation	2.00	1H:1V cut from 1.0 m E hydro pole to bench at Elev. 231.4 m
Stage 2 - Excavation	1.60	Excavate channel bottom to depth of 1.0 m
Stage 3 – Backfill	1.69	Backfill channel bottom excavation with 0.6 m rockfill
Stage 4 - Backfill	1.92	Backfill remainder of channel bottom excavation with 0.4 m clay. Regrade channel side slopes to 4H:1V

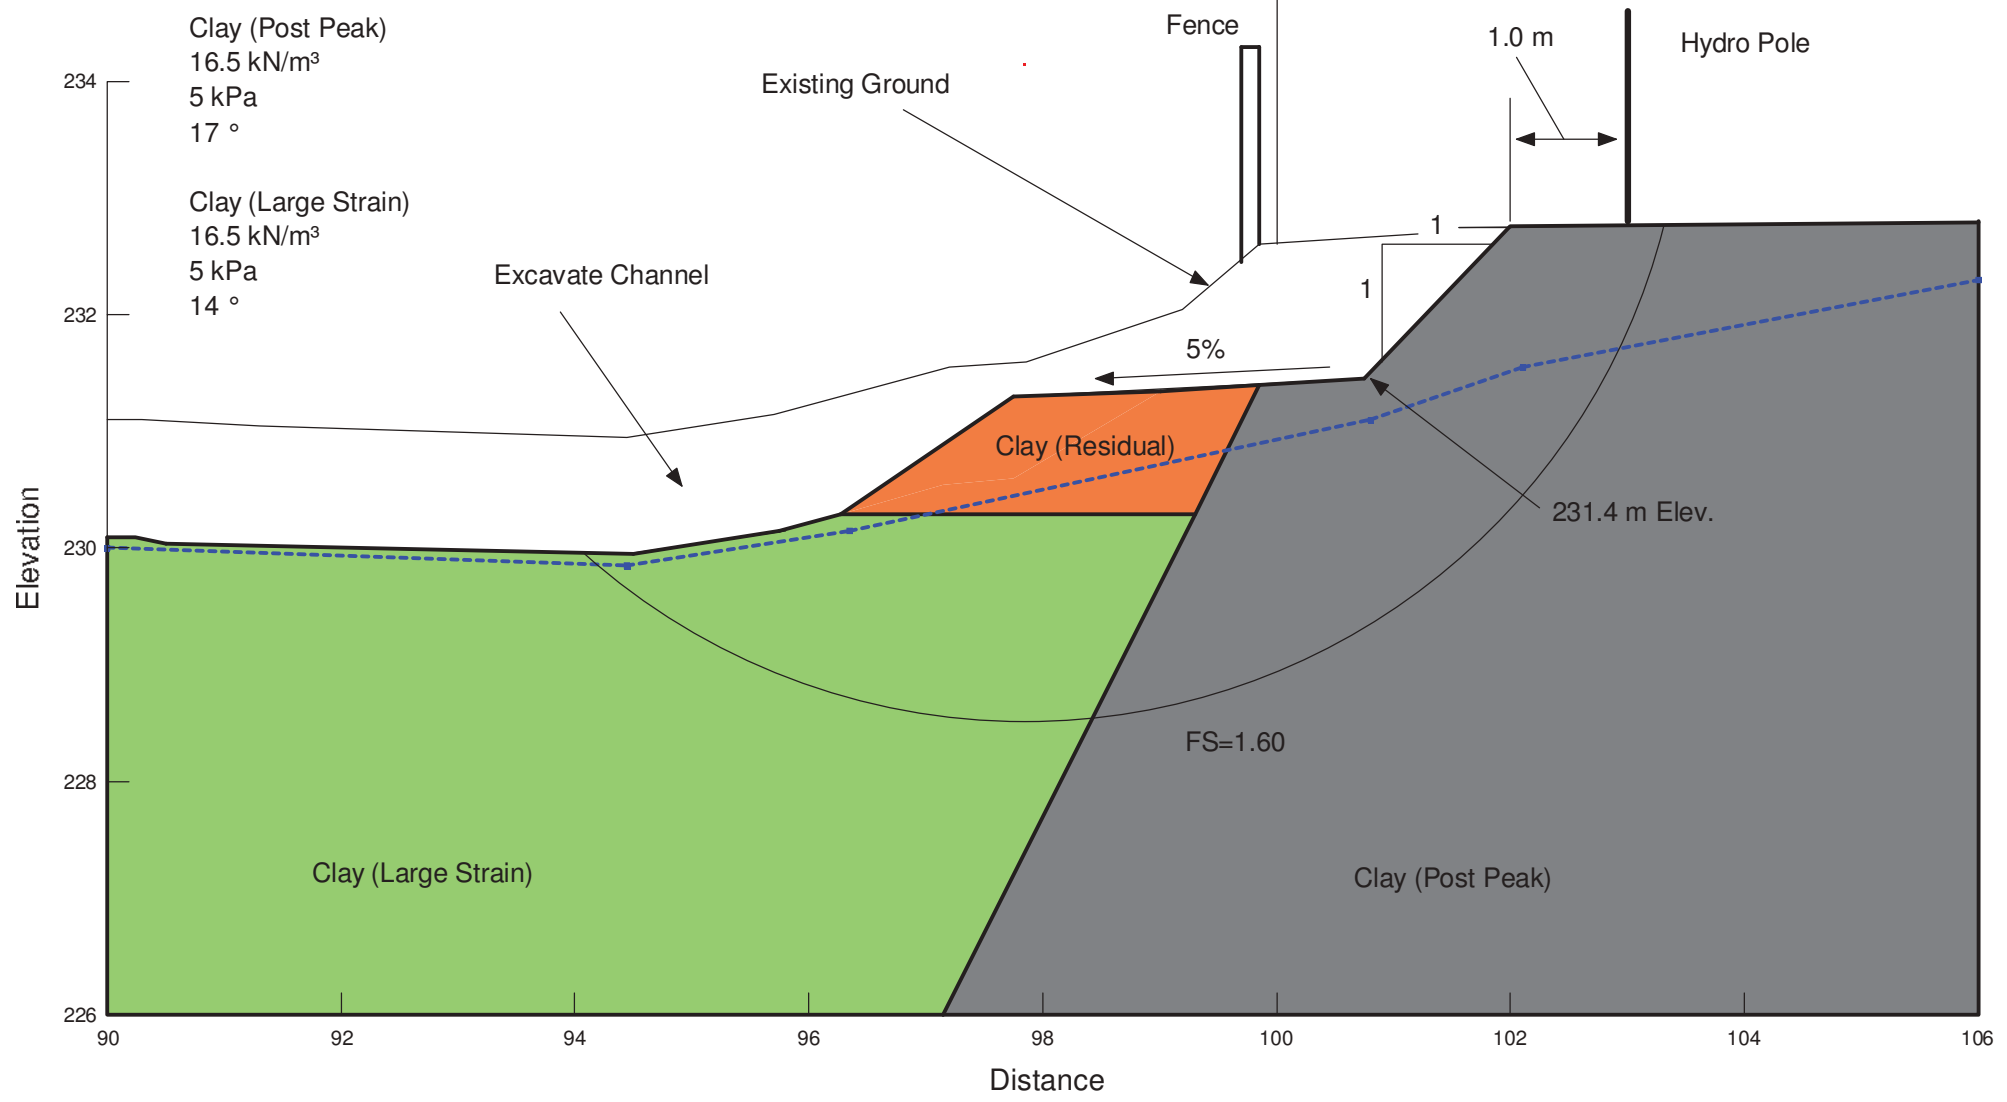
West Bank Stage 2 - Excavation

Cross Section D
 Bench @ 231.4 with 5% Cross Slope
 Channel Excavation

Omand's Creek Water Level at Creek Surface
 Bank Groundwater Level = 0.5 m below surface

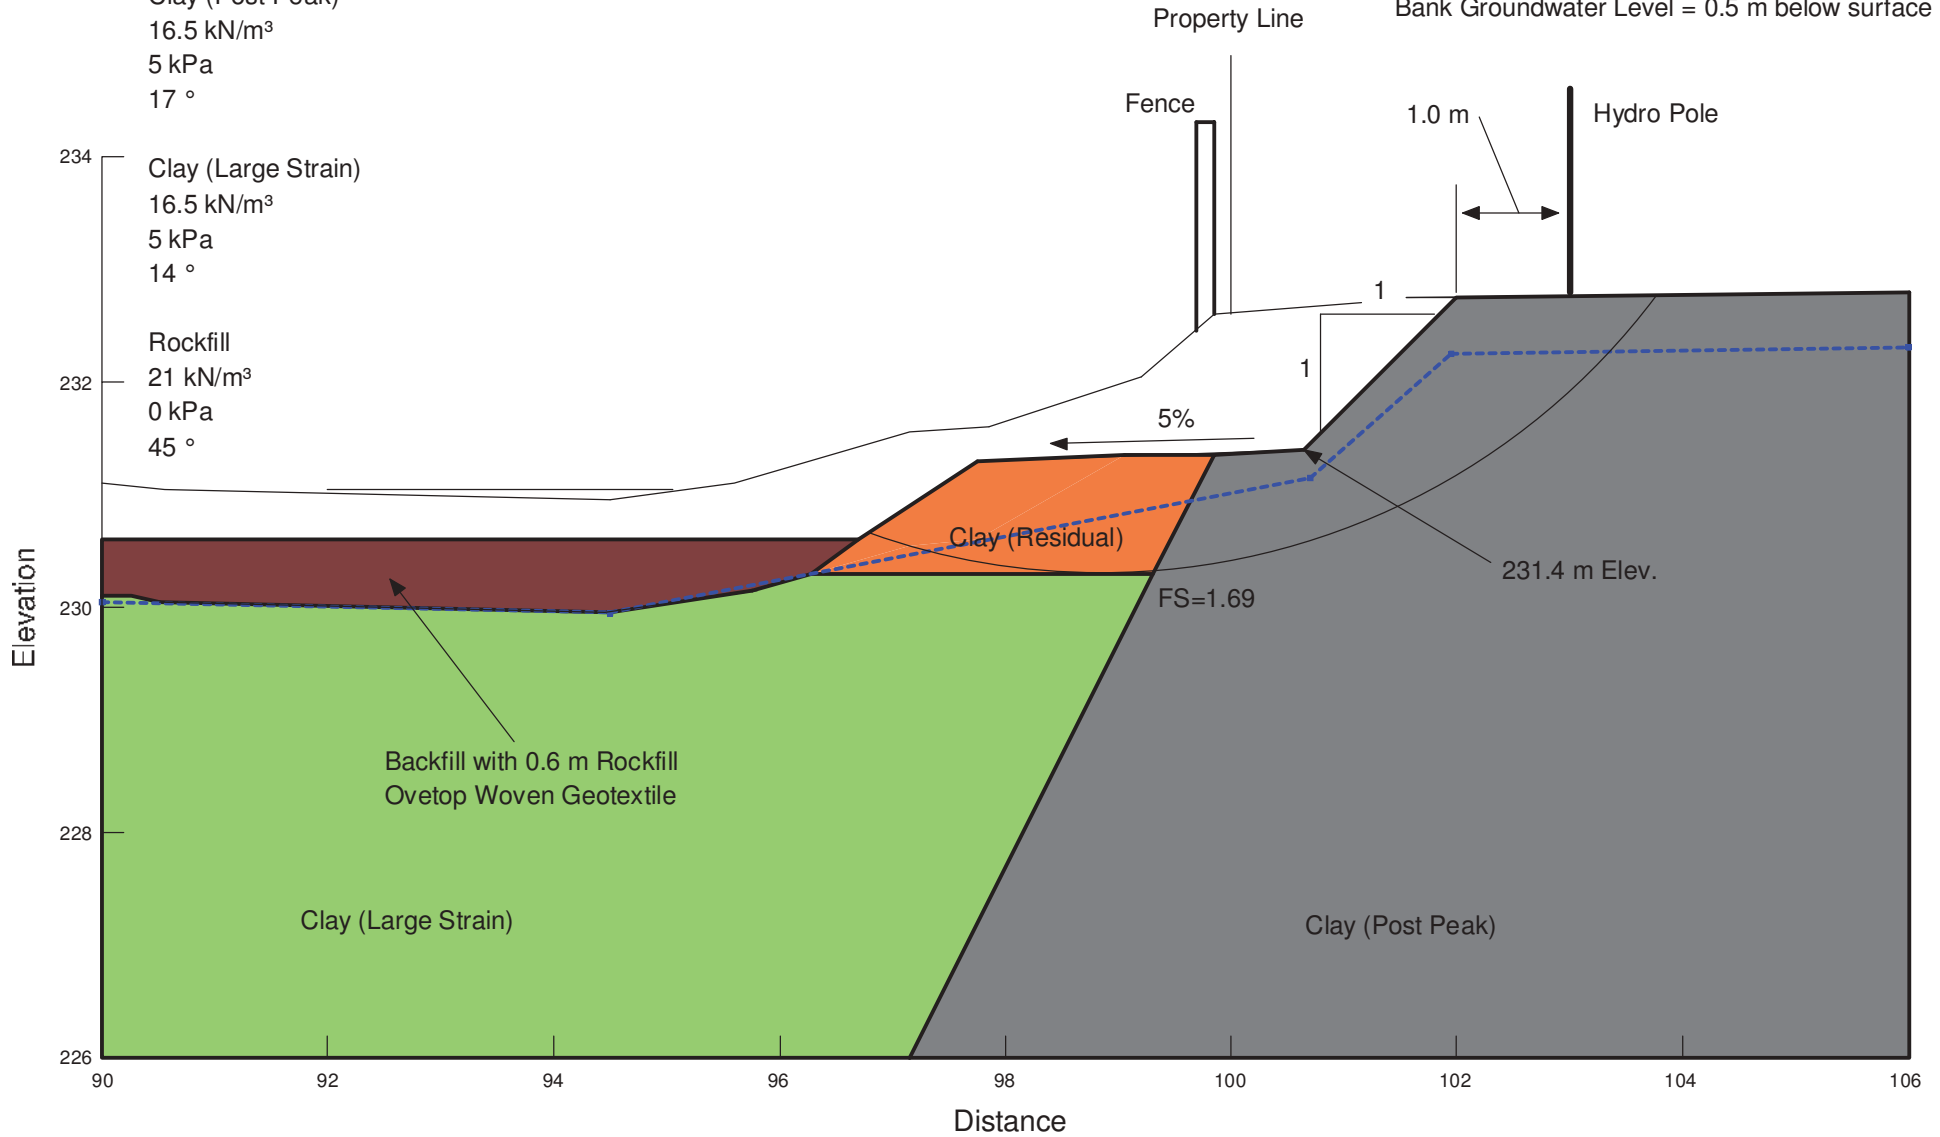
West Bank Stage 3 - Backfill

Tetra Tech Inc.
Dominion Bridge Site Remediation
Stability Analysis for Remedial Works
0002 011 00
Cross Section D
Partially Backfilled Channel

Omand's Creek Water Level at Original Excavation Floor
Bank Groundwater Level = 0.5 m below surface

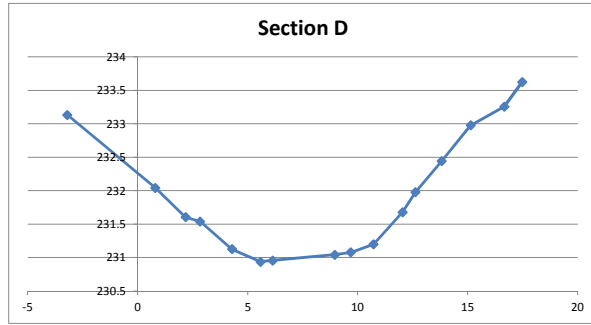
Station	Offset	Elevation	Manning Roughness
9+96.798	-3.202	233.134	0.045
10+00.796	0.796	232.043	0.045
10+02.175	2.175	231.606	0.045
10+02.834	2.834	231.541	0.045
10+04.279	4.279	231.127	0.030
10+05.580	5.58	230.937	0.030 Bottom
10+06.138	6.138	230.957	0.030
10+08.959	8.959	231.044	0.030
10+09.688	9.688	231.08	0.030
10+10.718	10.718	231.2	0.030
10+12.036	12.036	231.679	0.045
10+12.662	12.622	231.981	0.045
10+13.810	13.81	232.442	0.045
10+15.136	15.136	232.979	0.045
10+16.662	16.662	233.258	0.045
10+17.476	17.476	233.627	0.045

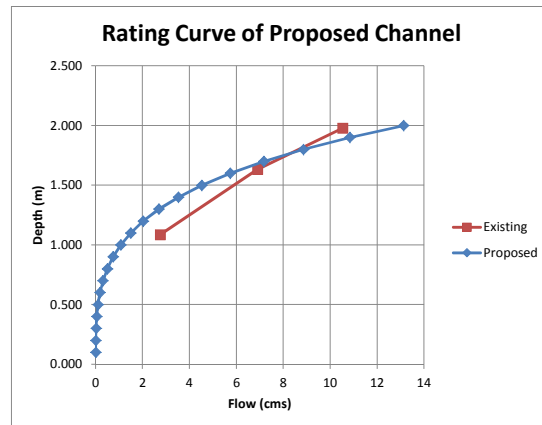
Depth (m)	Flow Area (sq m)	Hyd Radius (m)	AR ² /3	Flow (cms)	Velocity (m/s)
0.100	0.340	0.089	0.001	0.001	0.002
0.200	0.760	0.163	0.012	0.005	0.007
0.300	1.260	0.230	0.043	0.019	0.015
0.400	1.840	0.292	0.109	0.049	0.027
0.500	2.500	0.351	0.225	0.102	0.041
0.600	3.240	0.408	0.411	0.186	0.057
0.700	4.060	0.463	0.690	0.312	0.077
0.800	4.960	0.517	1.087	0.491	0.099
0.900	5.940	0.570	1.630	0.736	0.124
1.000	7.000	0.622	2.352	1.063	0.152
1.100	8.140	0.674	3.289	1.486	0.183
1.200	9.360	0.726	4.479	2.024	0.216
1.300	10.660	0.777	5.966	2.695	0.253
1.400	12.040	0.828	7.796	3.522	0.292
1.500	13.500	0.878	10.018	4.526	0.335
1.600	15.040	0.929	12.688	5.732	0.381
1.700	16.660	0.979	15.864	7.166	0.430
1.800	18.360	1.029	19.606	8.857	0.482
1.900	20.140	1.079	23.982	10.834	0.538
2.000	22.000	1.129	29.061	13.128	0.597

Return Period (years)	Normal Depth (m)	Flow Area (sq m)	Hyd Radius (m)	AR ² /3	Flow (cms)	Capacity of New vs. Existing
2	1.000	7.000	0.622	2.352	1.063	39% Less
5	1.600	15.040	0.929	12.688	5.732	83% Less
10	2.000	22.000	1.129	29.061	13.128	125% More
