The Manitoba Water Services Board

# **Spruce Woods Provincial Park Lagoon Replacement - Environment Act Proposal**

**Project Number:**

June 2013

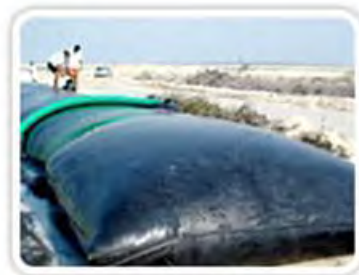
Dewatering the sludge will be through the use of Geobags. Geobags are made of geo-textile fabric which is woven from heavy plastic threads. A common Geo-Bag size is 13 m in diameter and 60 m long. This sized bag will hold 535 m<sup>3</sup> of material when it is full. The fabric has small openings of 50 to 100 microns between the threads. The lagoon sludge can be directly pumped into the bag, which retains the solids and allows water to pass through the small openings. Over approximately a 6 month period, the retained material dewateres and can then be hauled in dump trucks to a landfill.

Geobags appear to be the easiest method of dealing with the sludge from the existing lagoon.

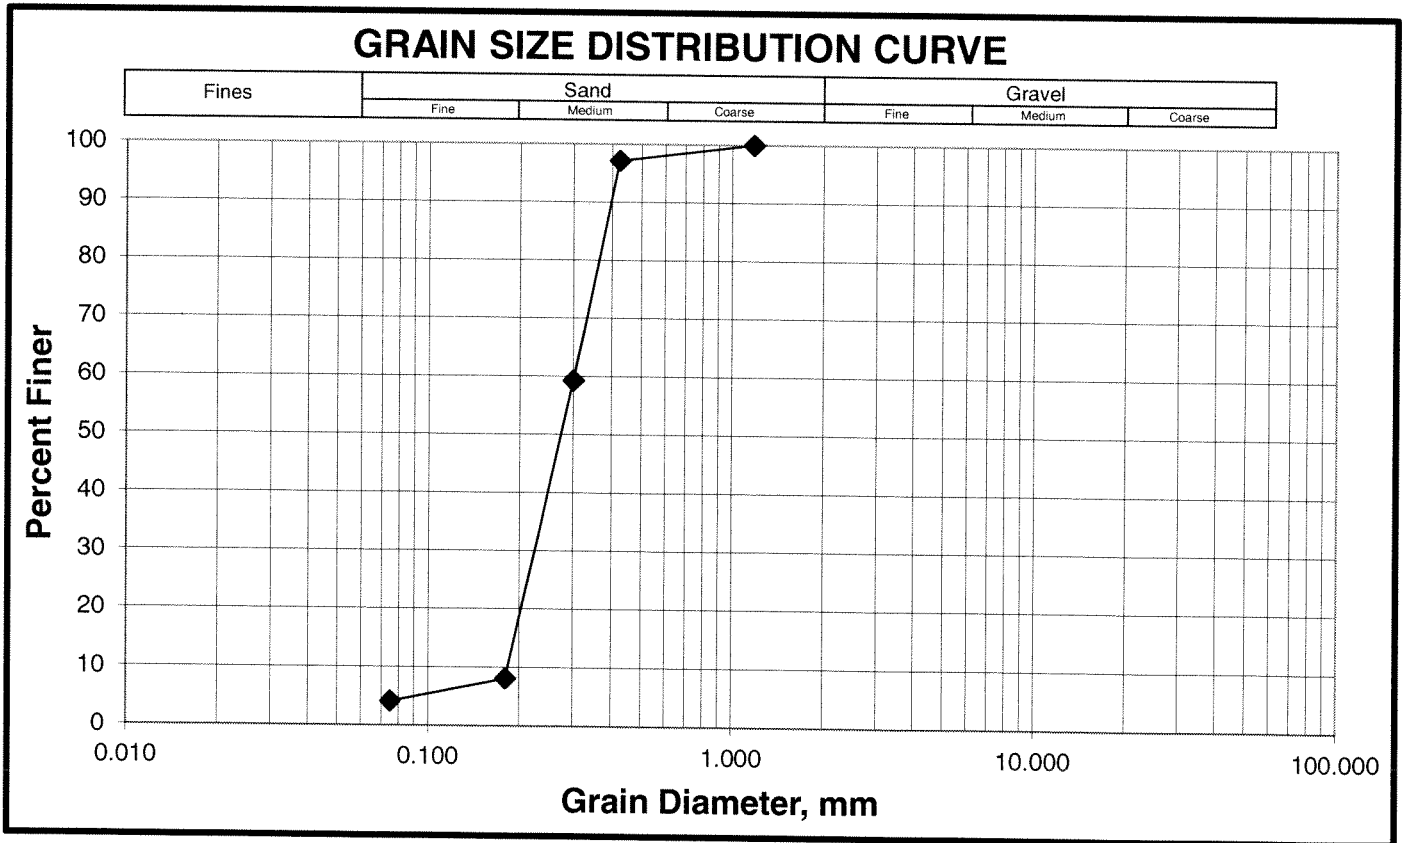
Sample Location: TH11-11 G55  
 Depth: 24.0 - 25.0'  
 Sample Description: Sand

Sieve (mm.)	Sieve No.	Total Percent Passing	Specification (min - max)
150.0	6"		
100.0	4"		
75.0	3"		
50.0	2"		
37.5	1.5"		
25.0	1"		
19.0	3/4"		
16.0	5/8"		
12.5	1/2"		
9.5	3/8"		
4.75	No. 4		
2.00	No. 10		
1.18	No. 16	100.0	
0.425	No. 40	97.2	
0.300	No. 50	59.3	
0.180	No. 80	8.1	
0.075	No. 200	4.1

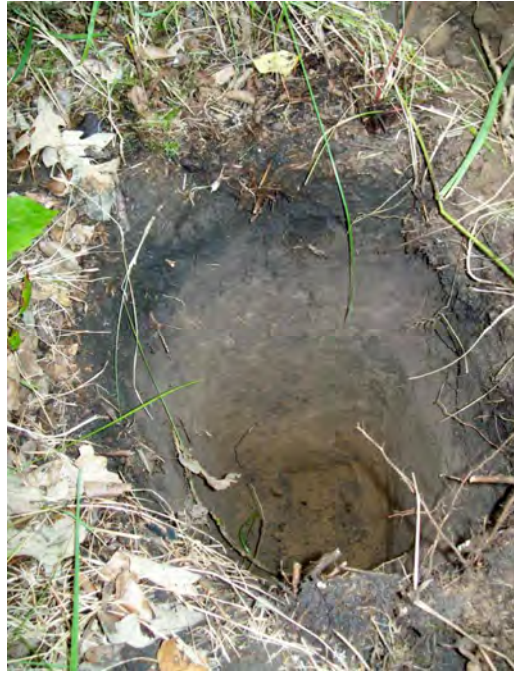
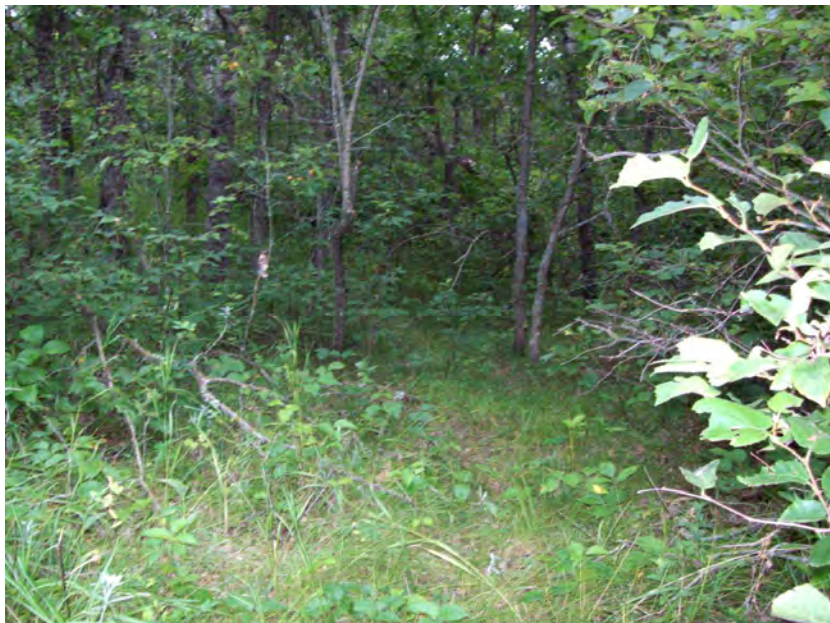
## Wheatland soil profile and landscape at the site 2

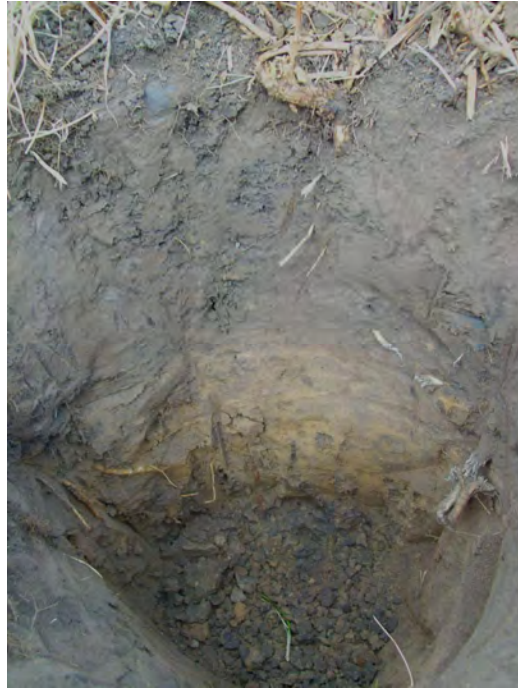
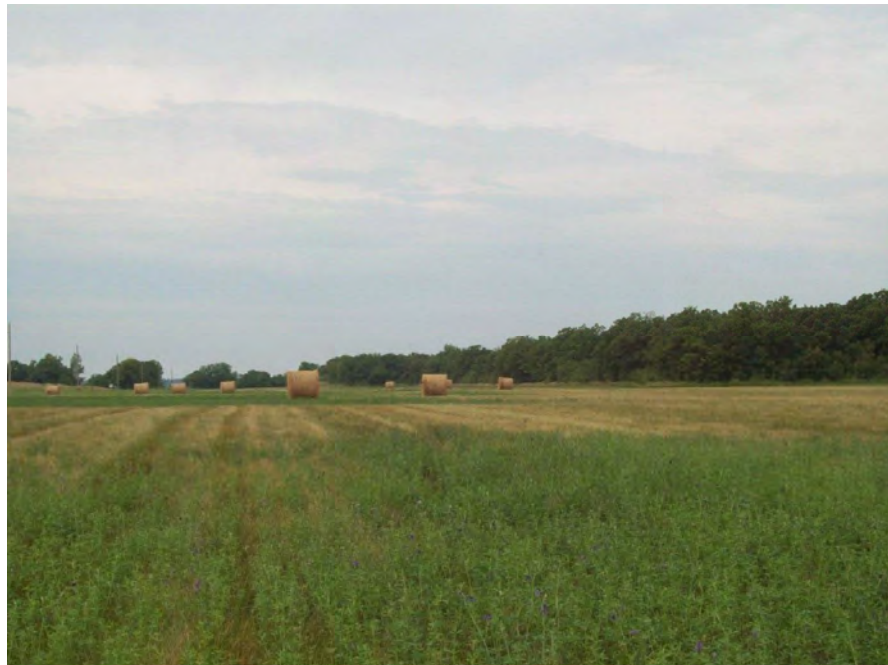
## Wellwood soil profile and landscape at the site 6

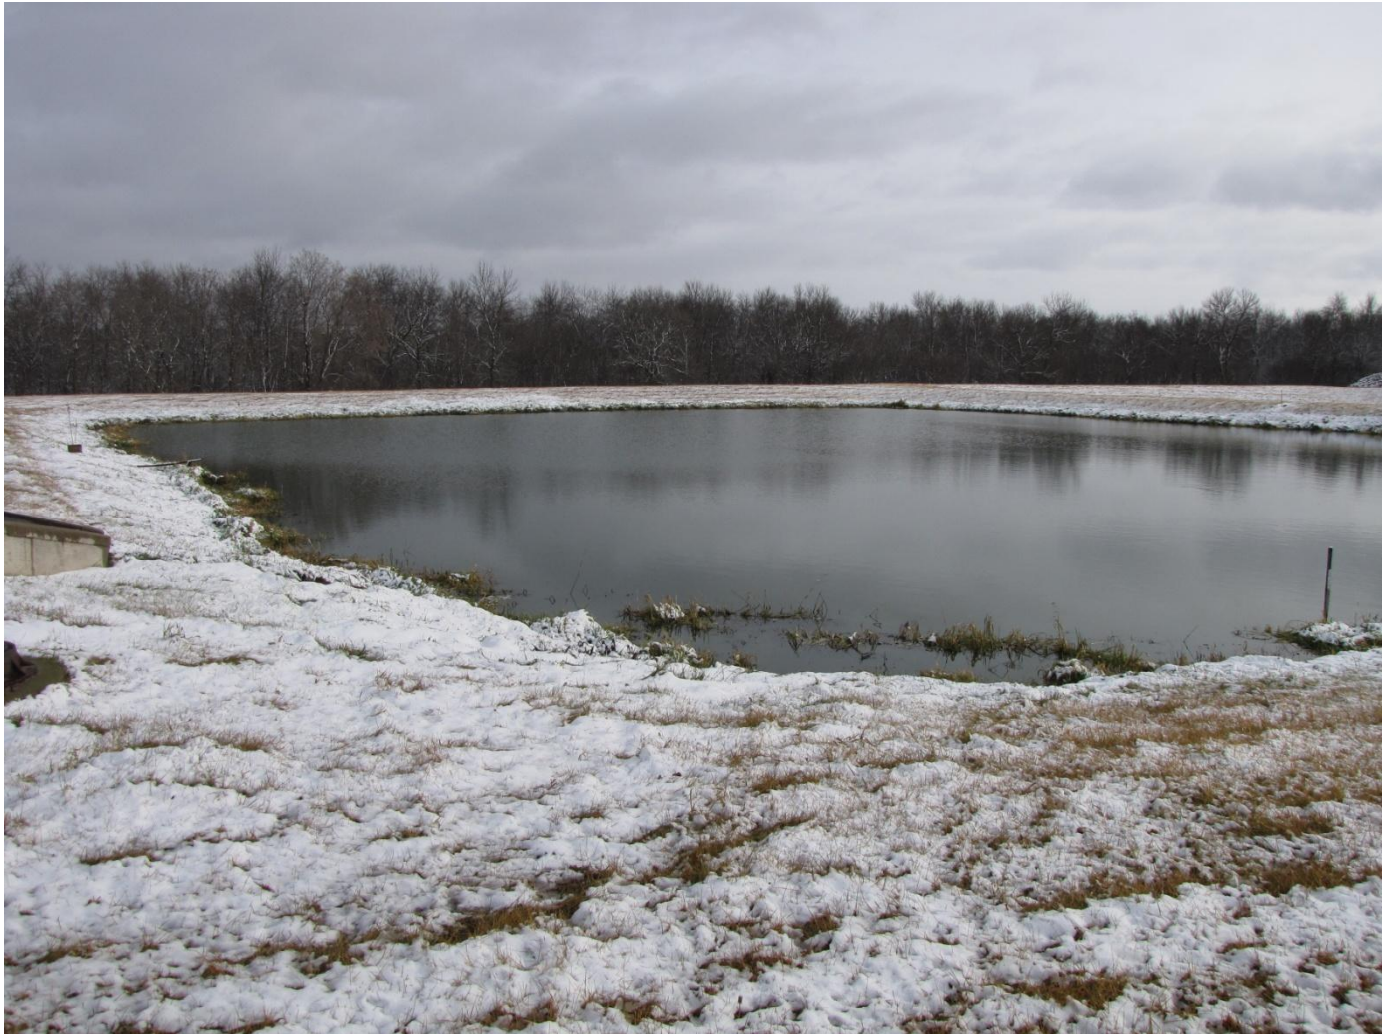
**Photograph 1.** Facing southeast showing the existing primary lagoon cell ↑

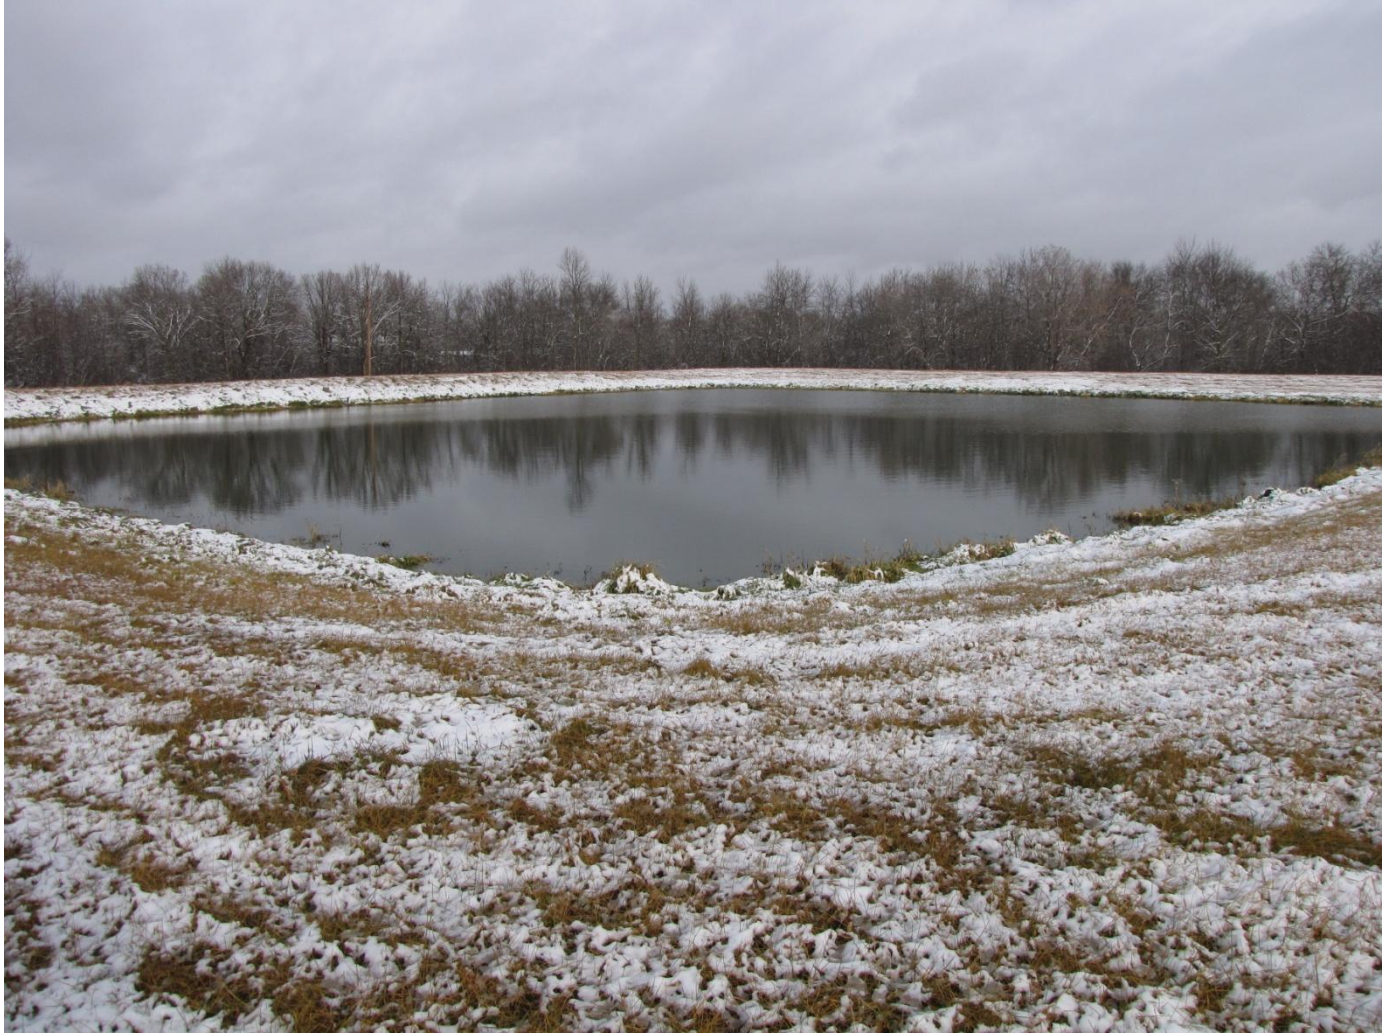
**Photograph 2.** Facing northeast showing the existing primary lagoon cell ↑

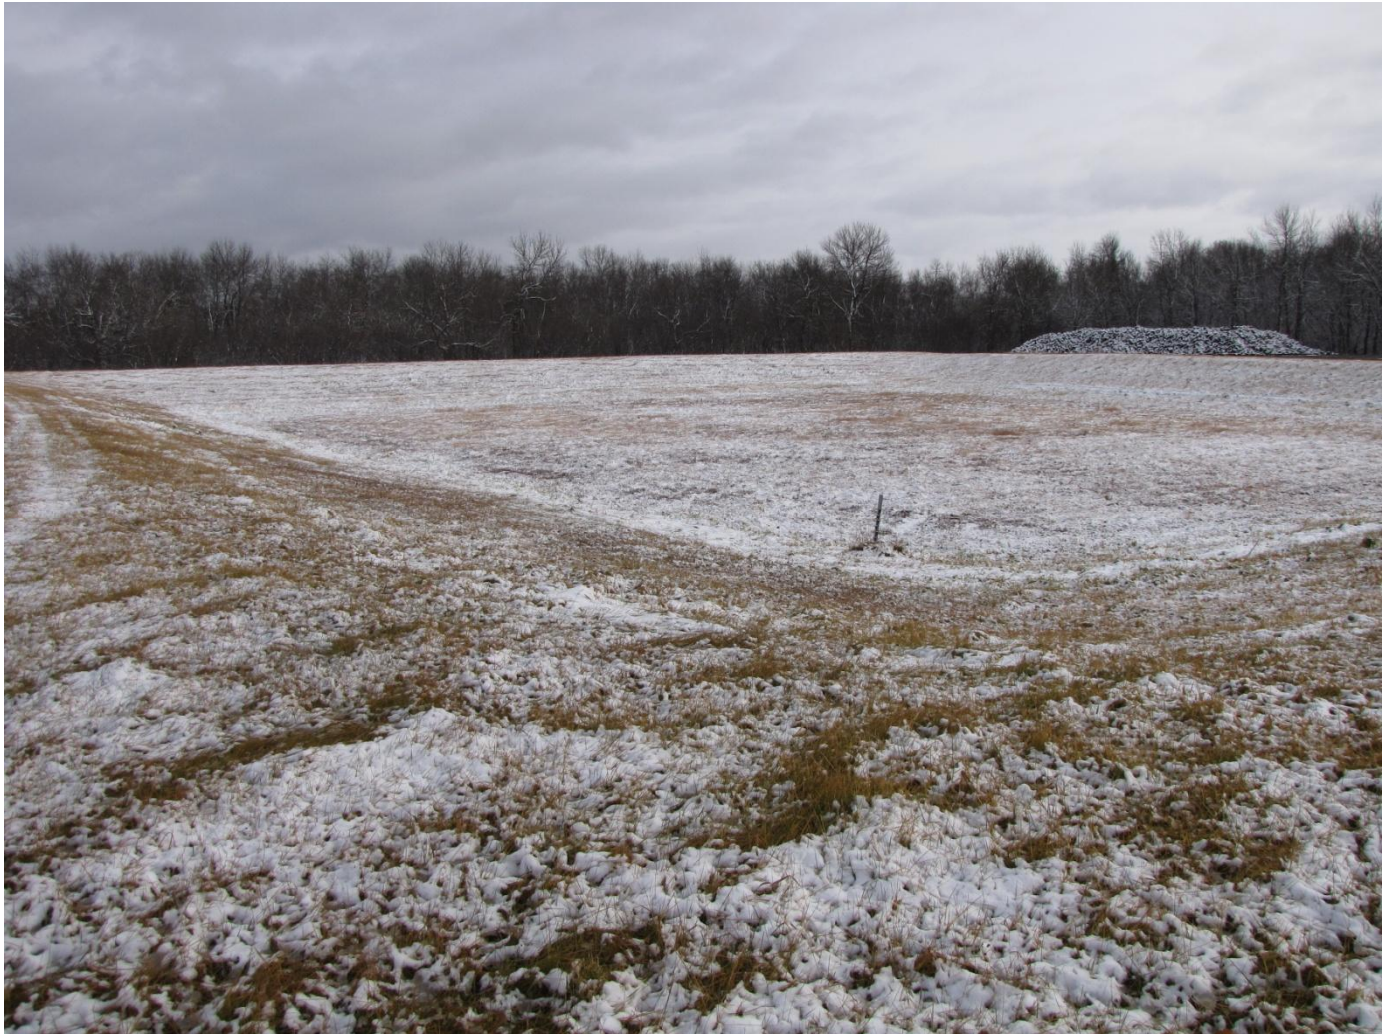
**Photograph 3.** Facing southeast showing the existing unused secondary lagoon cell ↑

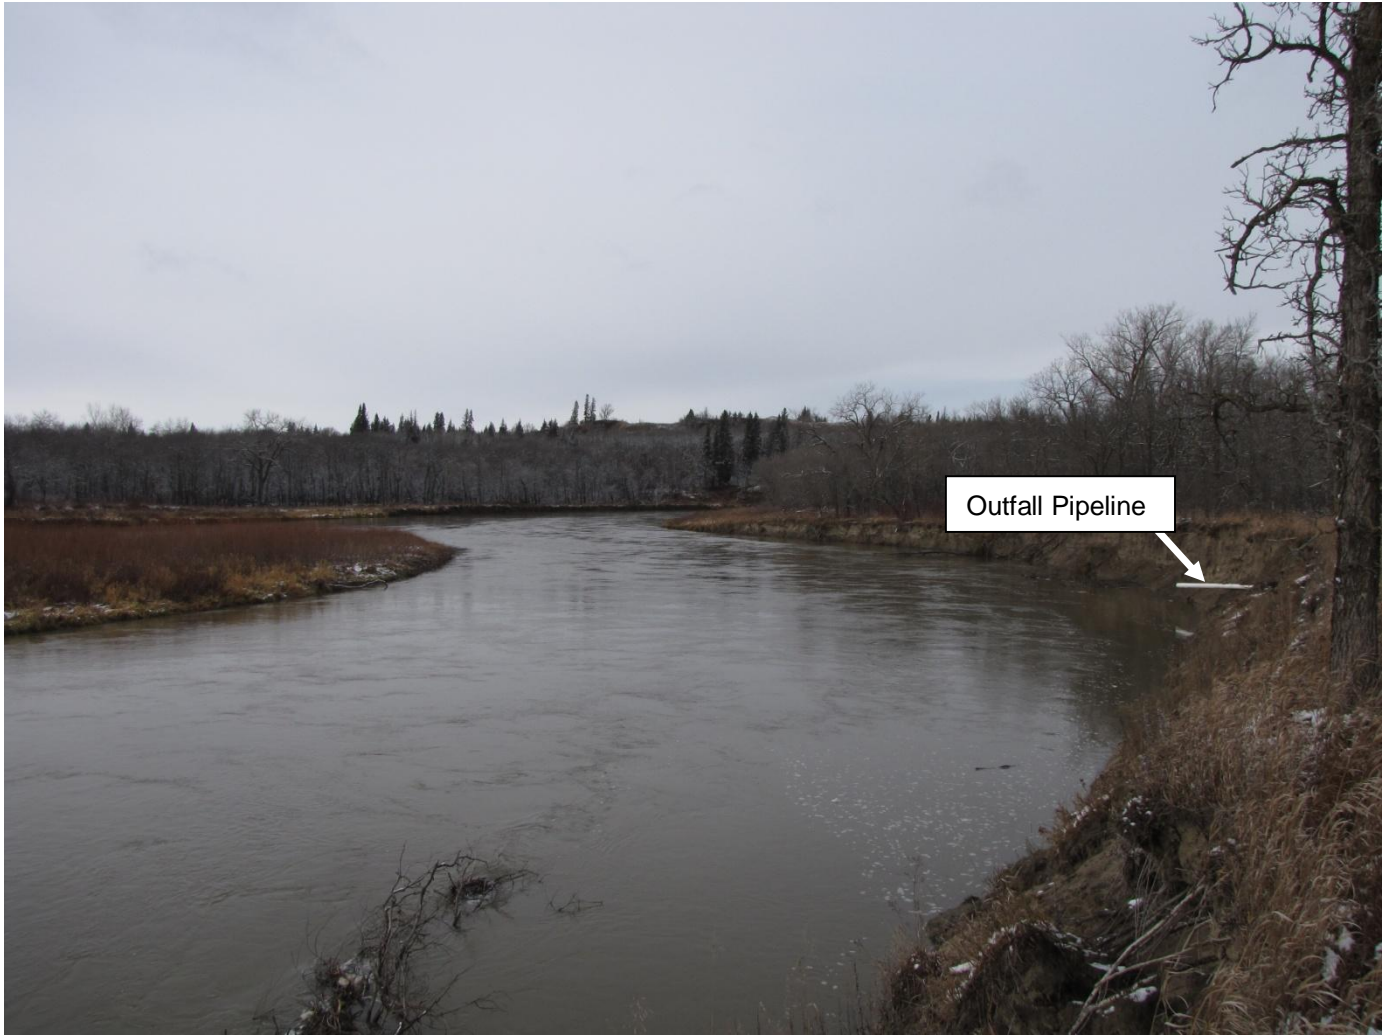
**Photograph 4.** Facing north showing the existing lagoon discharge pipe on the right hand side of the photograph ↑

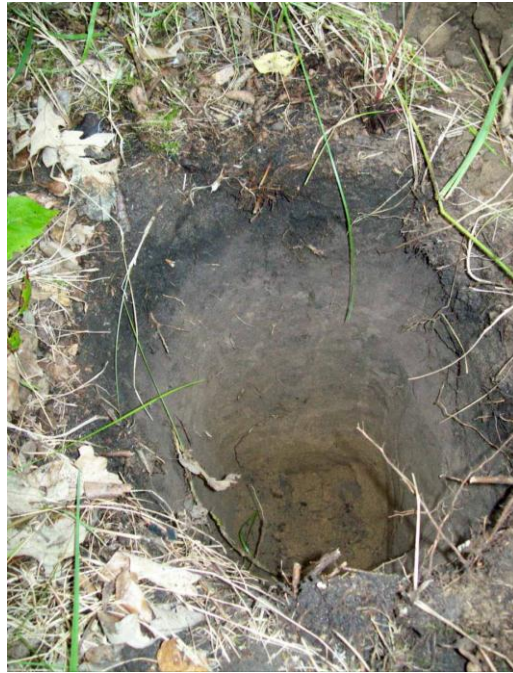
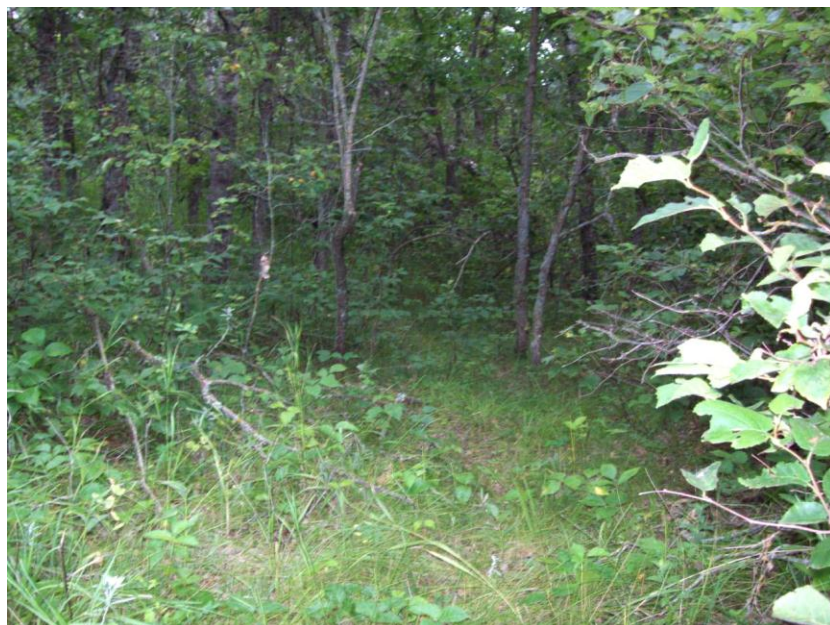
## Wheatland soil profile and landscape at the site 2

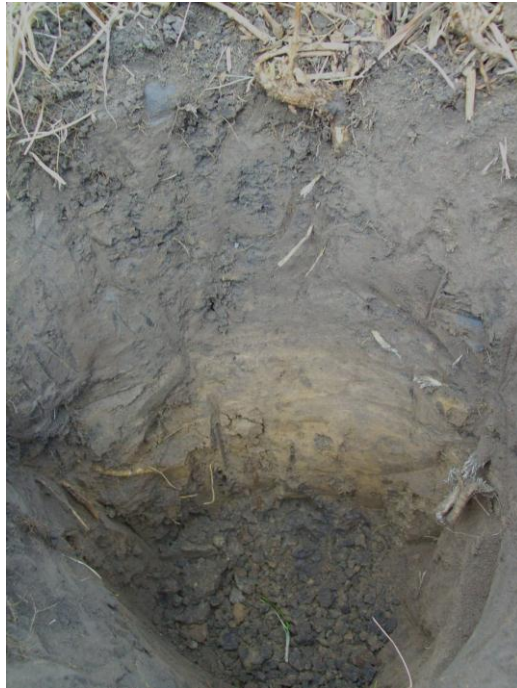
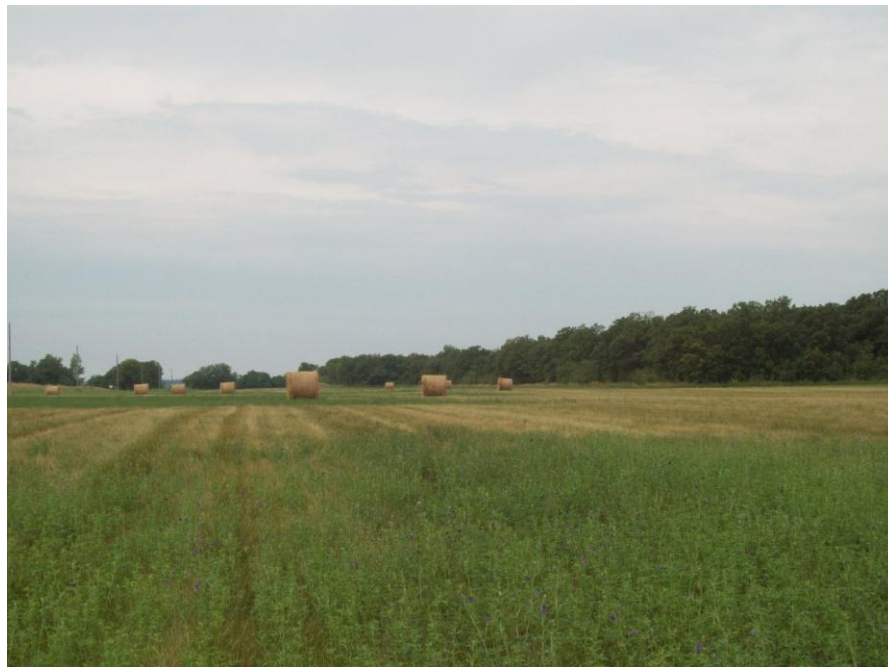
## Wellwood soil profile and landscape at the site 6

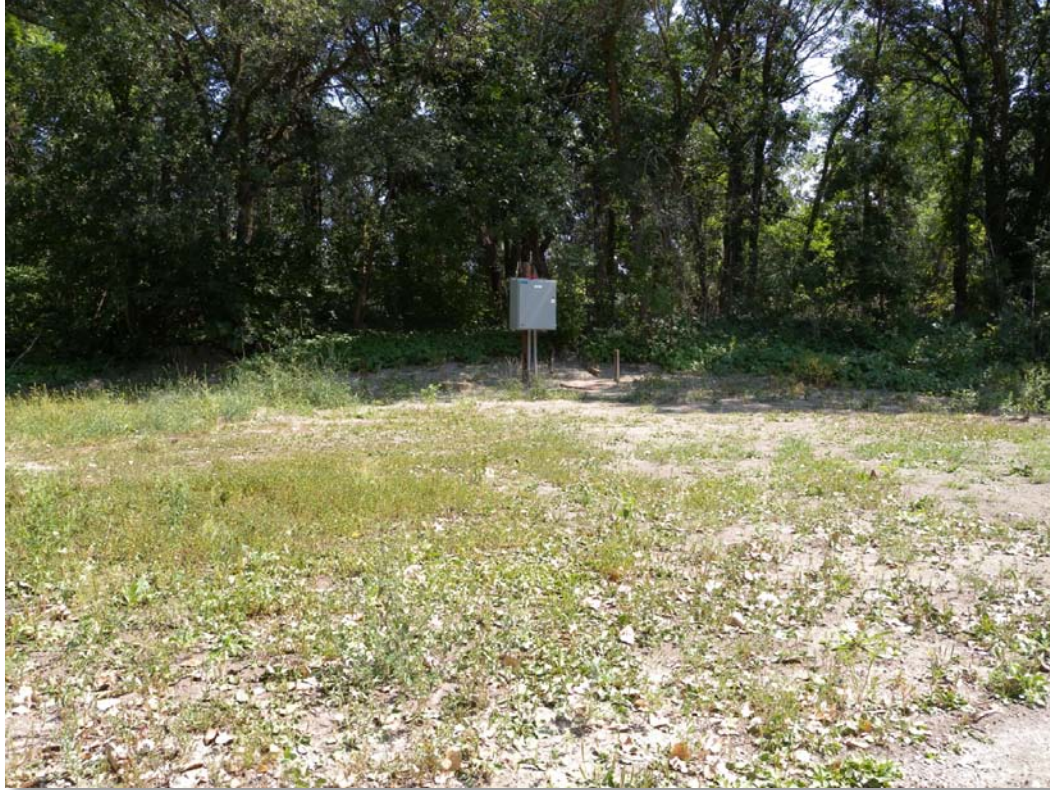
**Figure 3. Existing lift station.**

The existing lift station was visited during the survey; however it was evident that the replacement or upgrade construction would not affect heritage resources. The lift station is situated along a road leading into the lower bays of the Kiche Manitou Campground and is positioned on a built-up graveled area (Figure 3). The initial installation of the lift station and associated pipes would have disturbed the surrounding ground area and therefore has already undergone impacts. There are no heritage concerns for the upgrade or replacement of lift station.
